Gateway Asbestos and LBP Report

**SUBJECT: Asbestos Containing Material and Lead Based Paint Survey Results
Former Escondido Police Station
700 West Grand Avenue
APN 232-100-16-00
City of Escondido
County of San Diego, California 92025
EEI Project No. IPF-72198.1**

-REPORT-
ASBESTOS SAMPLING & LIMITED LEAD TESTING

For
Former Escondido Police Station
700 West Grand Avenue
Escondido, California

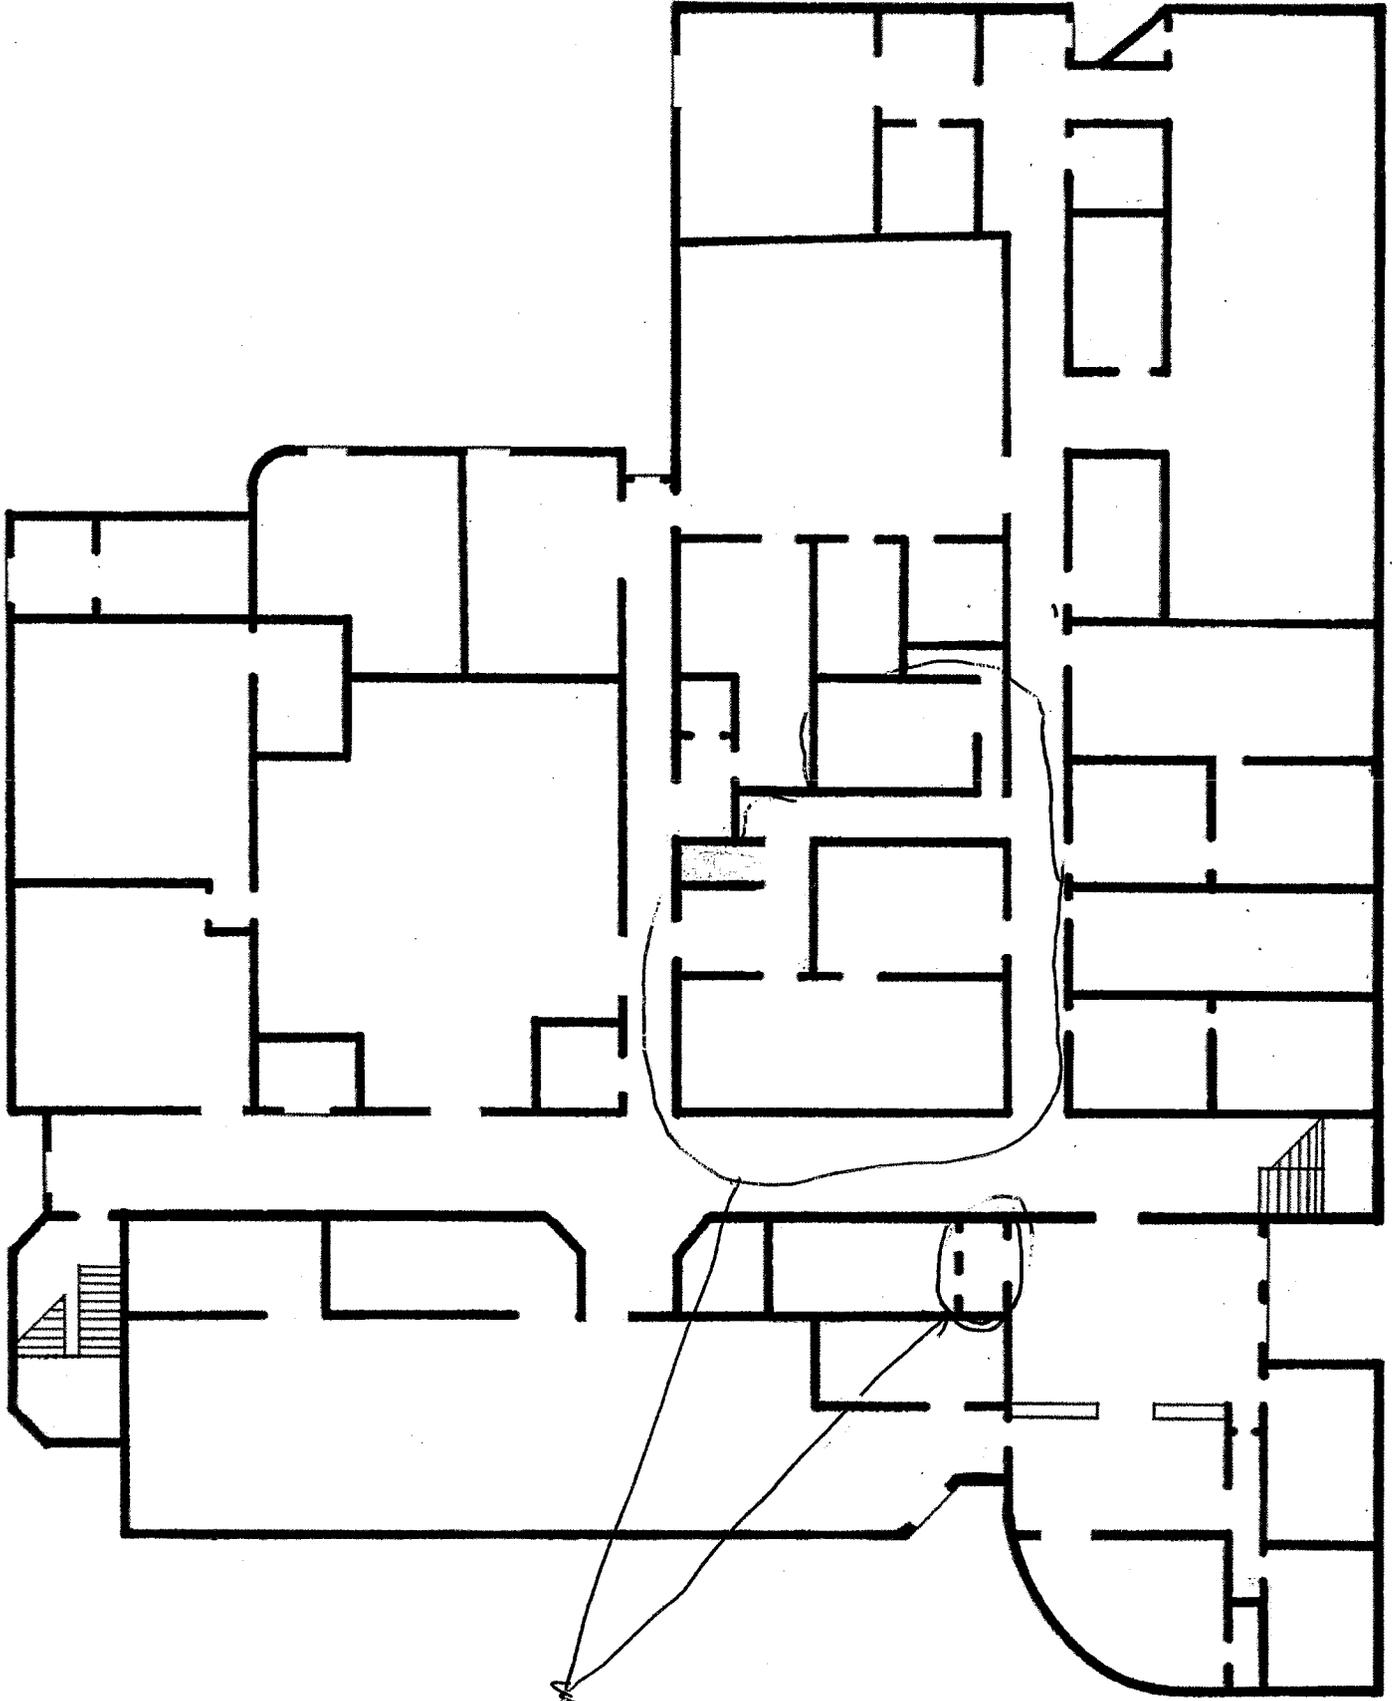
ESCONDIDO P.D. - FIRST FLOOR

XRF Test No.	Location	Component	Top Color	Substrate	Condition	Result (mg/cm ²)
8	1 st Floor Restrooms	Wall Tile	White	Tile	Intact	>9.9

P.E.
TILE
RESTROOM
WALLS

Any planned demolition/renovation activities that will impact lead components must be performed by certified/qualified representatives in compliance with EPA and DOSH rules and regulations. All lead coated components that are deteriorated or peeling should be stabilized in accordance with all applicable regulations prior to demolition work. A contractor who is trained and holds licenses and insurance in this field of hazardous materials remediation should conduct any lead related removal work. Exposure assessments and air monitoring should be conducted in the initial phases of any lead abatement to determine the amount of personal protection required by workers. All damaged loose and flaky lead will require removal prior to demolition activities. Lead components will need to be properly packaged and characterized utilizing TTLC, STLC and TCLP laboratory analysis as necessary to determine disposal requirements.
