**PRE-DEMOLITION
ASBESTOS AND LEAD-BASED PAINT
SURVEY REPORT**

**Palm Tree Lodge Motel
425 – 427 West Mission Avenue
Escondido, California**

Apex Project Number: 3616-A3021-001

December 20, 2016

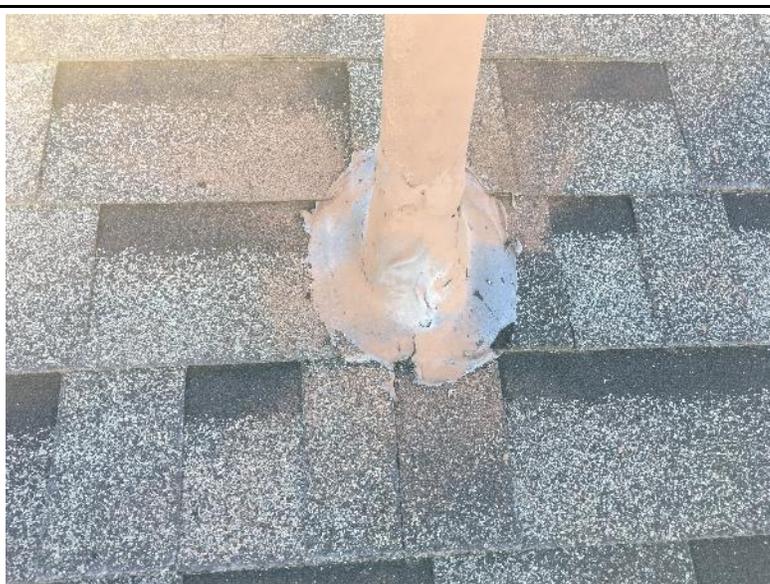
Photograph 3

View of the gray roof mastic on the roof of the restaurant.

ACM

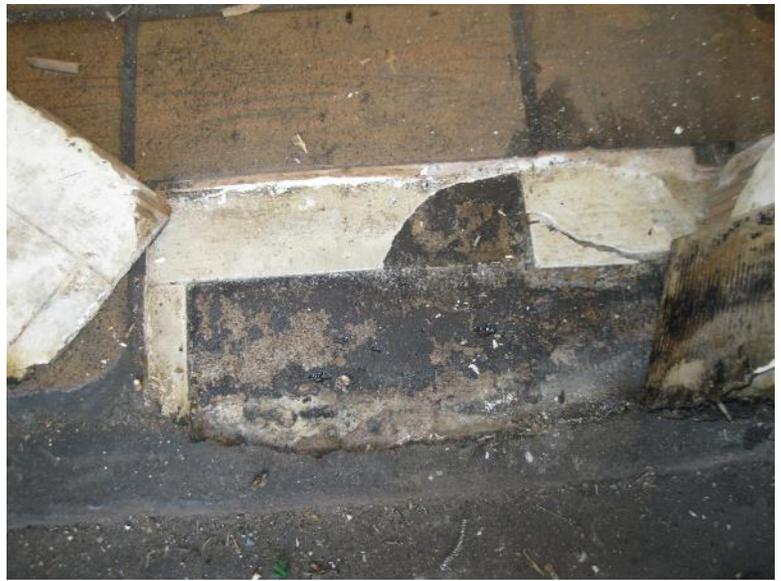
Photograph 7

View of the vinyl floor tile and associated black mastic beneath ceramic tile in the kitchen

ACM

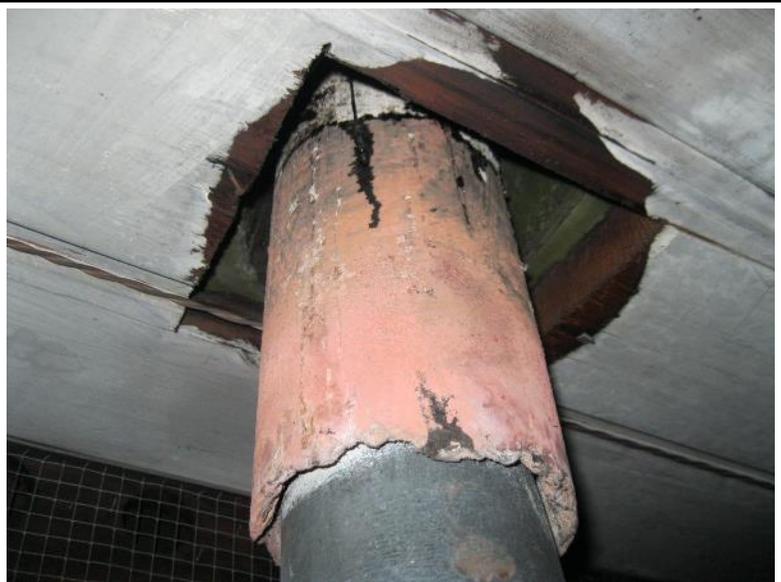
Photograph 8

View of the transite vent pipe attached to water heater vent

Assumed ACM

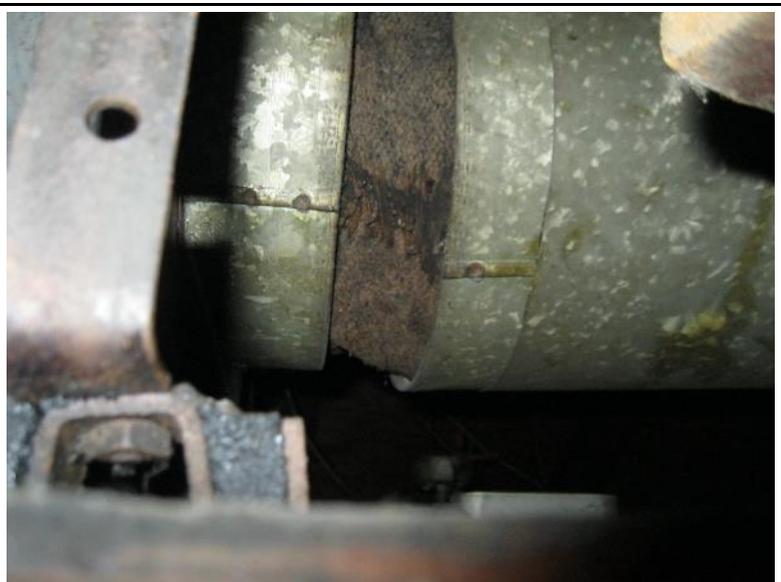
Photograph 9

View of the fibrous vibration joint attached to the fan above the restrooms

Assumed ACM

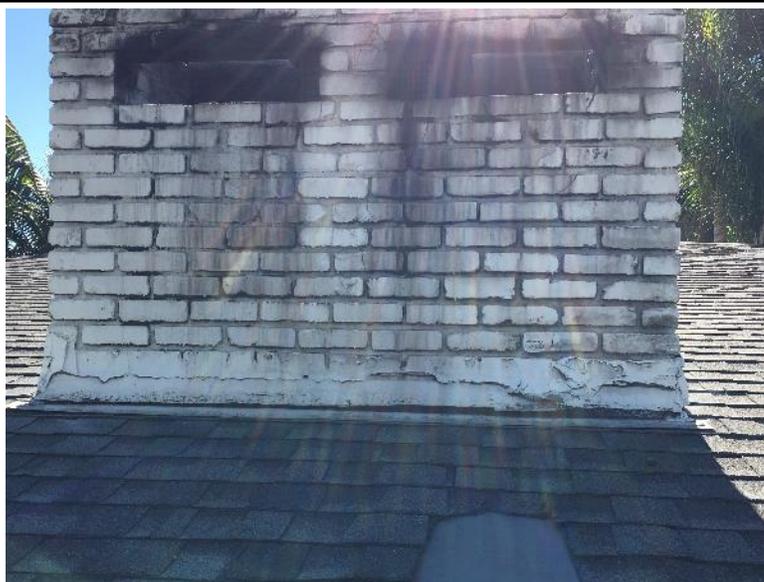
Photograph 11

View of the gray roof mastic around the chimney on the pool building roof

ACM

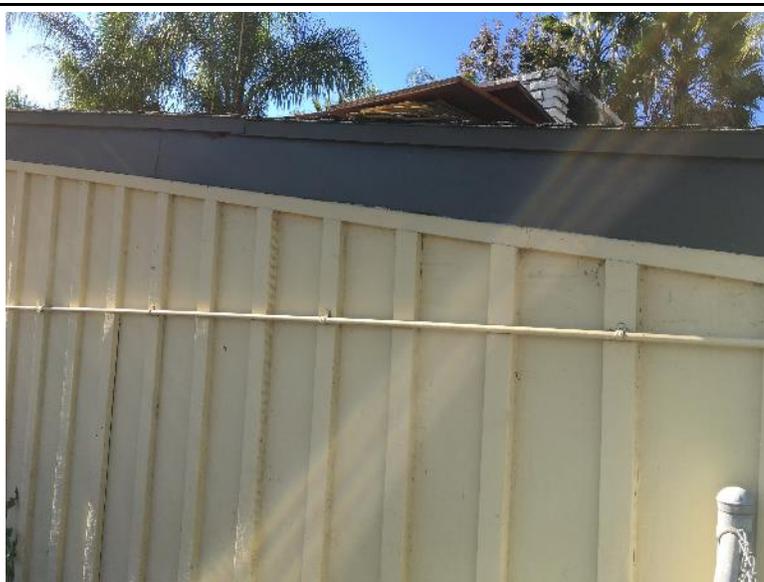
Photograph 12

View of the yellow exterior paint on the pool building

Lead-based paint

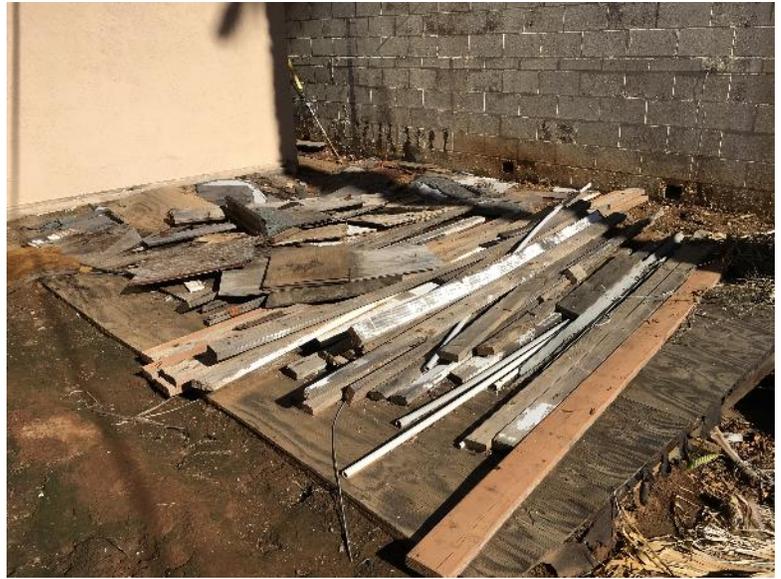
Photograph 13

View of the collapsed shed behind the main building. Roofing is mixed in with debris.

ACM

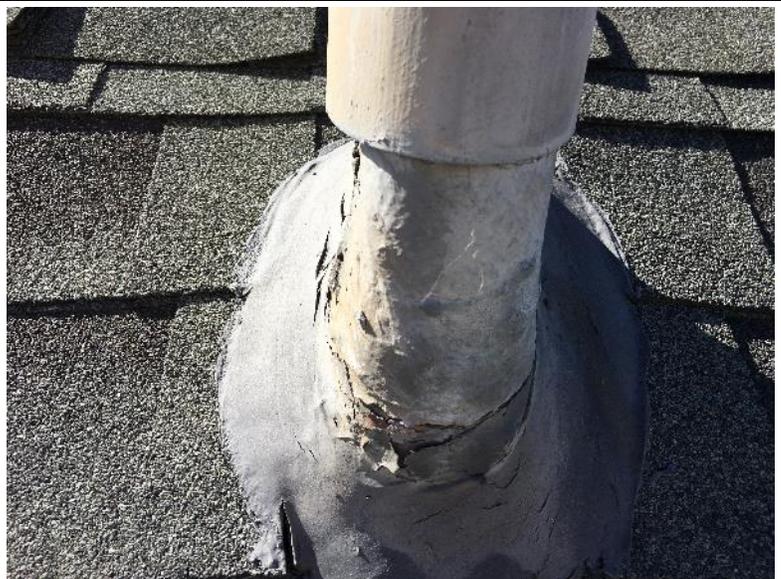
Photograph 15

View of the gray roof penetration mastic around a transite vent pipe penetrating the roof of the main building. Approximately 60 transite pipes are present in the building.

Mastic is ACM
Transite pipe is assumed ACM

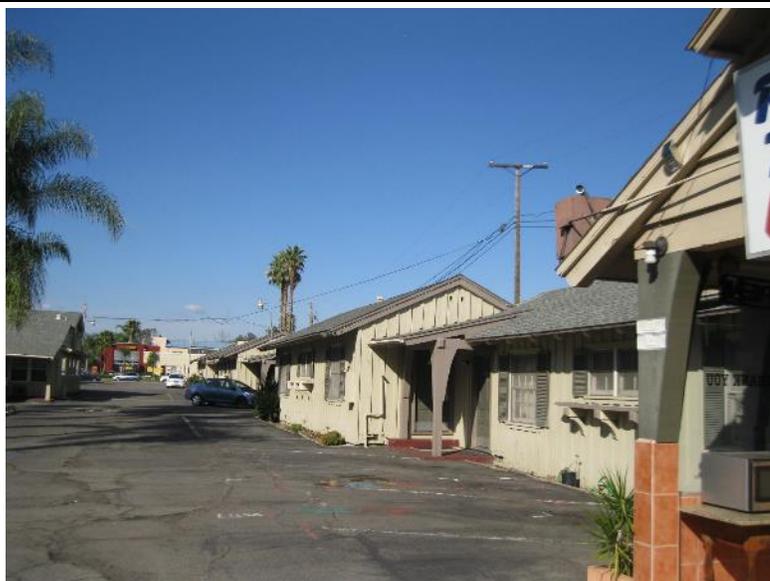
Photograph 16

View of window putty on small-paned windows of the main building

ACM

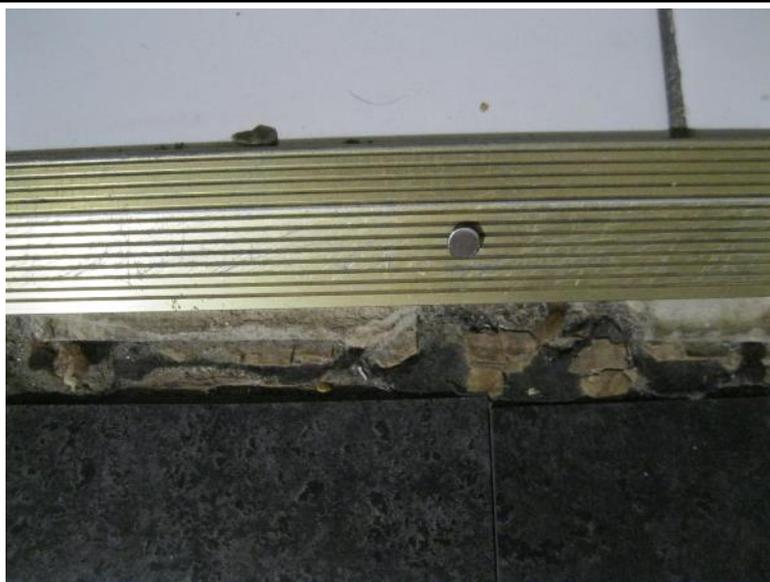
Photograph 17

View of aged brown linoleum beneath ceramic tile in bathrooms of all units

ACM

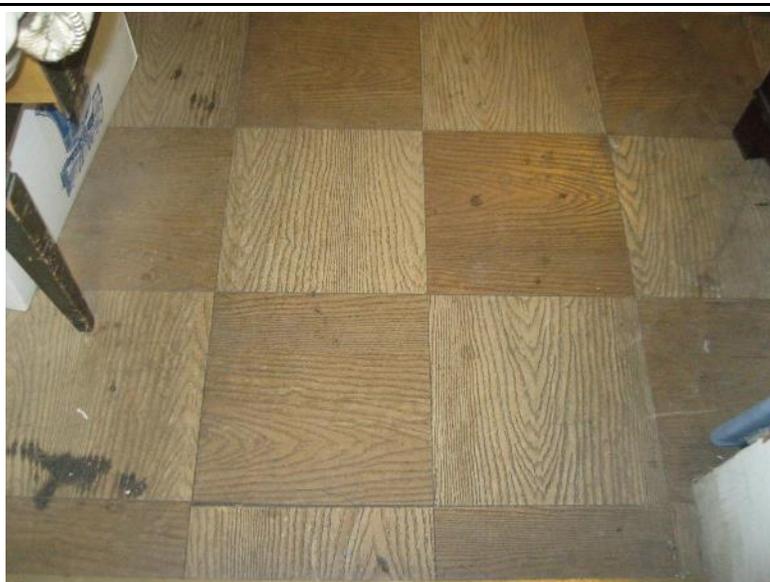
Photograph 18

View of wood-pattern linoleum within the laundry room

ACM

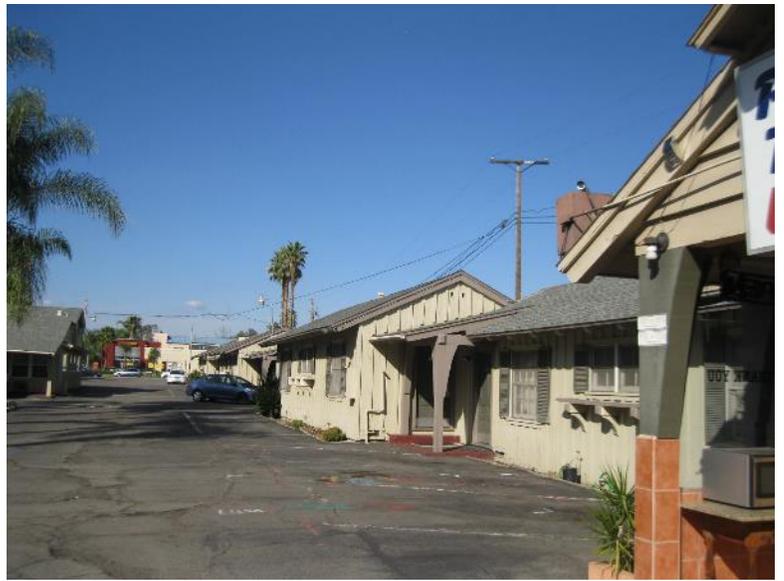
Photograph 19

View of brown paint on pillars and around doors, as well as dark brown paint on shutters

Lead-based paints

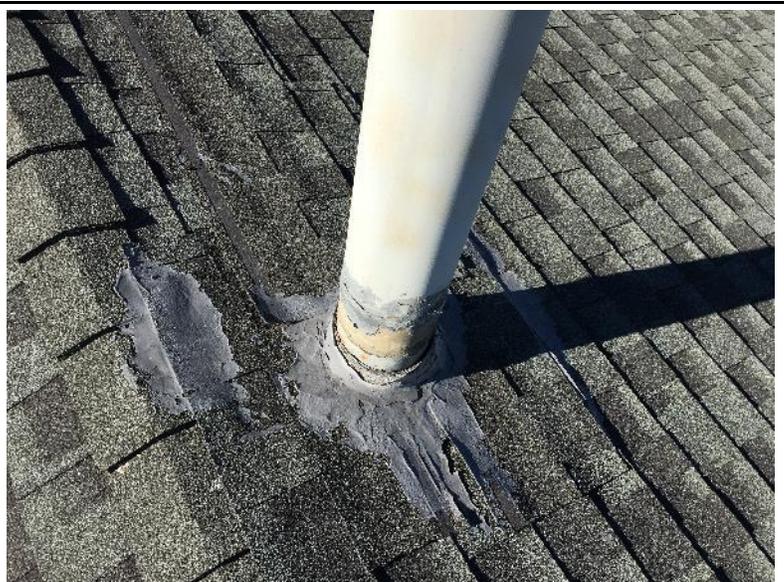
Photograph 21

View of gray roof penetration mastic on the roof of secondary motel building

ACM

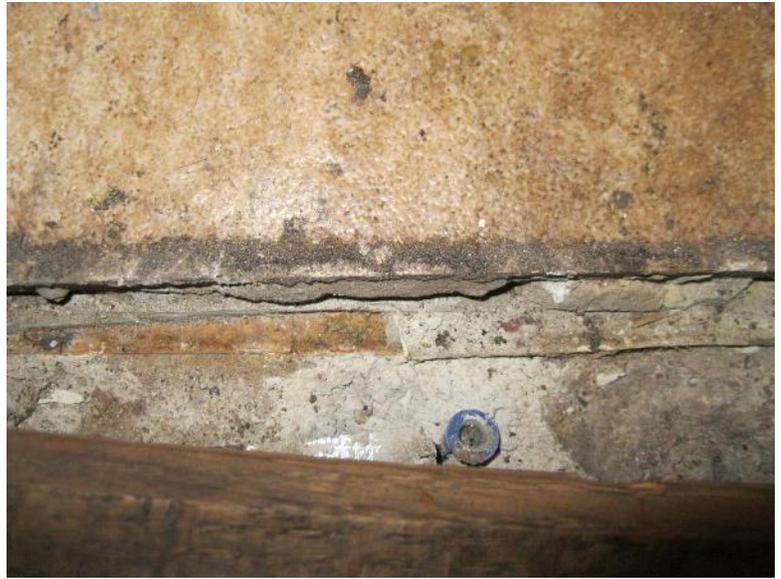
Photograph 22

View of old brown linoleum beneath
ceramic tile floors in bathrooms of
secondary motel building

ACM

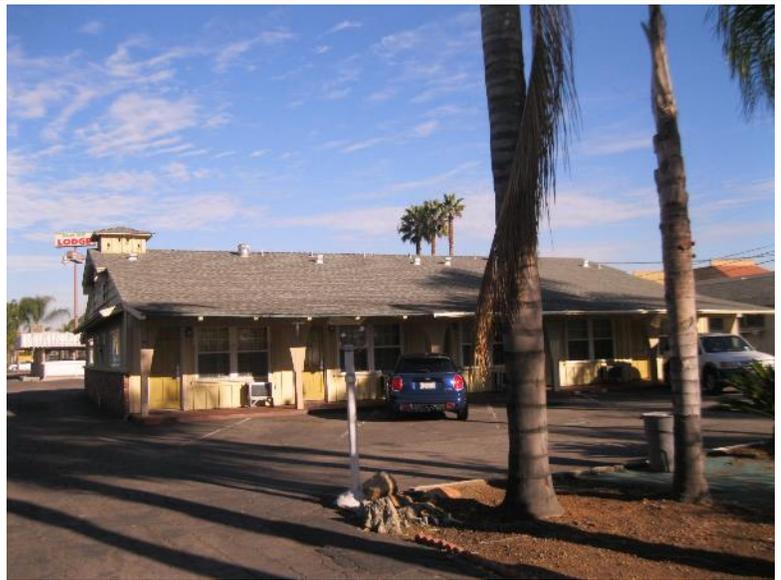
Photograph 23

View of the exterior of secondary motel
building, including beige paint on pillars
and trim

Lead-based paint
