Watershed Sanitary Survey Update

City of Escondido-Vista Irrigation District

Prepared for
City of Escondido and Vista Irrigation District
Escondido, CA
January 28, 2022

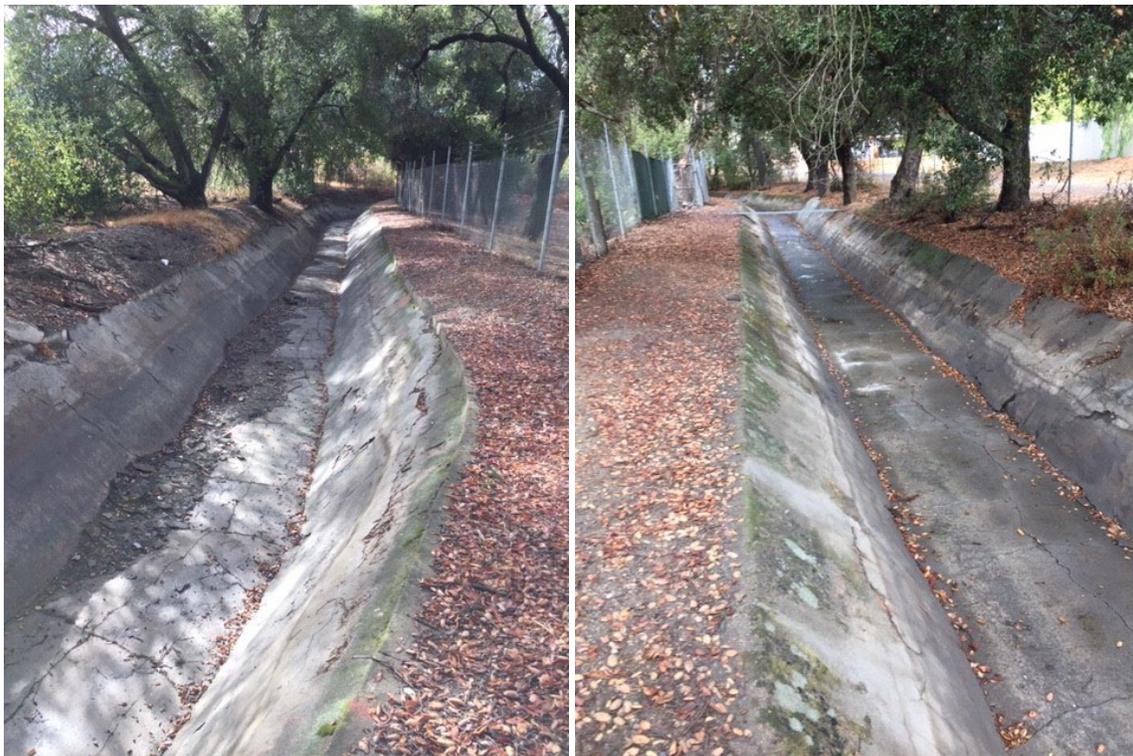
Figure 2-4. Escondido Canal segment near San Pasqual reservation, Downstream (left) and Upstream (right)

- (3) The Escondido Canal Watershed, located southeast of Pauma Valley, covers approximately 8,200 acres, or about 13 square miles. The Escondido Canal, comprised of concrete lined earthen ditches, hard rock tunnels, and steel siphons, was constructed in the 1890's and enlarged in the 1920's to convey Local Water to Lake Wohlford. The canal is owned and operated by Escondido and conveys water for the benefit of the Settlement Parties as described in the Settlement Agreement. The Escondido Diversion diverts water from the San Luis Rey River to the Escondido Canal, and flow in the canal is subject to both losses (primarily leakage from the canal) and gains (primarily runoff that washes into the canal). About 3 square miles of the watershed draining to the canal consist of steep mountain slopes, and runoff from high intensity storms can fill the canal. Landslides occasionally destroy or block portions of the canal, resulting in spills and loss of water. Water is generally not diverted into the Escondido Canal during the months of October and November, when the canal is shut down for scheduled maintenance. Figure 2-4 presents a photograph taken in mid-November 2021 of a portion of the Escondido Canal that will be replaced as part of the San Pasqual Undergrounding project.

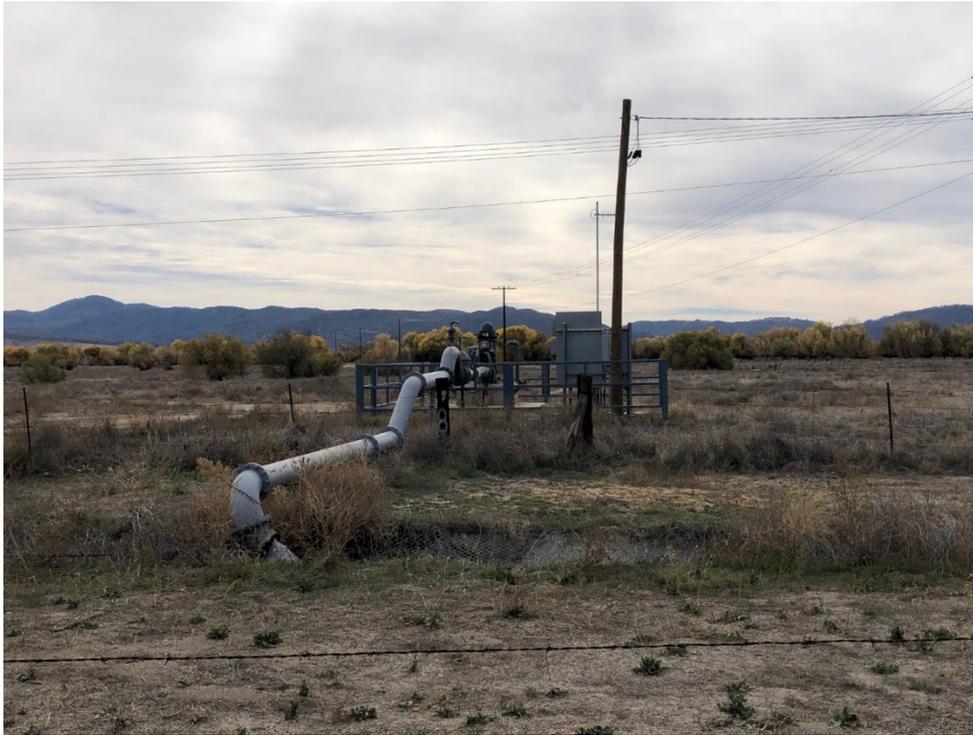
Figure 2-14. Lake Henshaw Groundwater Pumps

Figure 2-14 shows Lake Henshaw groundwater pumps for Warner Valley Groundwater Basin.

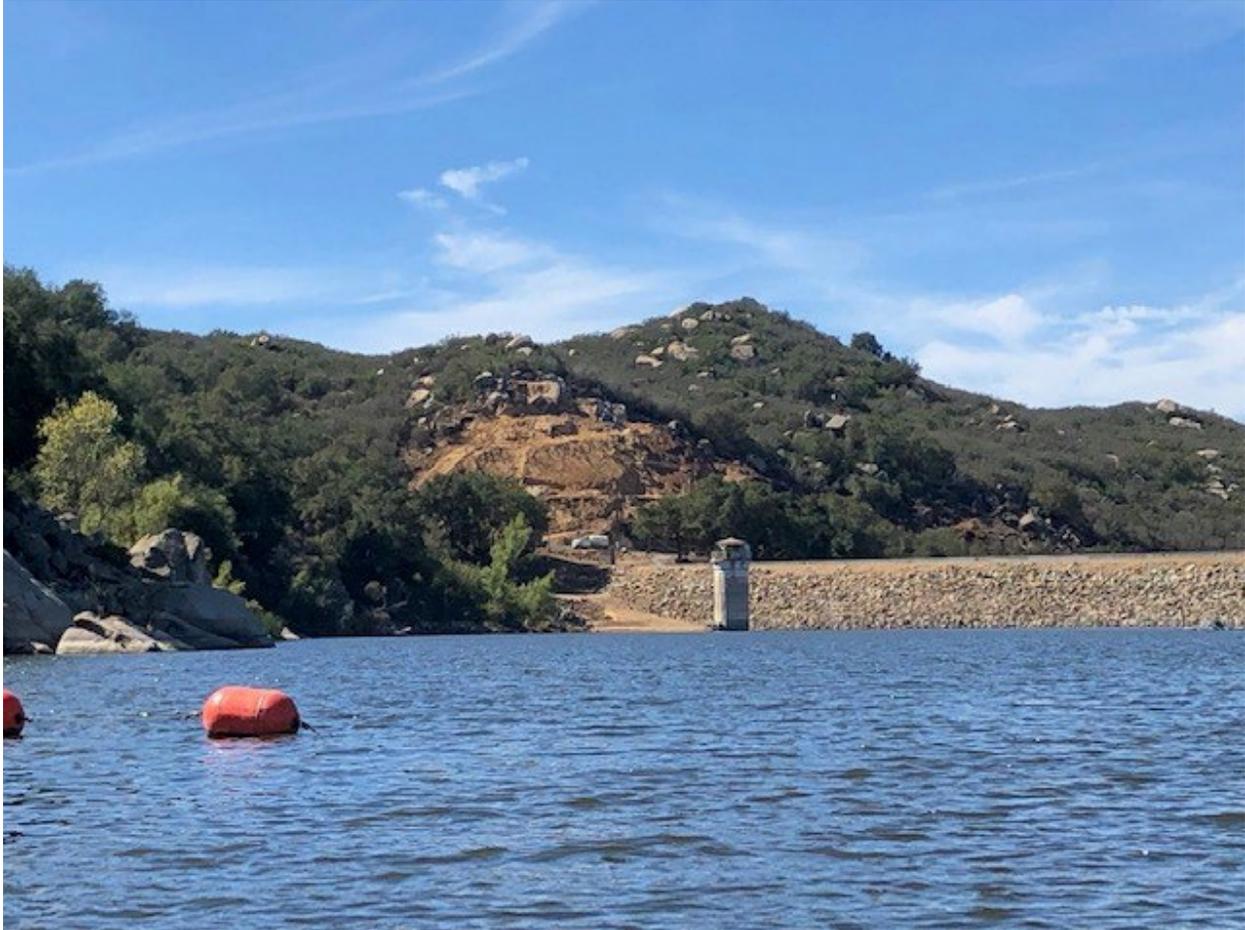
Figure 2-16. Lake Wohlford Dam Replacement Construction

The Lake Wohlford Dam Replacement Project would raise the dam crest approximately 120 feet above the foundation grade to an elevation of 1,490 feet, and the crest would span approximately 775 feet. The new roller compacted concrete dam will be located approximately 200 feet downstream of the existing dam and will inundate areas that have been dry since 2007 (Escondido-VID, 2016). Potential water quality impacts are not expected to be significant according to the project's September 2020 Final EIR but may warrant additional sampling before and after implementation of the project and an increased surveillance of water quality data obtained as water level increases. Figure 2-16 shows a photograph of construction on the Lake Wohlford Dam Replacement project.

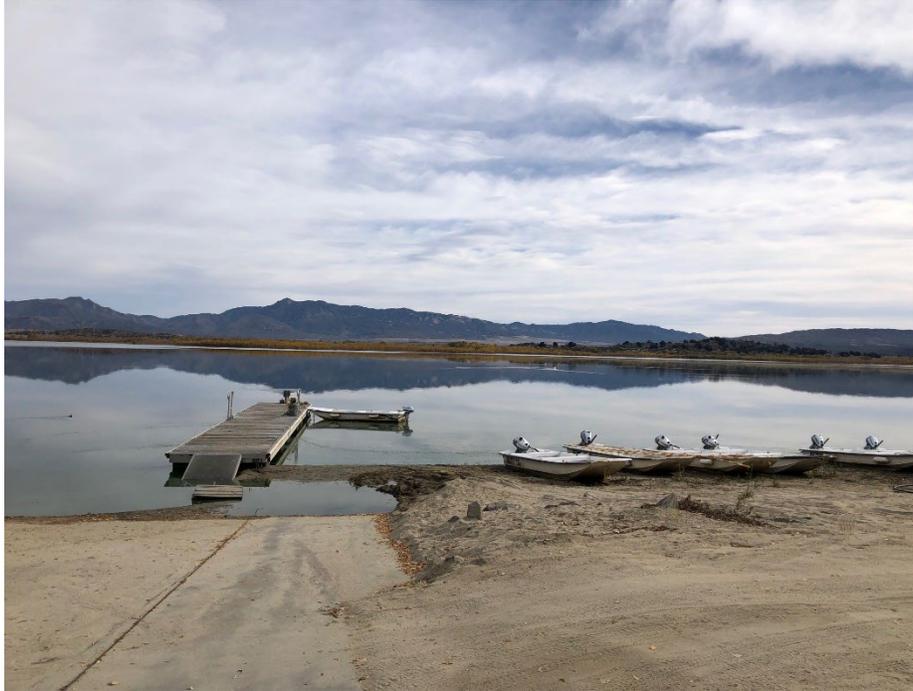
Figure 3-6. Lake Henshaw Boat Docking Area

Lake Henshaw. Lake Henshaw is managed by VID Water Resources personnel. The 66-square mile area owned by VID that includes Lake Henshaw and its surroundings is fenced, and access is restricted by locked gates. "No Trespassing" signs are posted frequently along the fence. Fishing from boat and shore are allowed; swimming and body contact activities are prohibited. Access to the dam and intake areas is limited by on-shore fences and in-water buoy lines. The fences, over 200 miles in length total, are maintained by the ranchers as part of their grazing lease with VID. The ranchers' presence also provides additional surveillance of this major watershed area. Figure 3-6 and Figure 3-7 show the boat docking area and a warning sign for algae toxins (respectively) taken during the site visit.

² At Lake Henshaw, lake users that bring their own boat are asked where they have been before Lake Henshaw. Boats are inspected, and if needed, they are steam cleaned before given access to the lake to prevent the introduction of quagga mussels.

Water has not been released to the San Luis Rey River during periods of high cyanobacteria concentrations. Advisory signage is posted near the Lake Henshaw boating dock as shown in Figure 3-6. Caution signage is posted above 0.8 µg/L, warning signage above 6.0 µg/L, and danger signage above 20.0 µg/L.

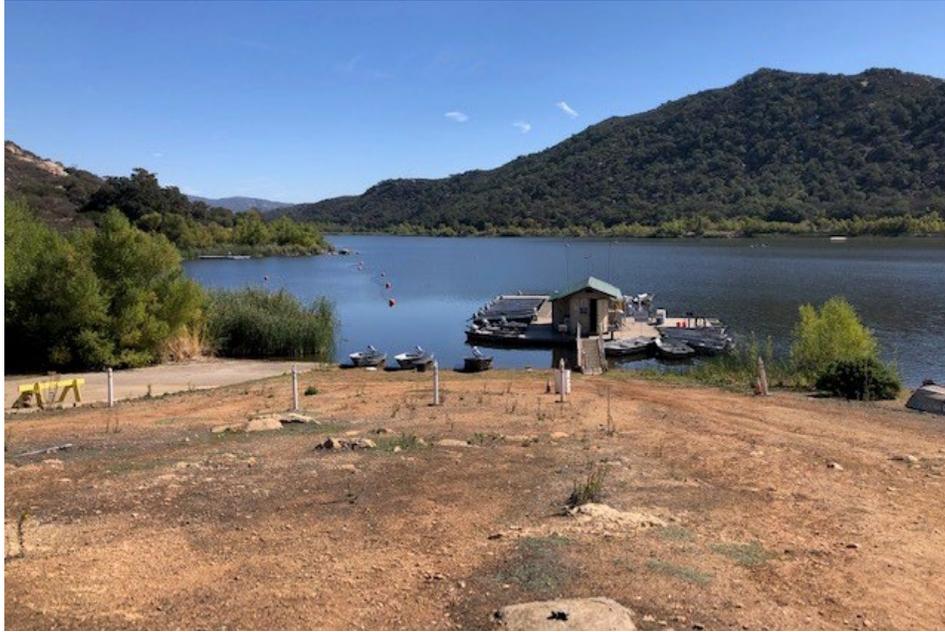
Figure 3-8. Lake Wohlford Boat Docking Station

Lake Wohlford. Lake Wohlford is owned and managed by the City of Escondido. Direct management and surveillance at the lake are provided by park rangers. No swimming or body contact is allowed. Access to Lake Wohlford is limited to the north and south shores. In-water buoy lines and on-shore fences restrict access to the dam and intake areas, and to the lake inflow areas. Figure 3-8 shows the Lake Wohlford boat docking area and Figure 3-9 presents signage on prohibited activities.

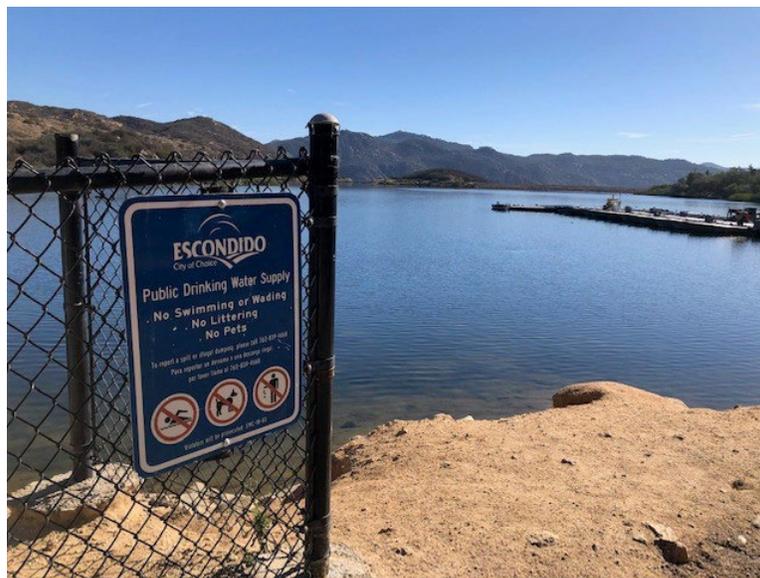
Figure 3-11. Dixon Lake Education Signage

Dixon Lake. Dixon Lake is owned and managed by the City of Escondido. Access to Dixon Lake is restricted in the vicinity of the dam and intake by in-water buoys and on-shore fences. Direct management and surveillance at the lake are provided by park rangers. No swimming or body contact is allowed. A campground is located on a hill on the southwest side of the lake. During storm events, campground runoff could make its way to Dixon Lake. Figure 3-10 shows the Dixon Lake recreation area, Figure 3-11 presents signage on prohibited activities, and Figure 3-12 shows the boat docking area.
