APPENDIX A

REPORT OF THE SEISMIC REFRACTION SURVEY

(PREPARED BY: SUB SURFACE SURVEYS)

Attn: **Robert Merrill** re: Seismic refraction survey, ISKCON Cultural Ctr, Escondido, CA

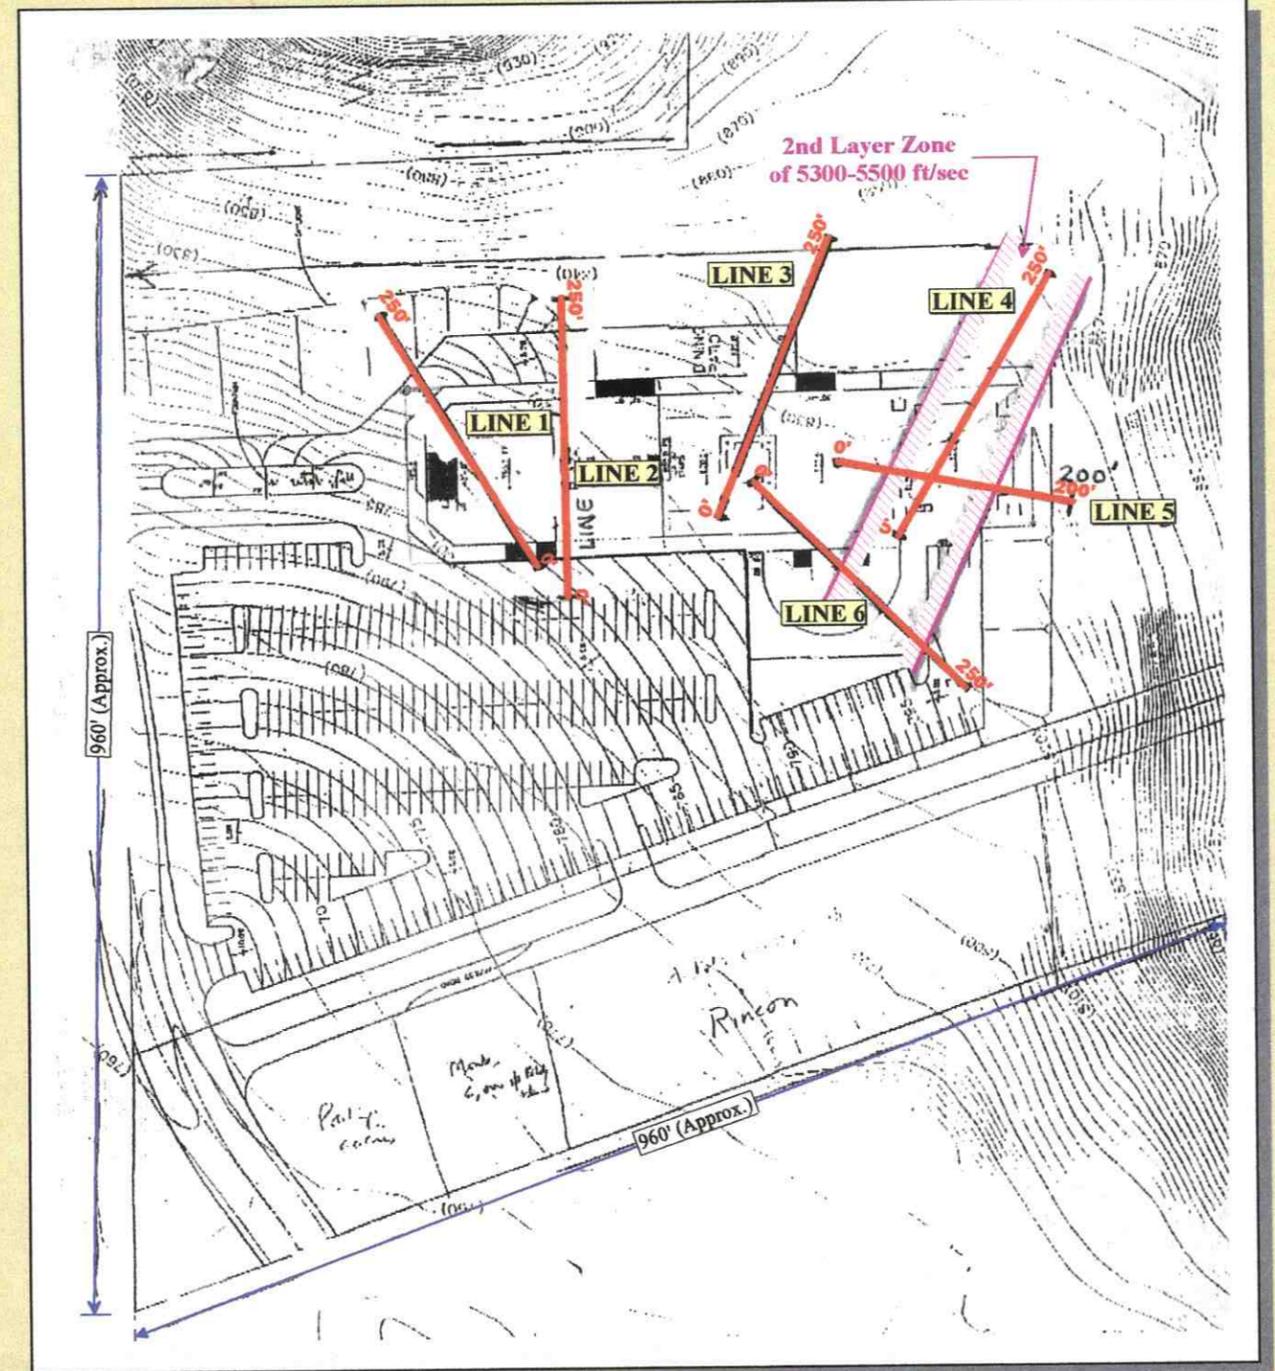
FIGURE 2

Survey Design - Locations of the six seismic lines, numbered 1 through 6, are illustrated (Fig. 2). It is seen that each of the lines is located so that it is both on and off the building footprint, with some lines off on both sides of the building. Spread lengths are 250 feet from off end shot to off end shot. Geophone interval was 10 feet, and there was a 10 foot offset from off end shots to nearest geophone. There was also a 20 foot gap between geophones 12 and 13 where the split spread shot was fired. The exception, line 5, had a geophone interval of eight feet with eight foot off end shot offsets and a 16 foot gap between geophones 12 and 13 where the split spread shot was fired. The reason for the shortened geophone interval on line 5 was that a topographic and flora barrier to the south effectively prevented further expansion in that direction. These spread lengths allow for an investigation to depths of approximately 75 feet, and 60 beneath line 5. This is significantly deeper than any planned cut slopes. The spreads were shot forward, split spread and reverse. This redundancy aids in determining dip and undulations in layer boundaries.

LINE LOCATION MAP

modeling program averaged velocities under these lines, and part of lines 5 & 6 are off this zone. The zone is depicted by color on the line location map (Fig. 2). Line 4, totally within the zone, more closely defines the zone's velocity properties; the velocity analysis of lines 5 & 6 approximately defines its edges.

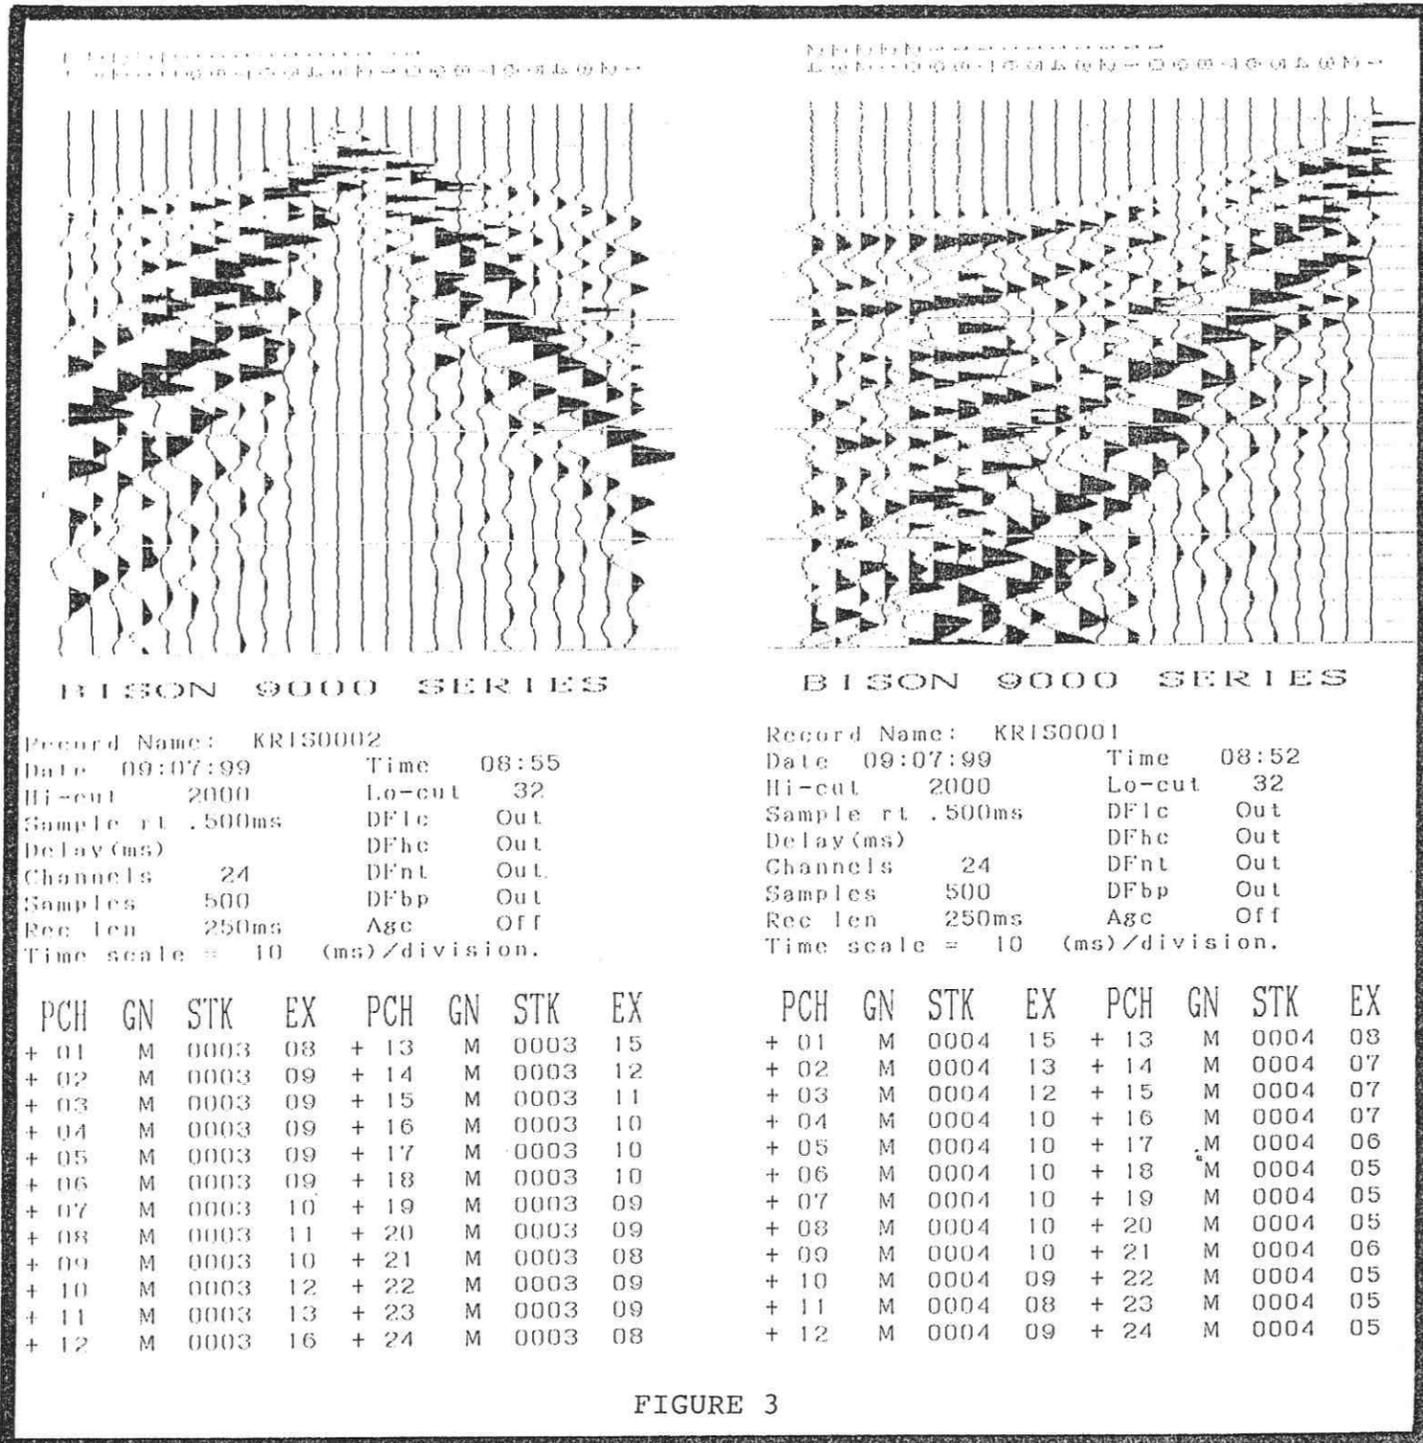
FIGURE 3

Interpretation - Monitor records are produced in the field with each shot. These are prints of the raw data as it comes in to the recorder. They show the quality of the data, so that the operator can determine whether or not the data are pickable, or shots need to be repeated. Two representative monitor records, one a split spread shot from line 1 and a forward shot from the same line (Fig. 3) are illustrated.

First energy arrivals are seen to be quite sharp on the raw records, although some very minor wind noise is coming in mostly on the far offset traces. This is not uncommon for off end shot records. Even so, with use of a computer picking program, with zoom, filtering, etc., there was no difficulty in picking the first energy arrivals. There should not be significant variation in picked arrival times should first breaks be picked by several persons independently.

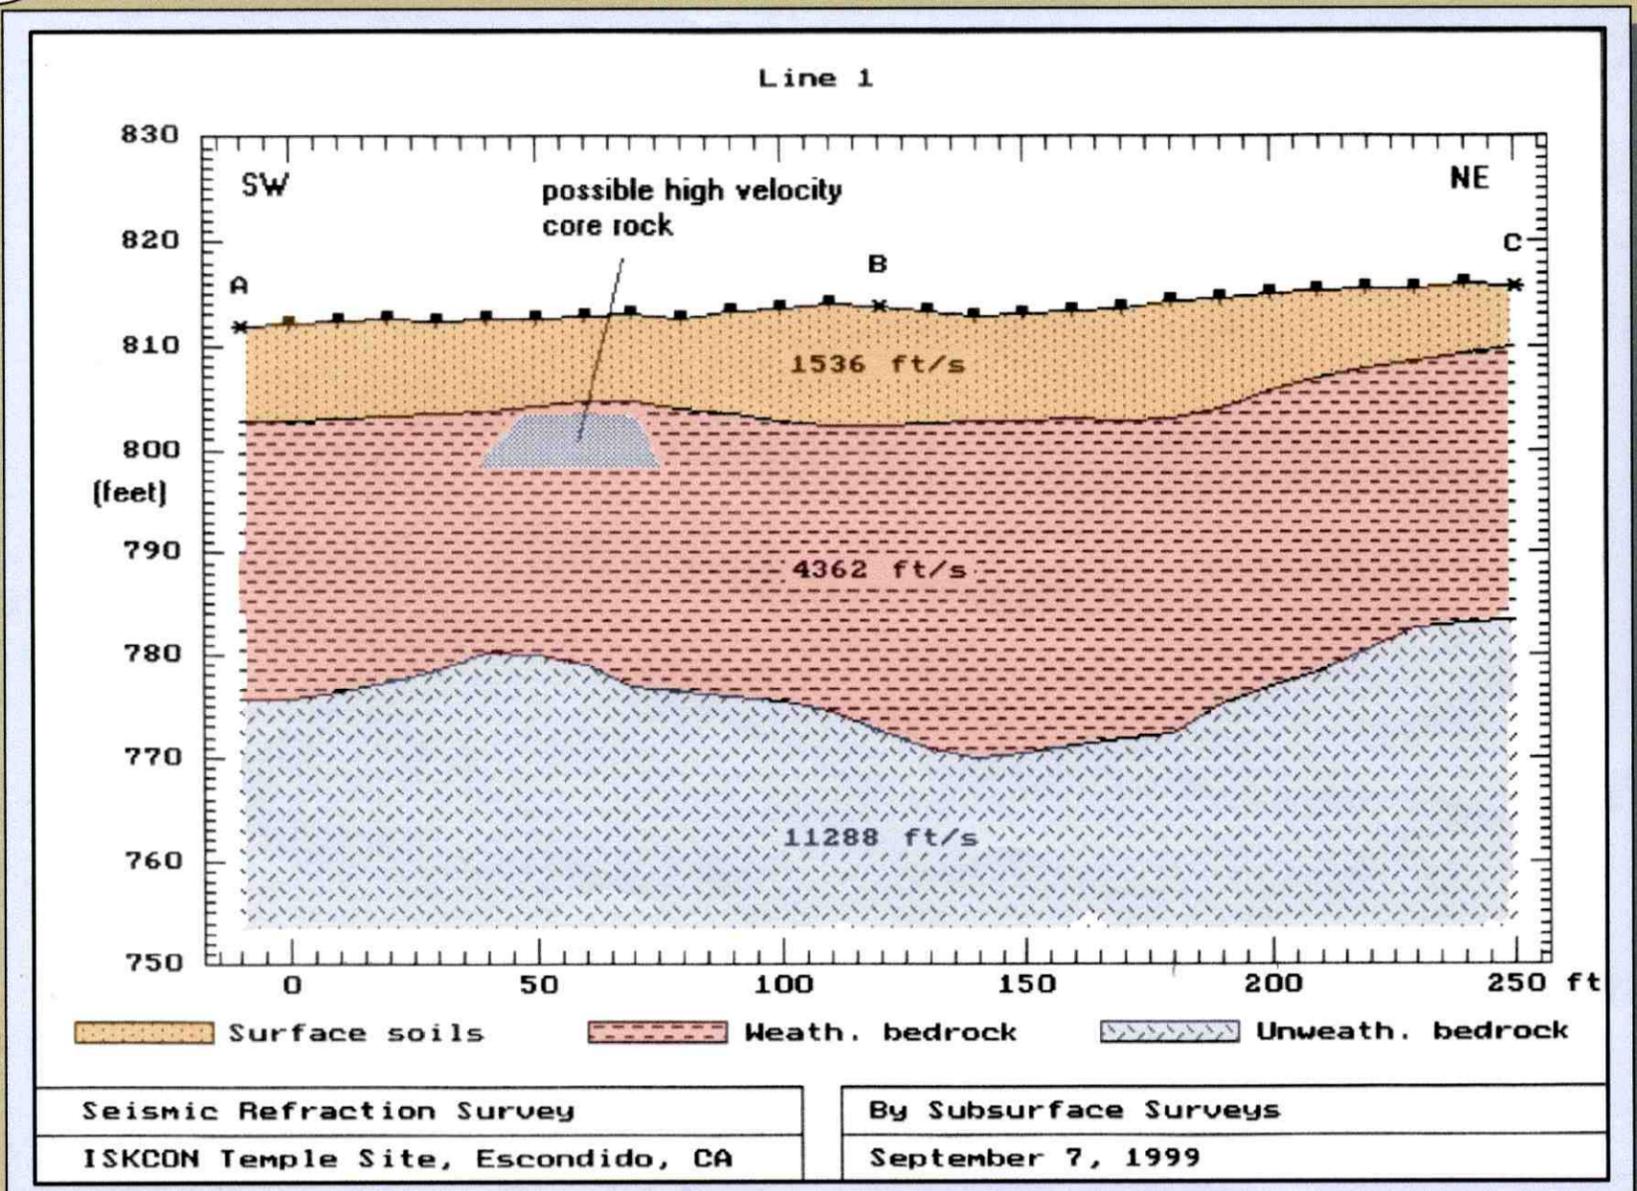
FIGURE 9

There is a very local relatively high velocity zone under line 1 (See Fig. 9). This could be another small dike. There is also a possibility that it is a core rock, but these usually do not occur alone. At any rate it appears to be rippable with heavy equipment.

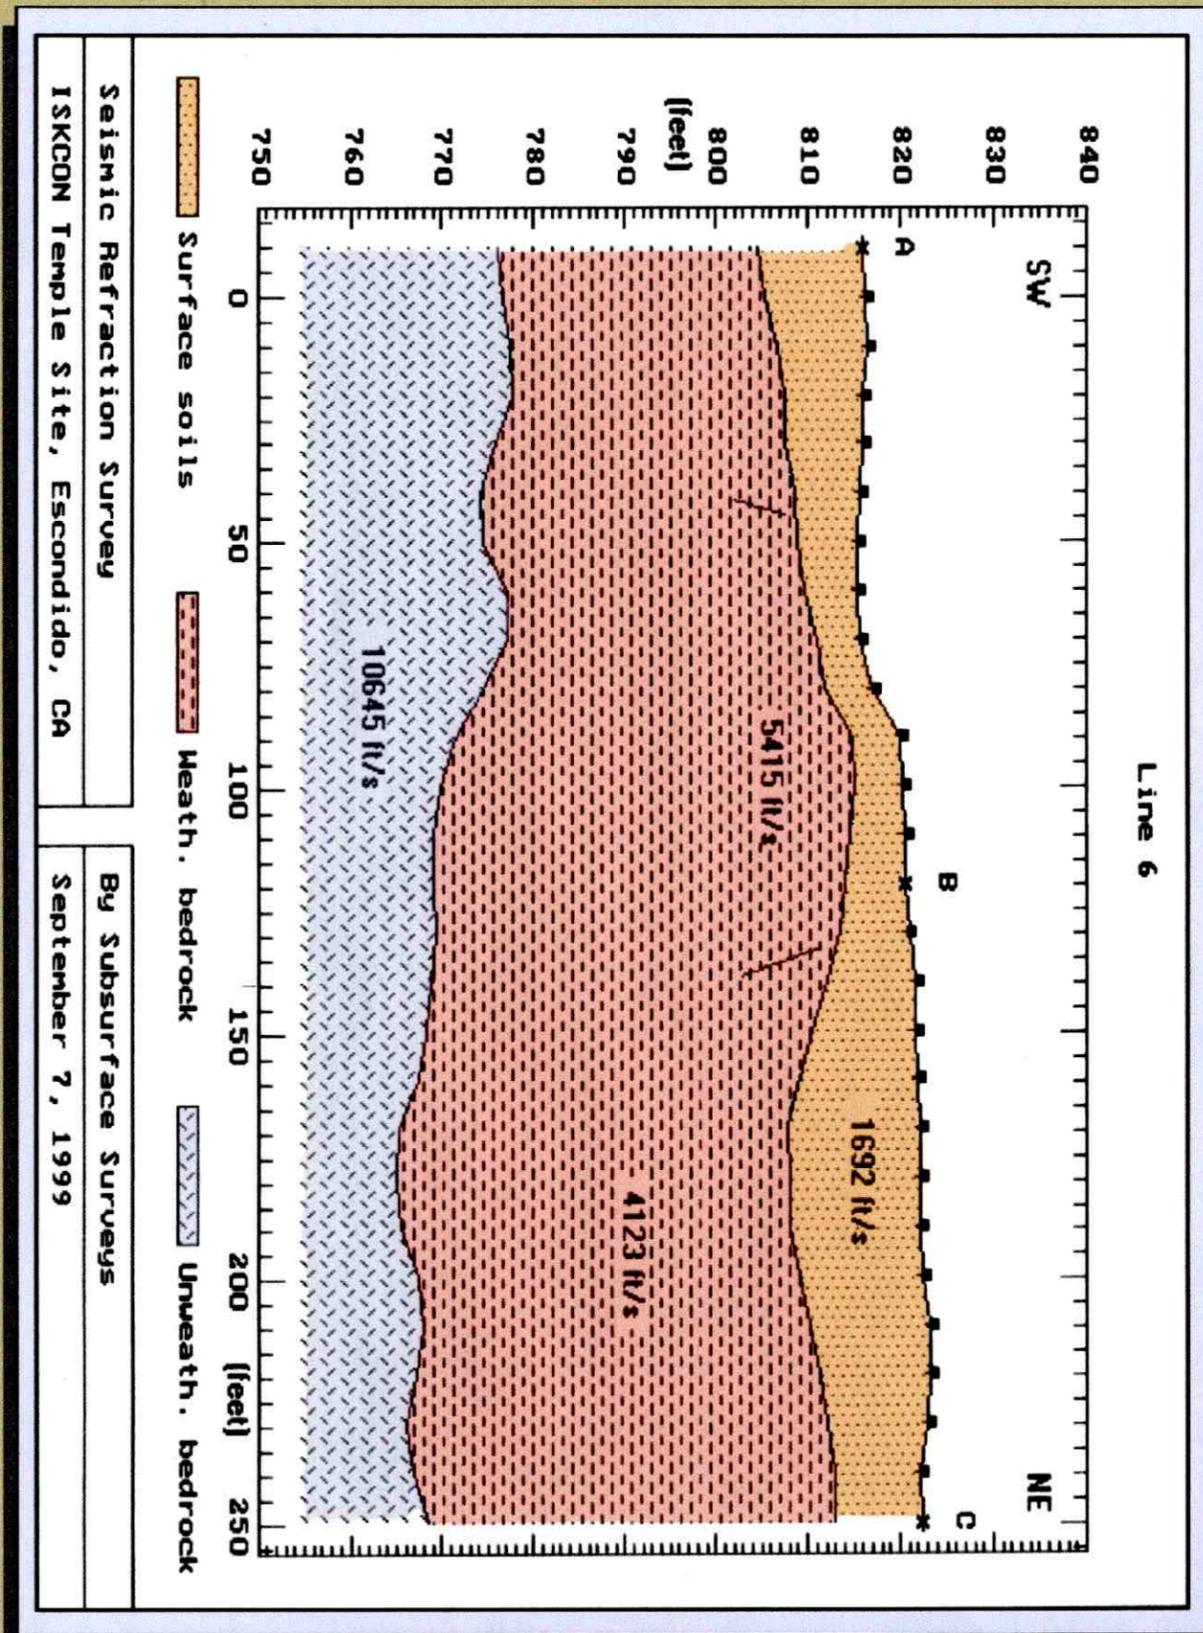
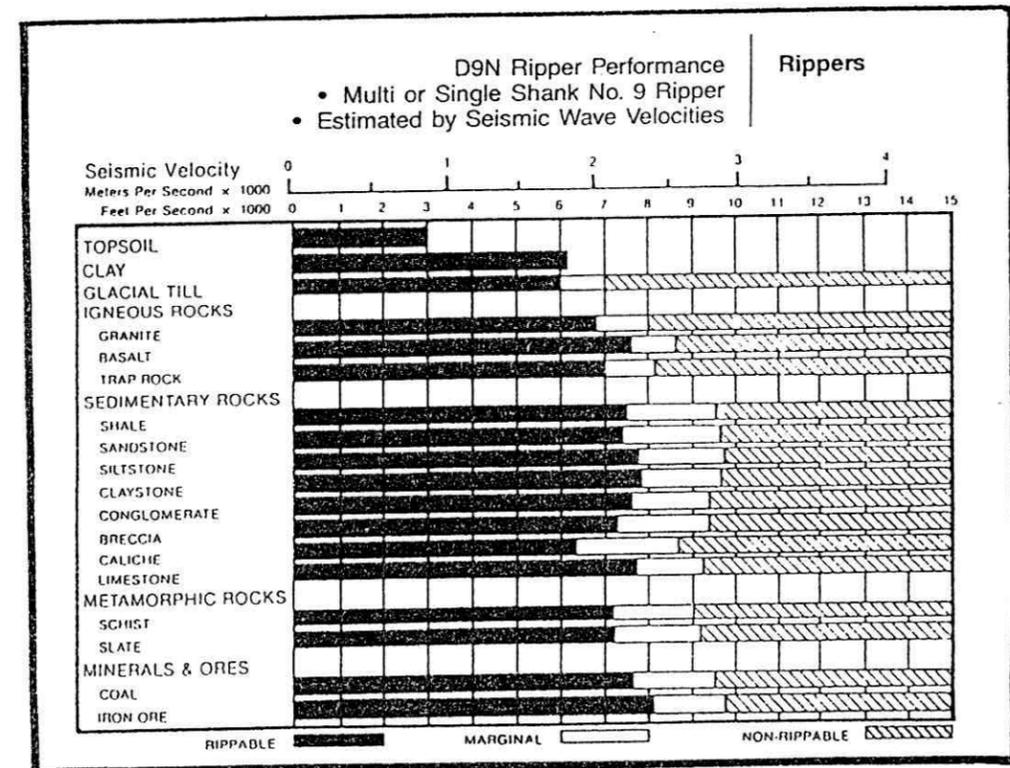
Figure 15. Caterpillar rippability chart

The Caterpillar Rippability chart is illustrated (Fig. 15) and is the basis for determining rippability of the rocks encountered in the survey. The chart is empirical, but is based on thousands of field and laboratory samples. It is seen that layers 1 and 2 are easily rippable everywhere sampled. Layer 3, to the extent of sampling, should be considered non-rippable, even with heaviest equipment. Its closest distance from the surface is approximately 25 feet under line 2. Everywhere else, where sampled, it is deeper from the surface. Thus, it appears that non-rippable rock will not be encountered in the foundation work for the Temple and Cultural Center.

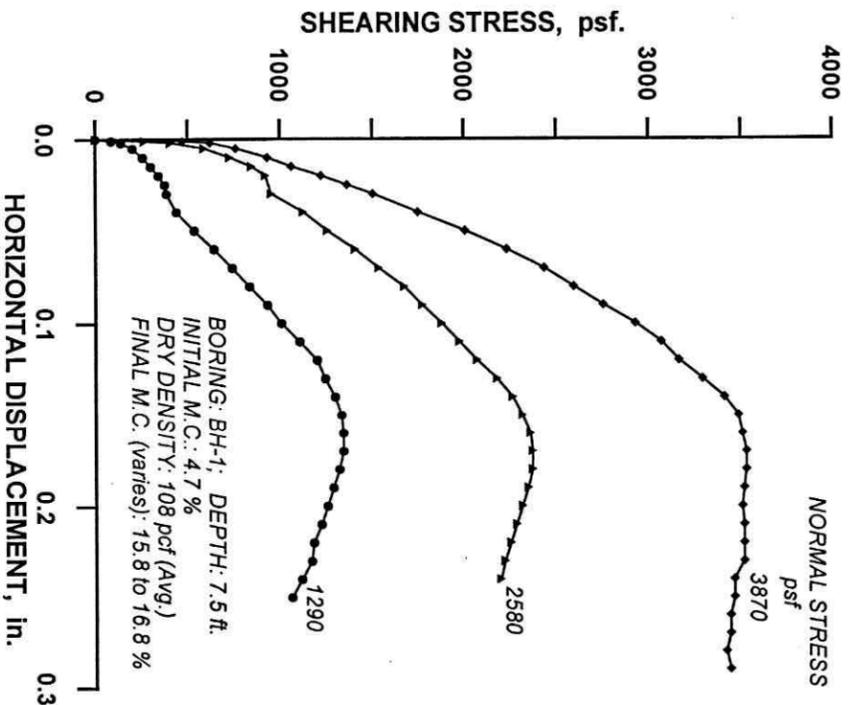
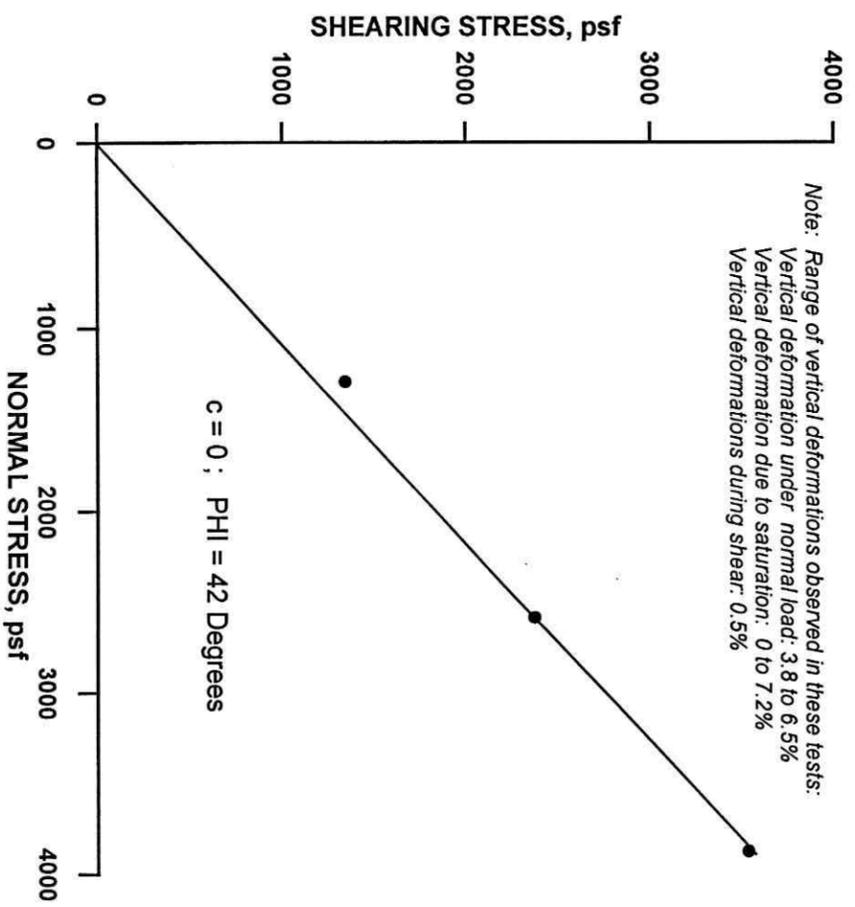
RESULTS OF DIRECT SHEAR TESTS			
ISKCON CULTURAL CENTER			
Job No.	Date	Drawn By	Figure
99-020	OCT. 1999	B.R.	C-5

a) SHEARING STRESS / DISPLACEMENT CURVES

b) STRENGTH ENVELOPE

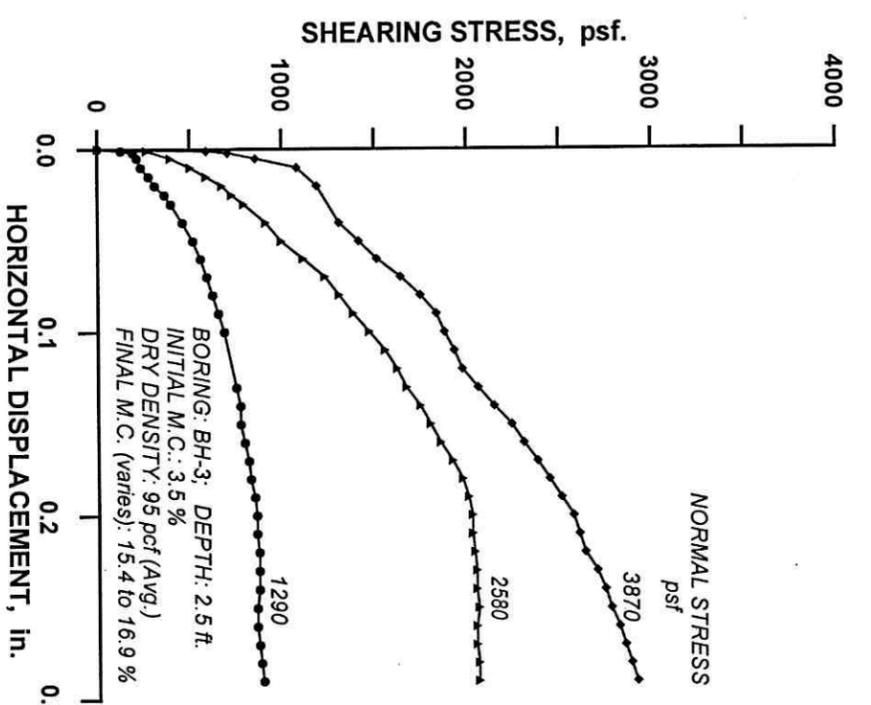
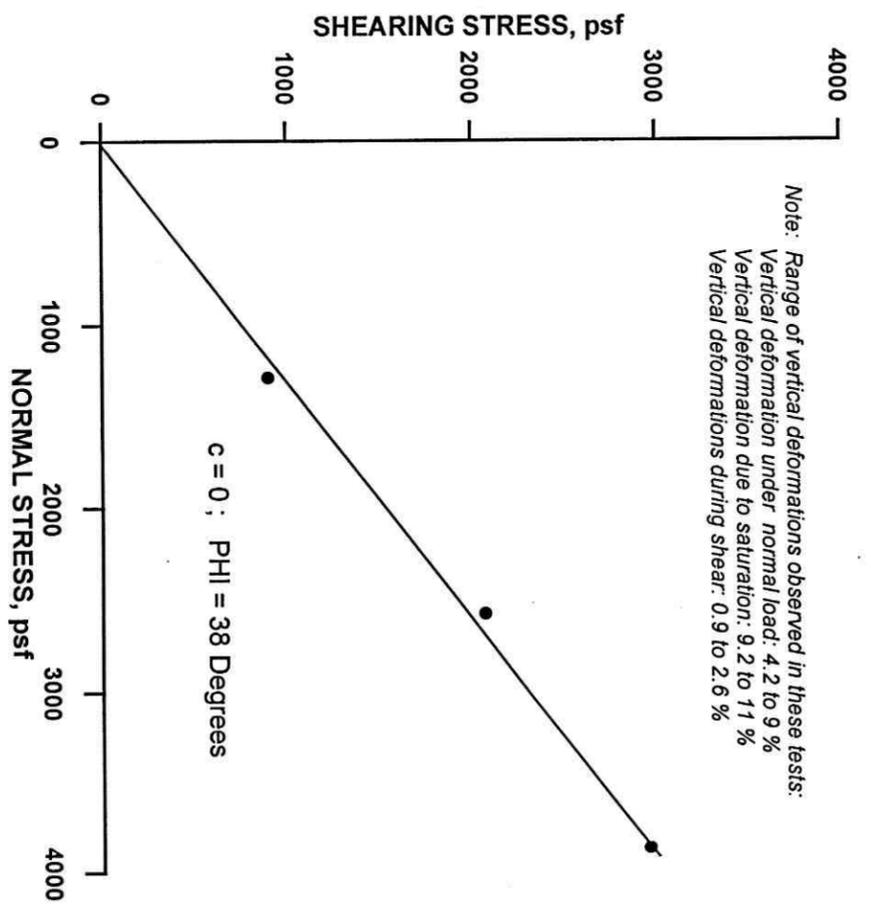
RESULTS OF DIRECT SHEAR TESTS			
ISKCON CULTURAL CENTER			
Job No.	Date	Drawn By	Figure
99-020	OCT. 1999	B.R.	C-4

a) SHEARING STRESS / DISPLACEMENT CURVES

b) STRENGTH ENVELOPE

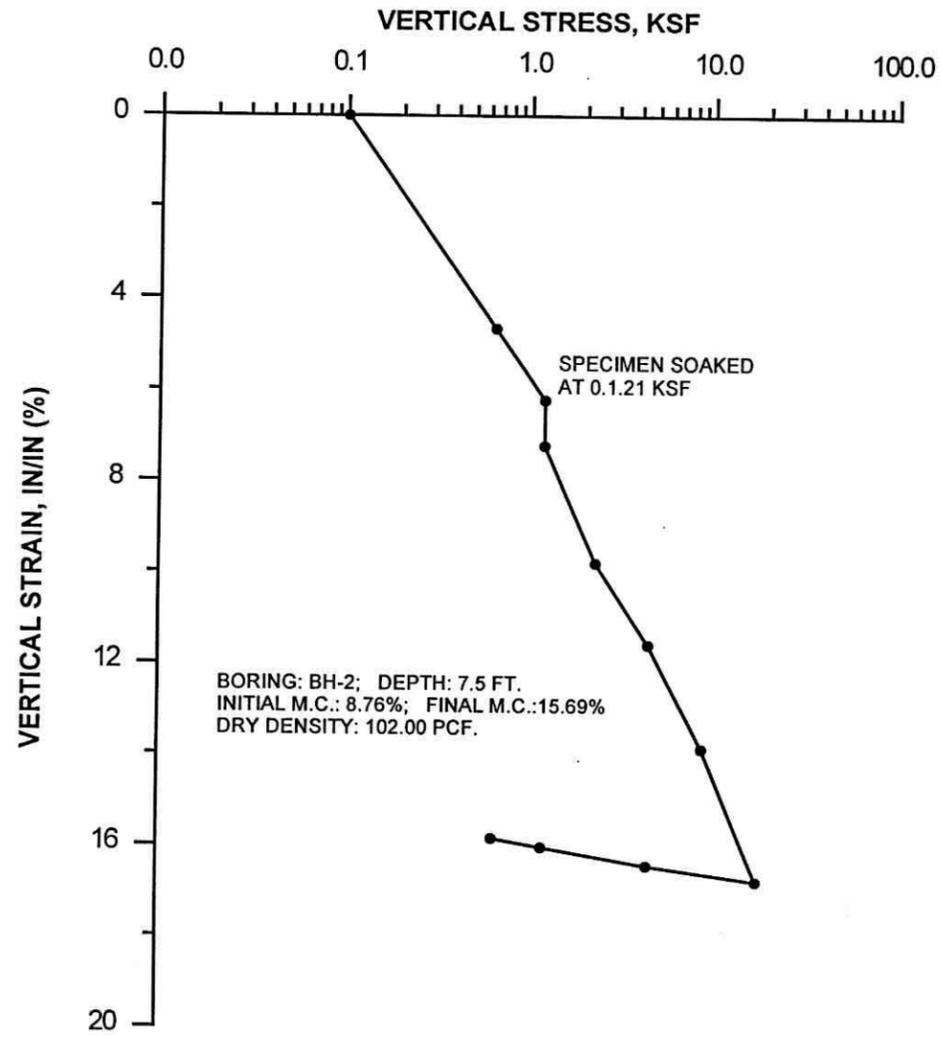
Job No.	Date	Drawn By	Figure
99-020	NOV. 1999	K.R.	C-7

RESULTS OF 1-D COMPRESSION TEST

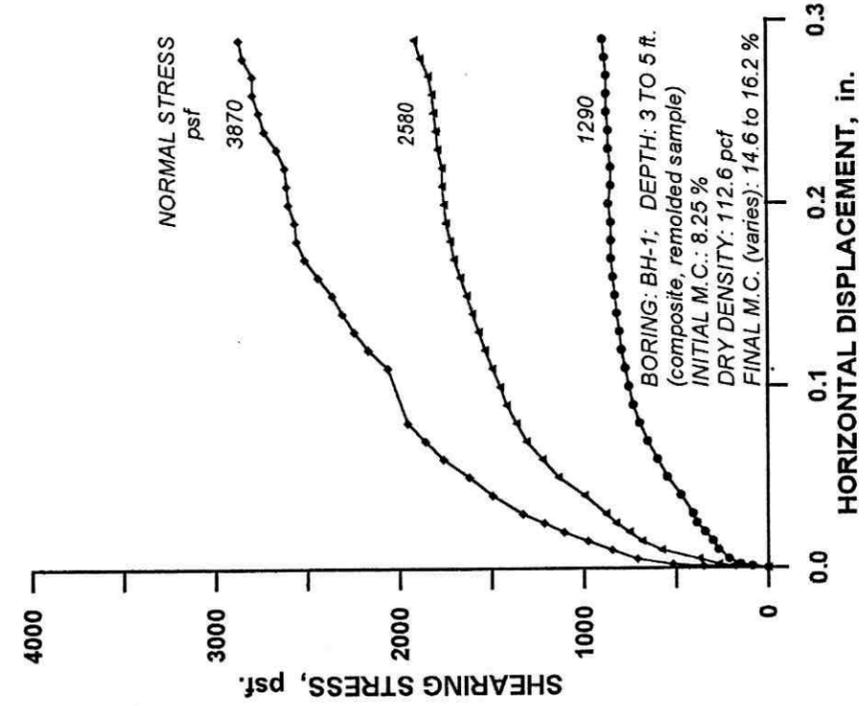
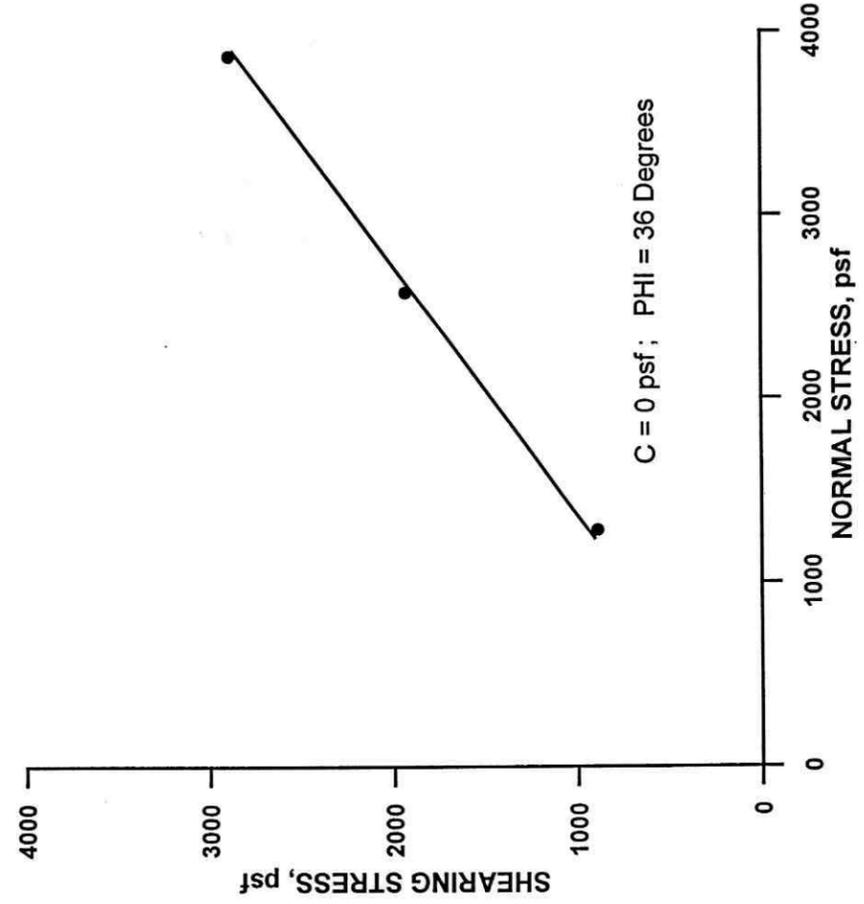
Job No.	Date	Drawn By	Figure
99-020	NOV. 1999	K.R.	C-6

a) SHEARING STRESS / DISPLACEMENT CURVES

b) STRENGTH ENVELOPE

RESULTS OF DIRECT SHEAR TESTS

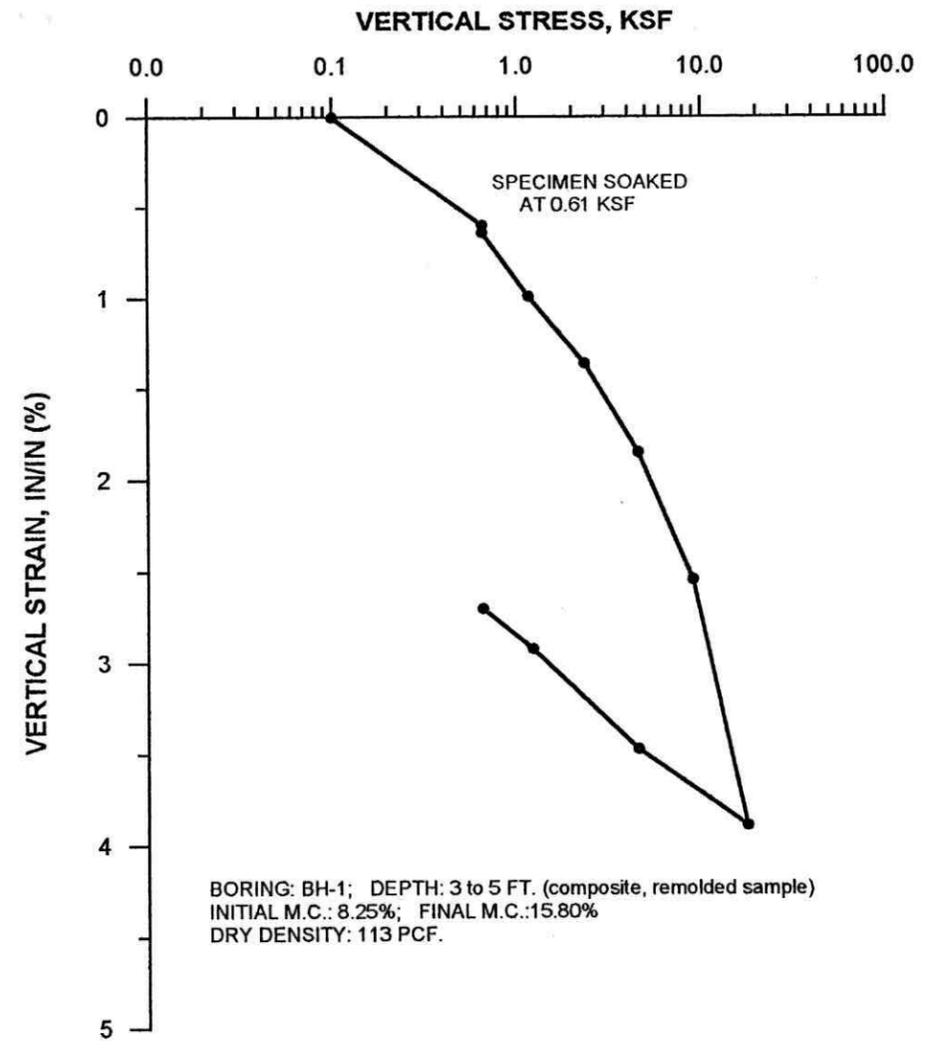
Job No.	Date	Drawn By	Figure
99-020	NOV. 1999	K.R.	C-10

RESULTS OF 1-D COMPRESSION TEST
