Potential CDFW Jurisdiction/Impacts

On-site Conceptual Mitigation Plan

THE VILLAGES

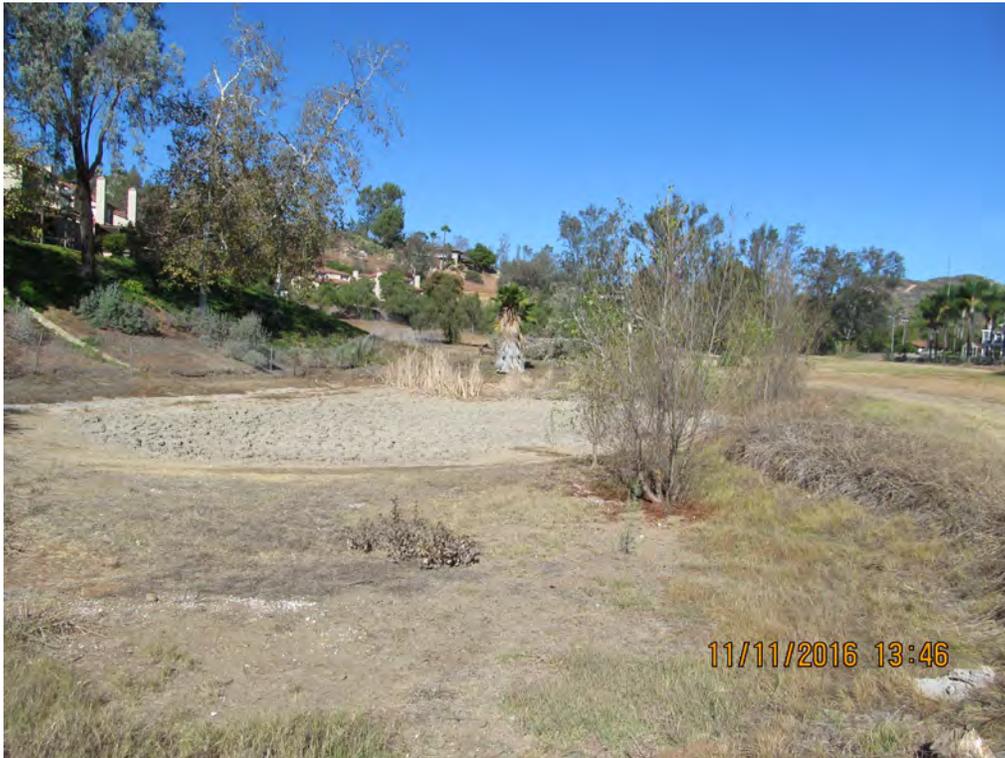
Photo 3. Former pond at the east end of the golf course, looking northeast.

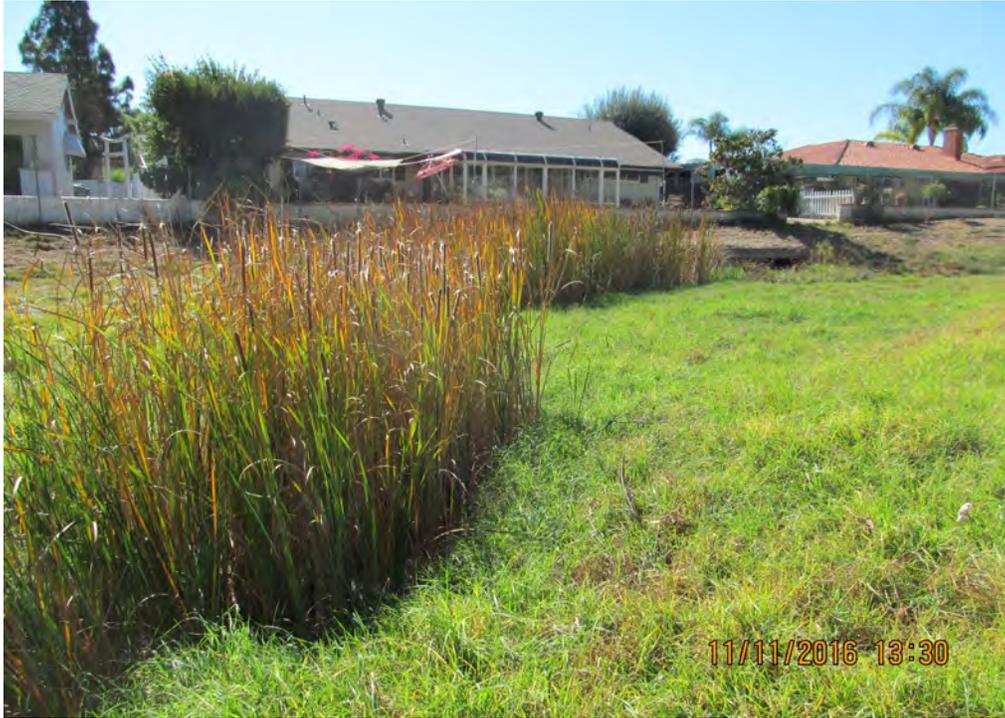
Photo 5. Section of freshwater marsh located behind the golf course buildings along Country Club Lane, looking west.

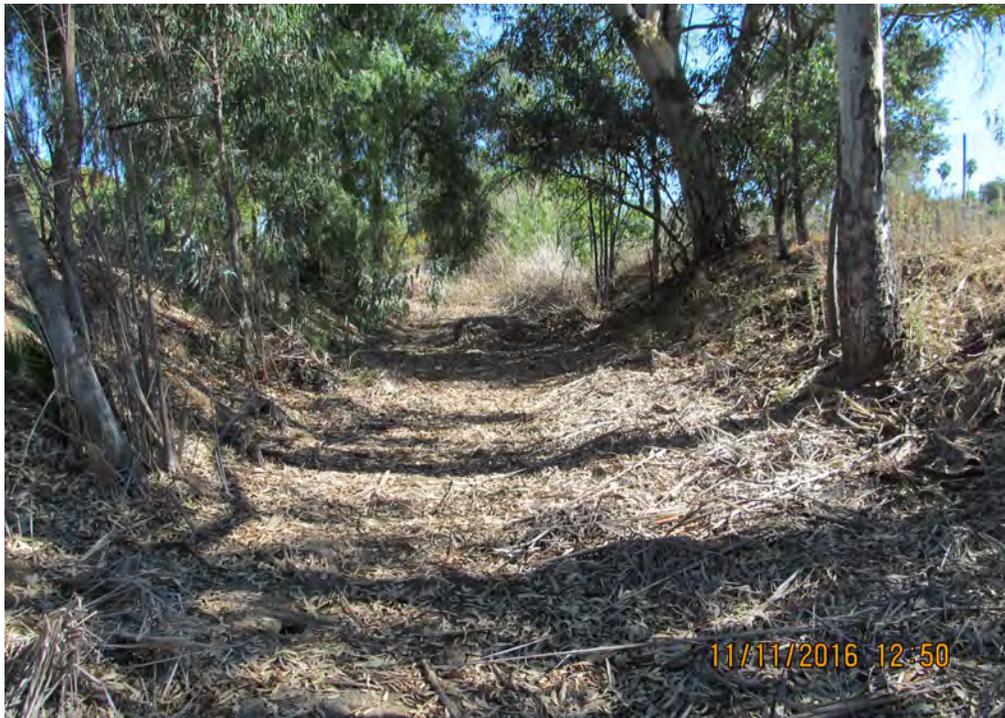
Photo 6. Earthen bottomed channel characterized by non-native riparian vegetation. The channel is located on the south side of Country Club Lane, looking west. Small patch of remnant freshwater marsh can be seen in the background of photo.

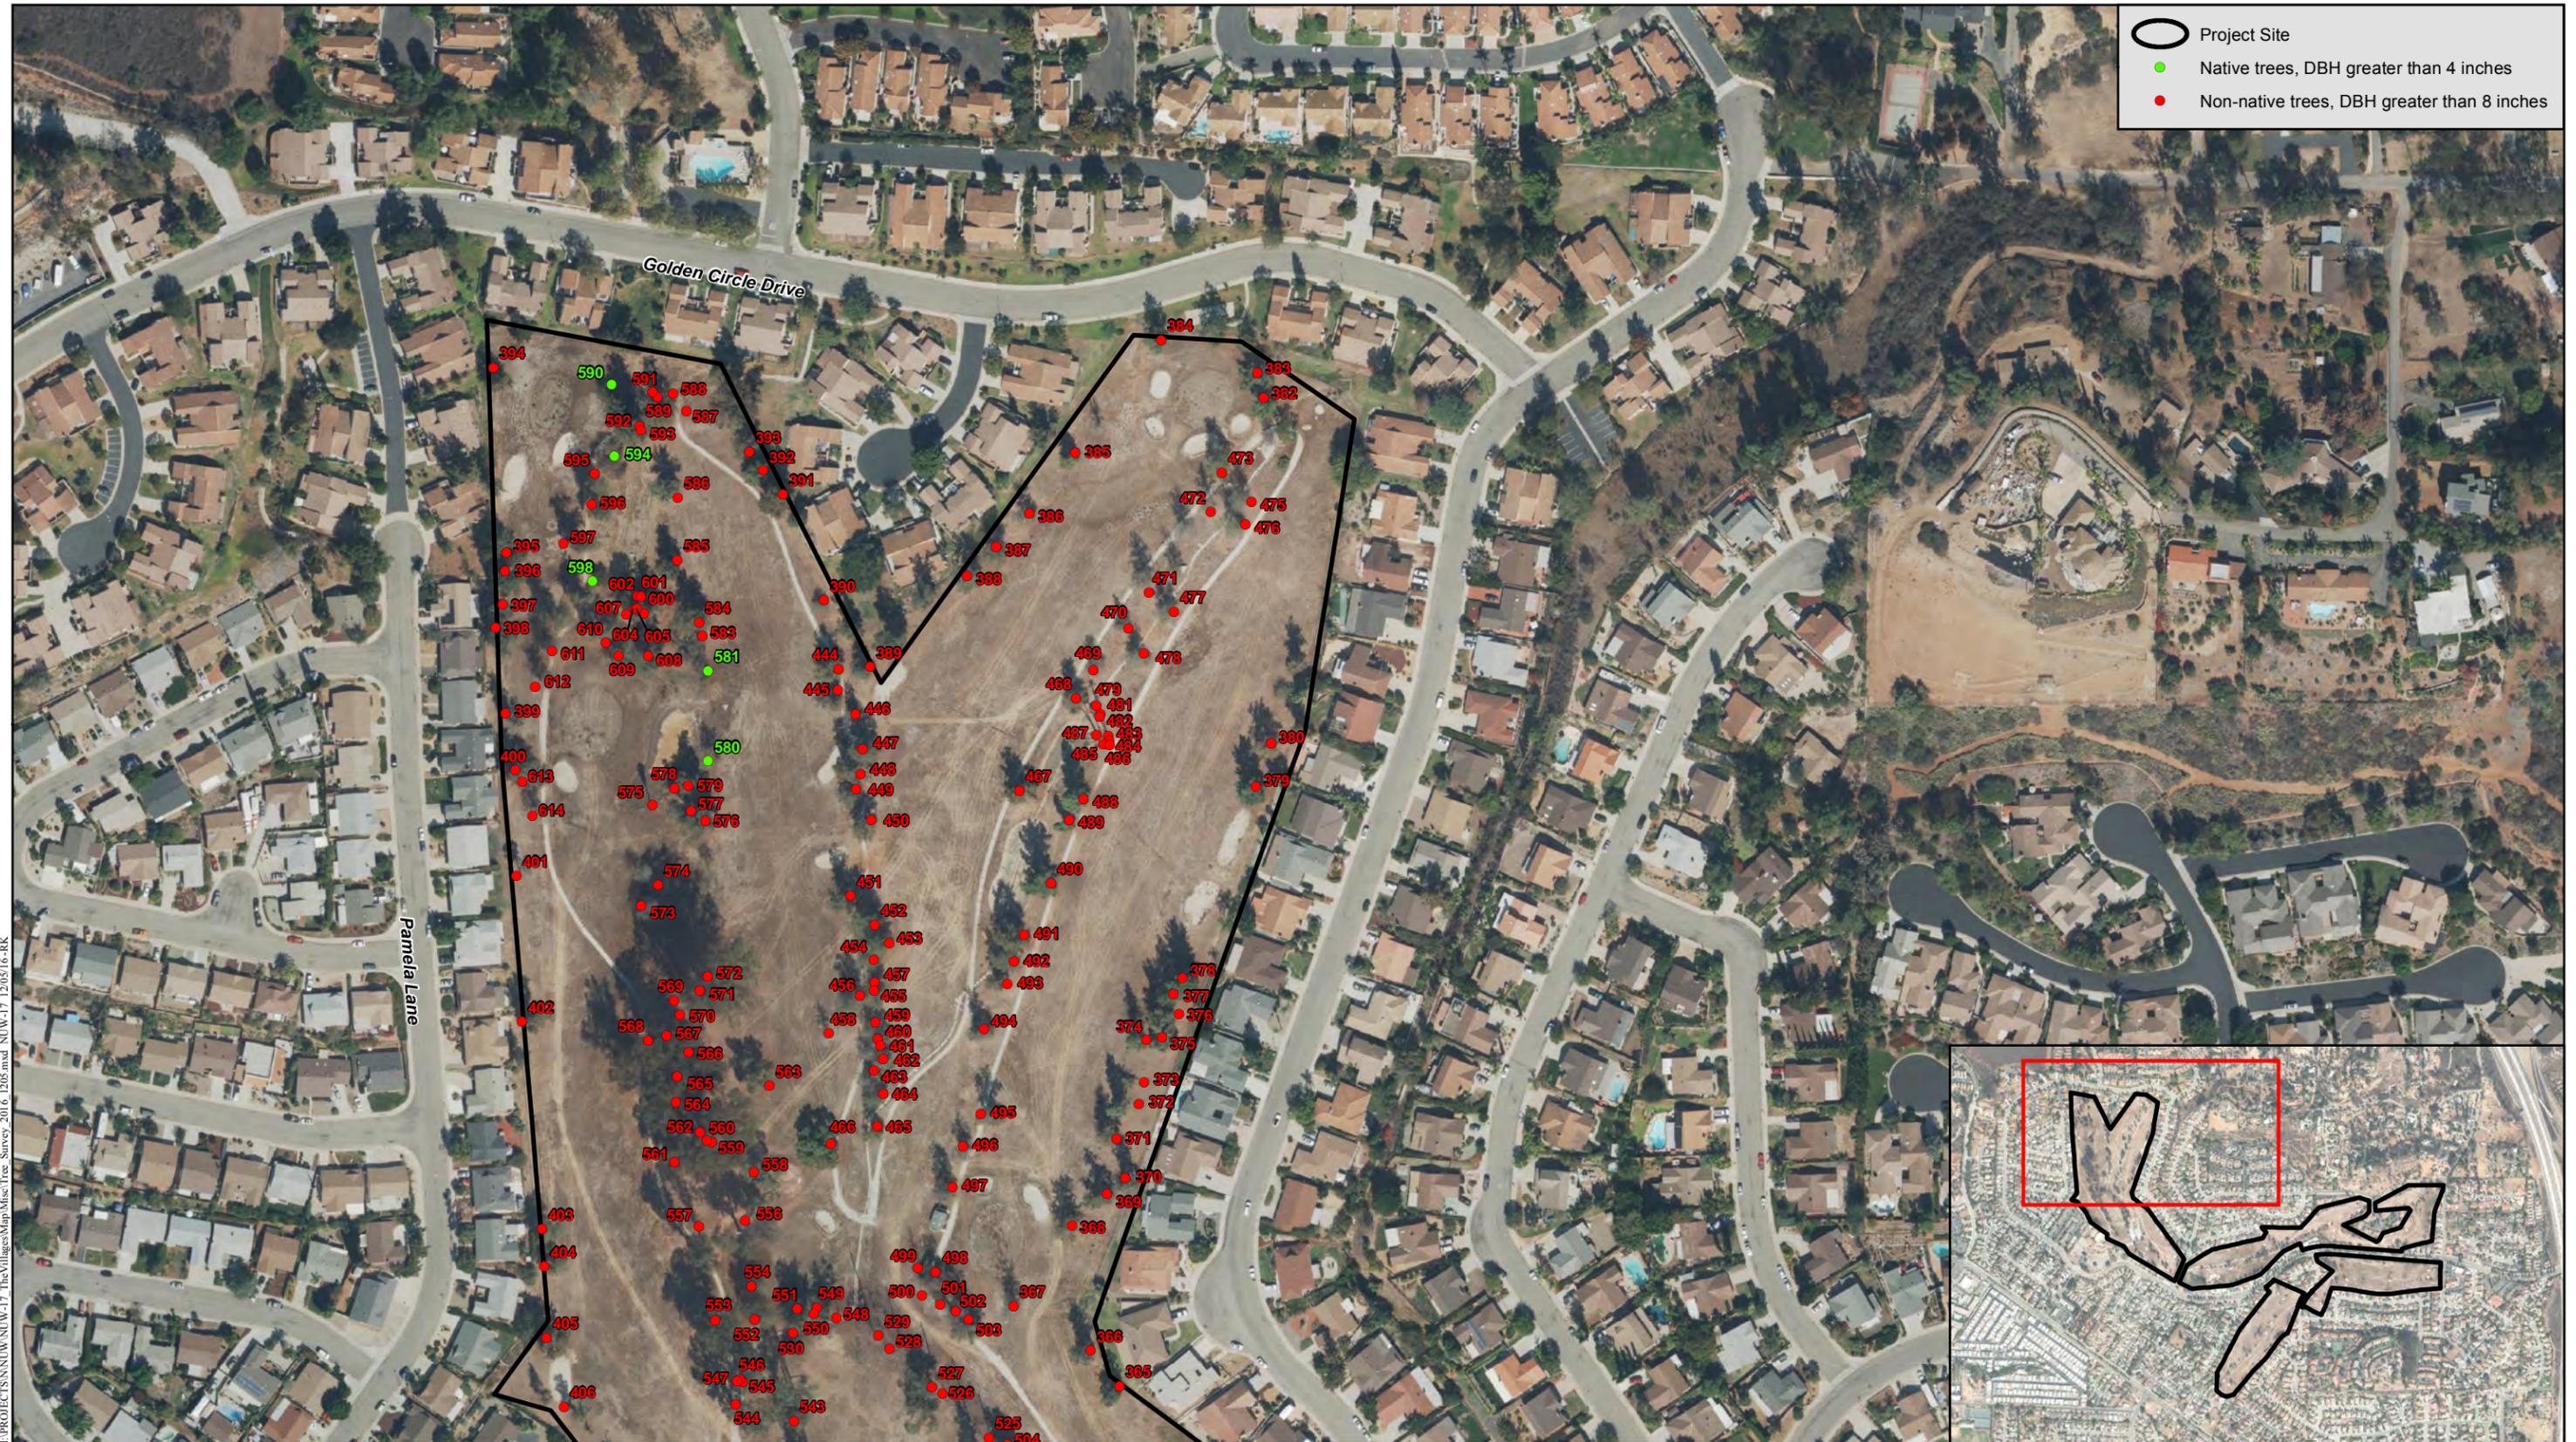
Map 1

Tree Survey

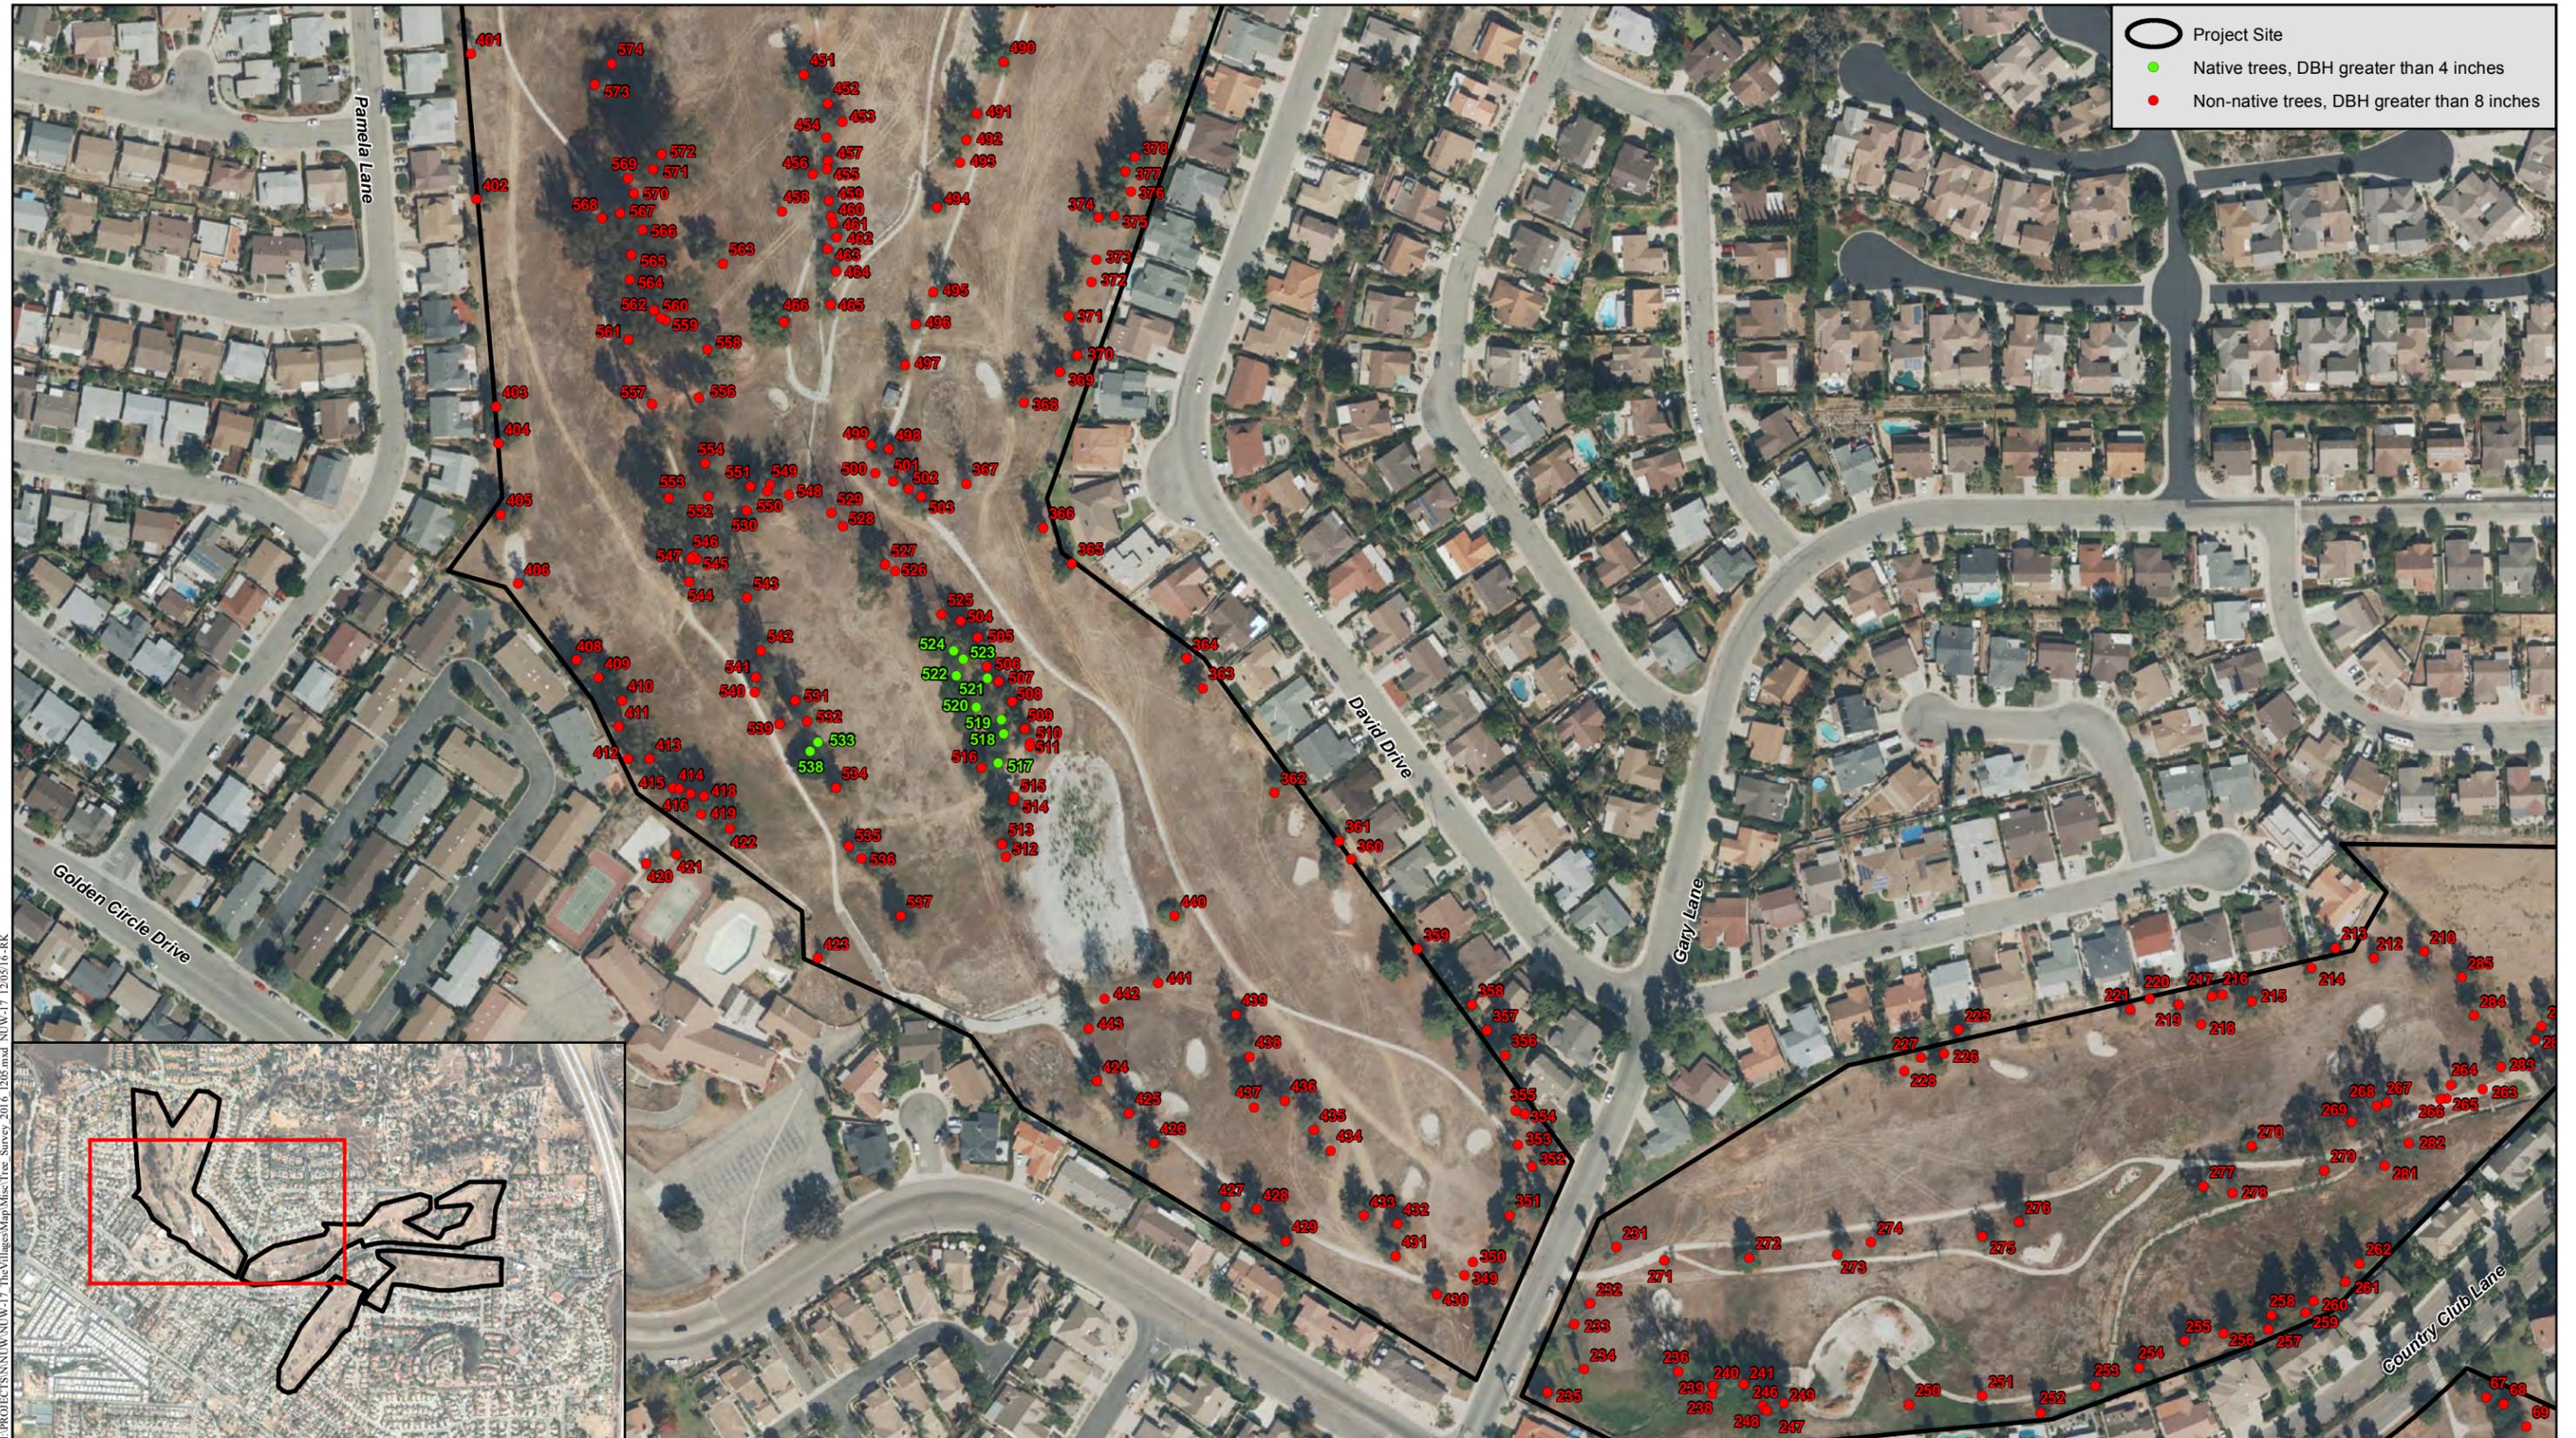
Map 2

Tree Survey

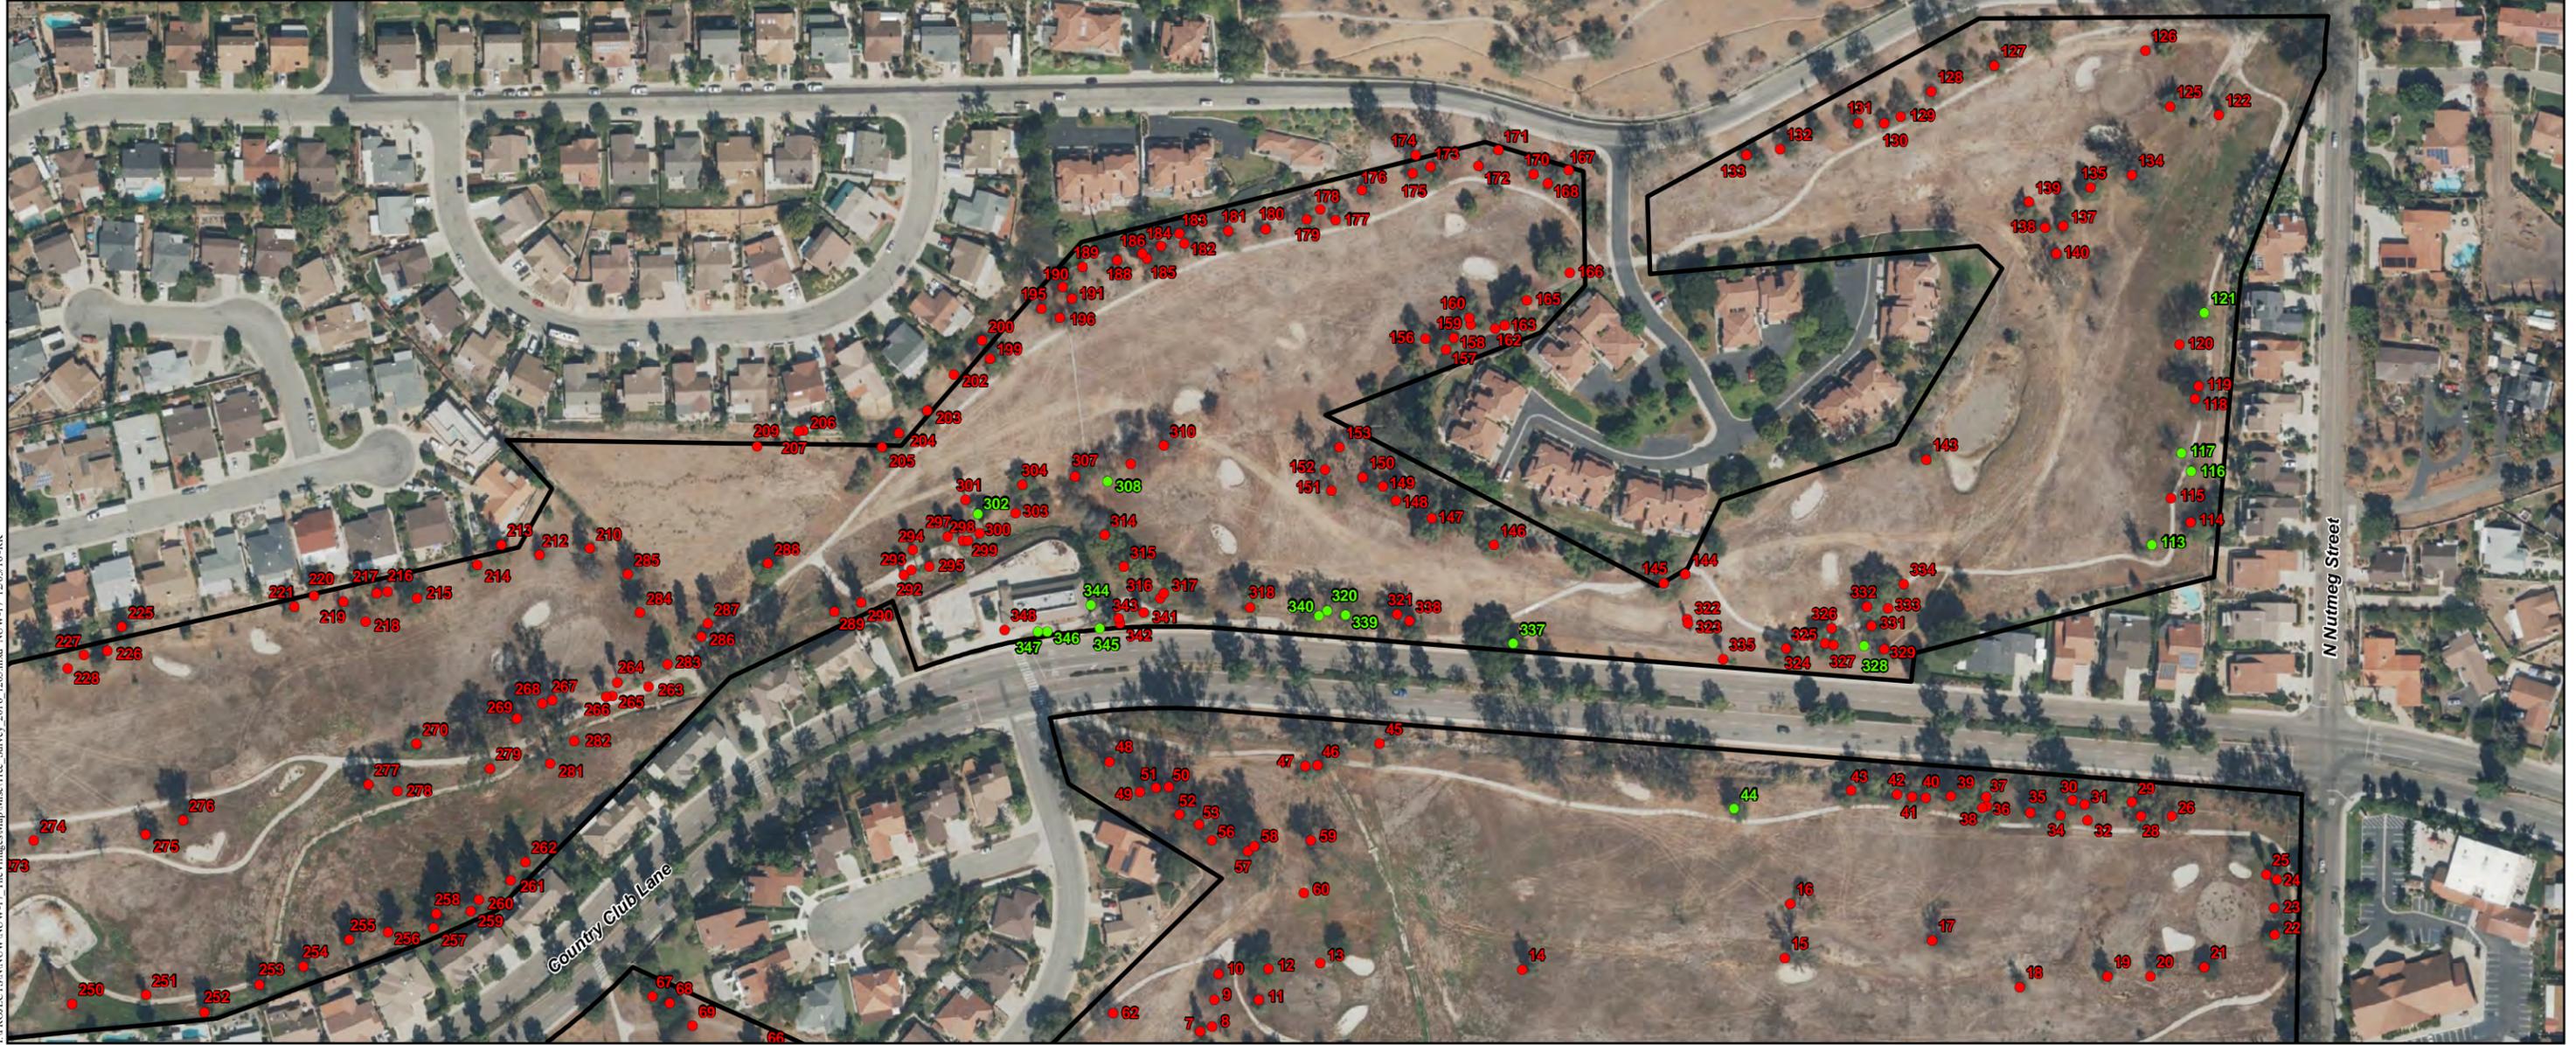
Map 3

Tree Survey
