The Villages - Escondido Country Club

Biological Technical Report

June 2017

Prepared by:
HELIX Environmental Planning, Inc.
7578 El Cajon Boulevard
La Mesa, CA 91942

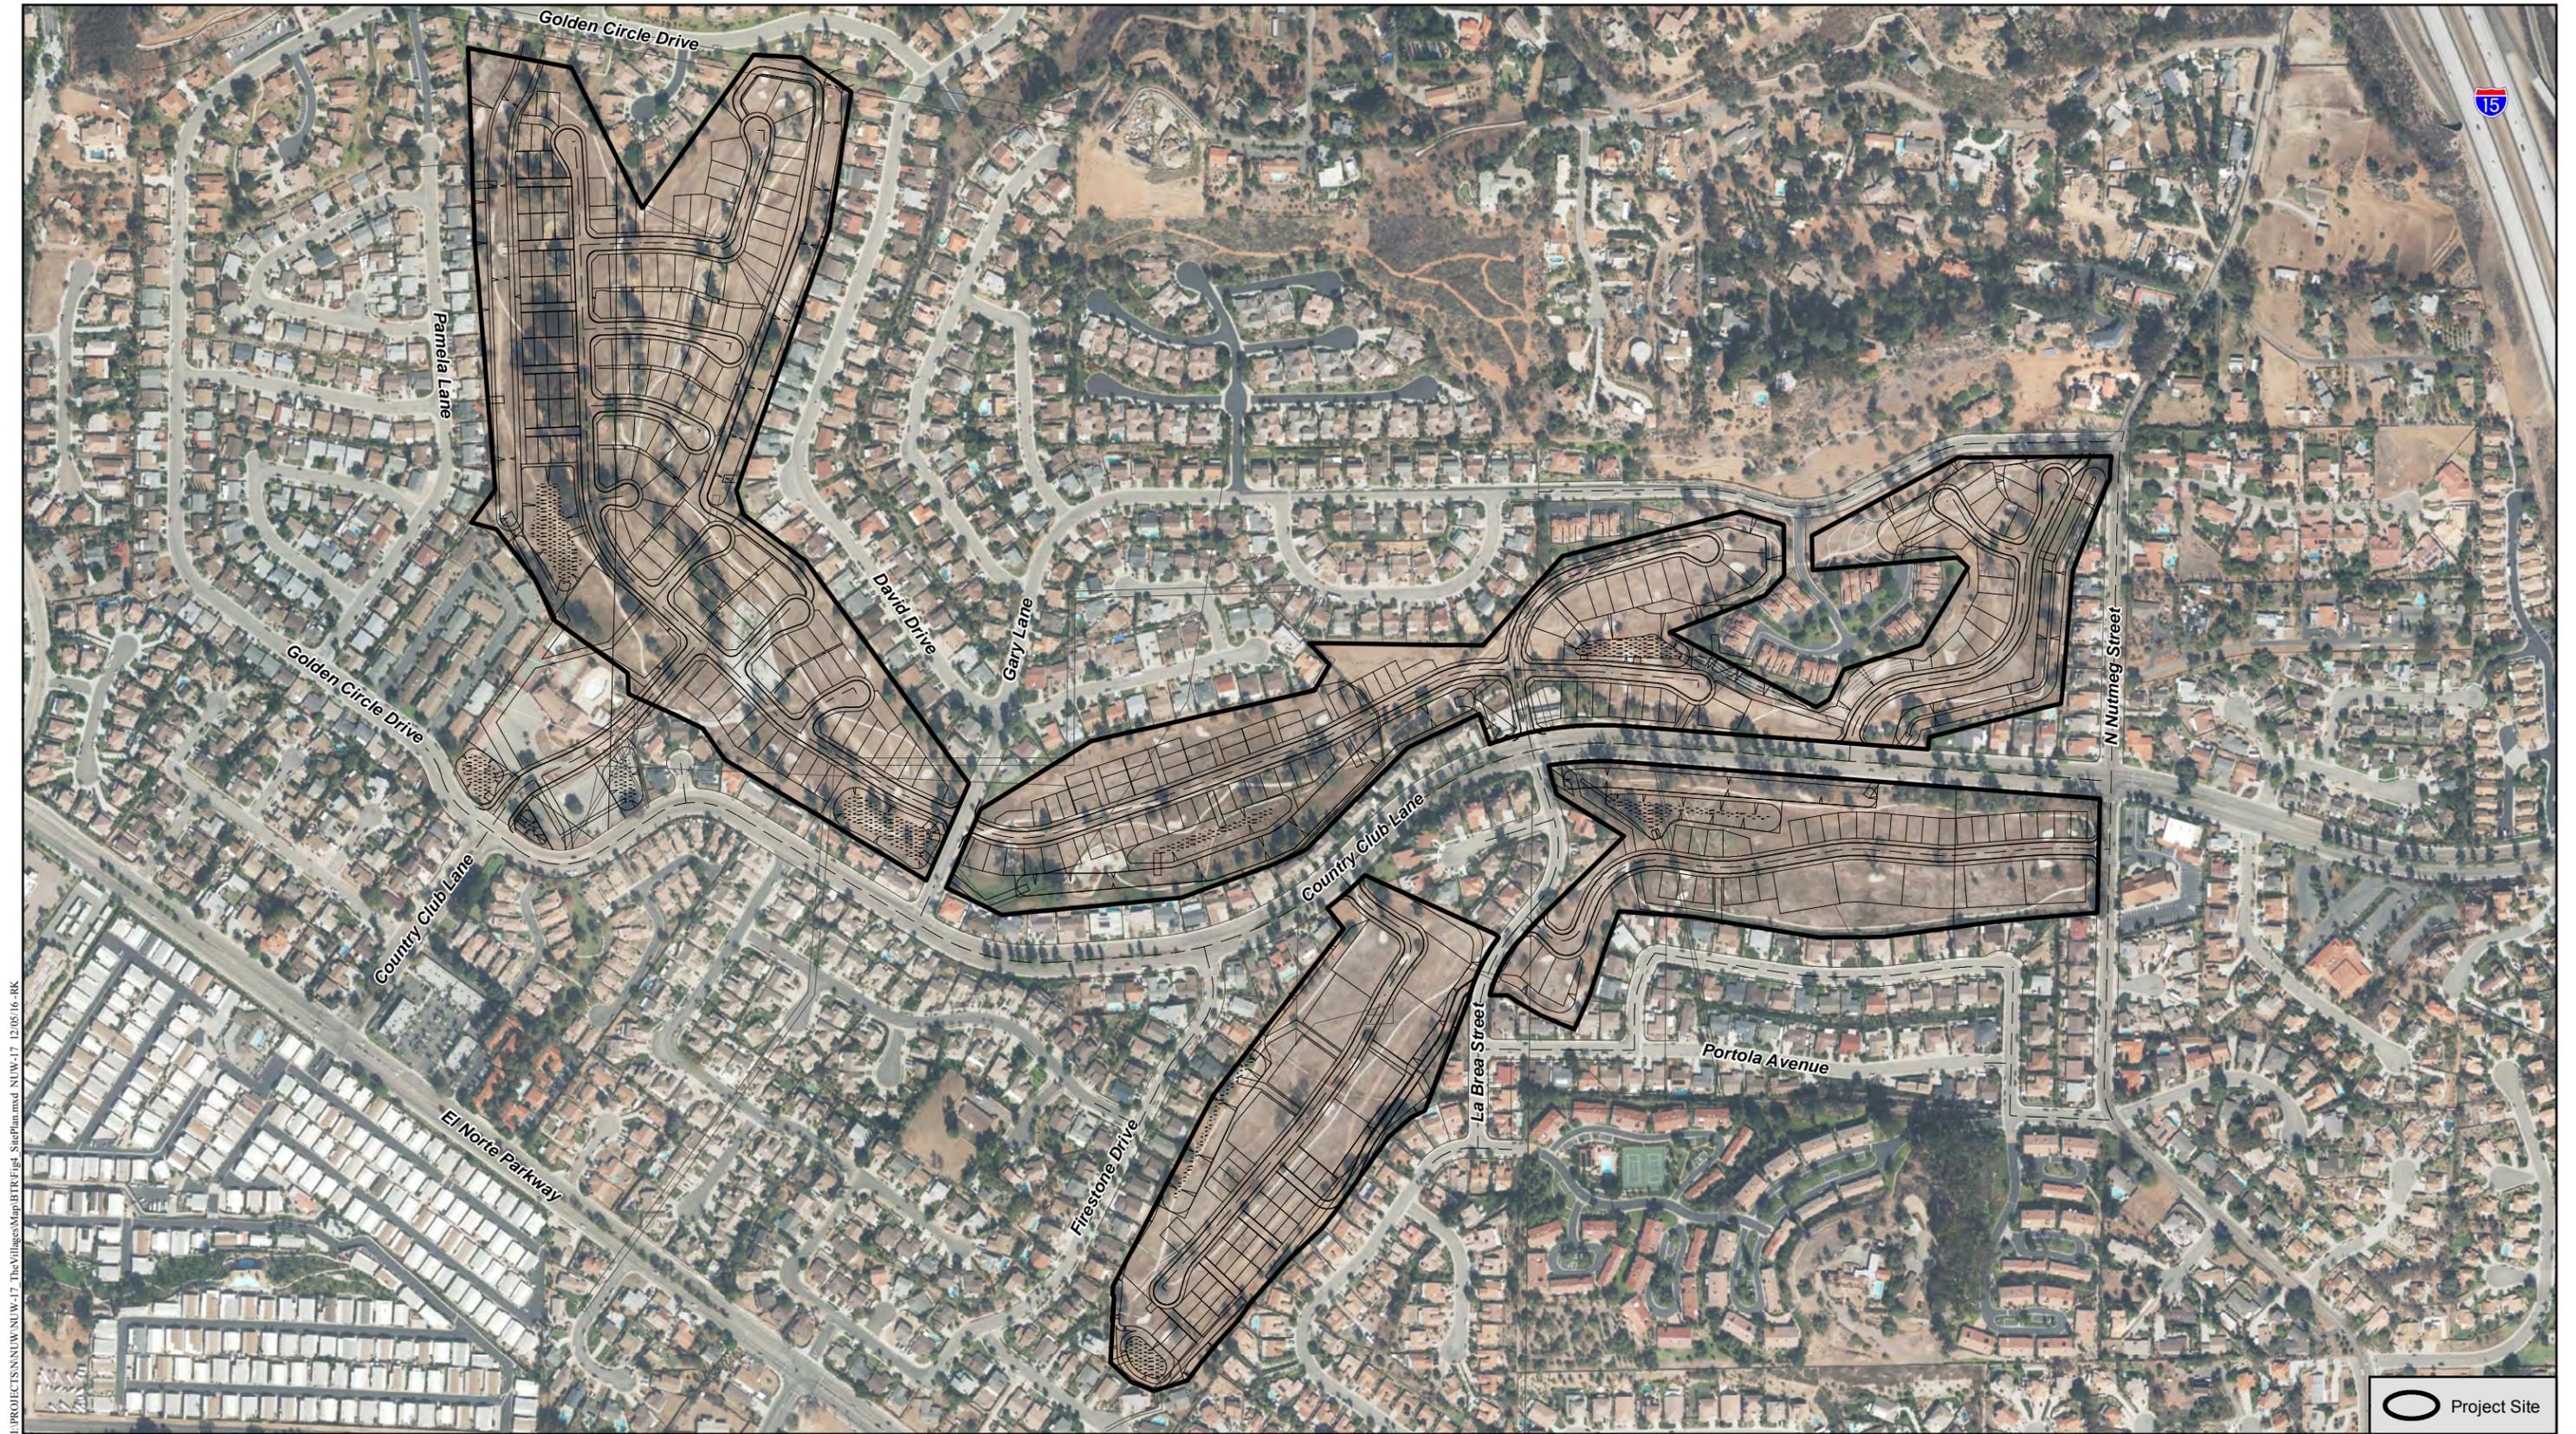
Figure 4

Site Plan

The proposed project consists of a General Plan Amendment to the Land Use Element, Zone Change to S-P Zone, a Vesting Tentative Map and Specific Plan to allow for development of the 392 single-family dwelling unit project (Figure 4). The total project area is approximately 109.3 acres. The new land uses proposed for the Villages Specific Plan Area include Open Space System, Clubhouse with recreational, social and farm amenities, and three single-family residential Villages.

The 46-acre Open Space System will consist of 32 acres of landscaped Greenbelt and 14 acres of environmental channels and retention basins to convey stormwater from San Marcos Creek through the project site and clean stormwater from the project site. The Greenbelt will have a series of pocket parks along an approximately 4-mile long walking trail system.

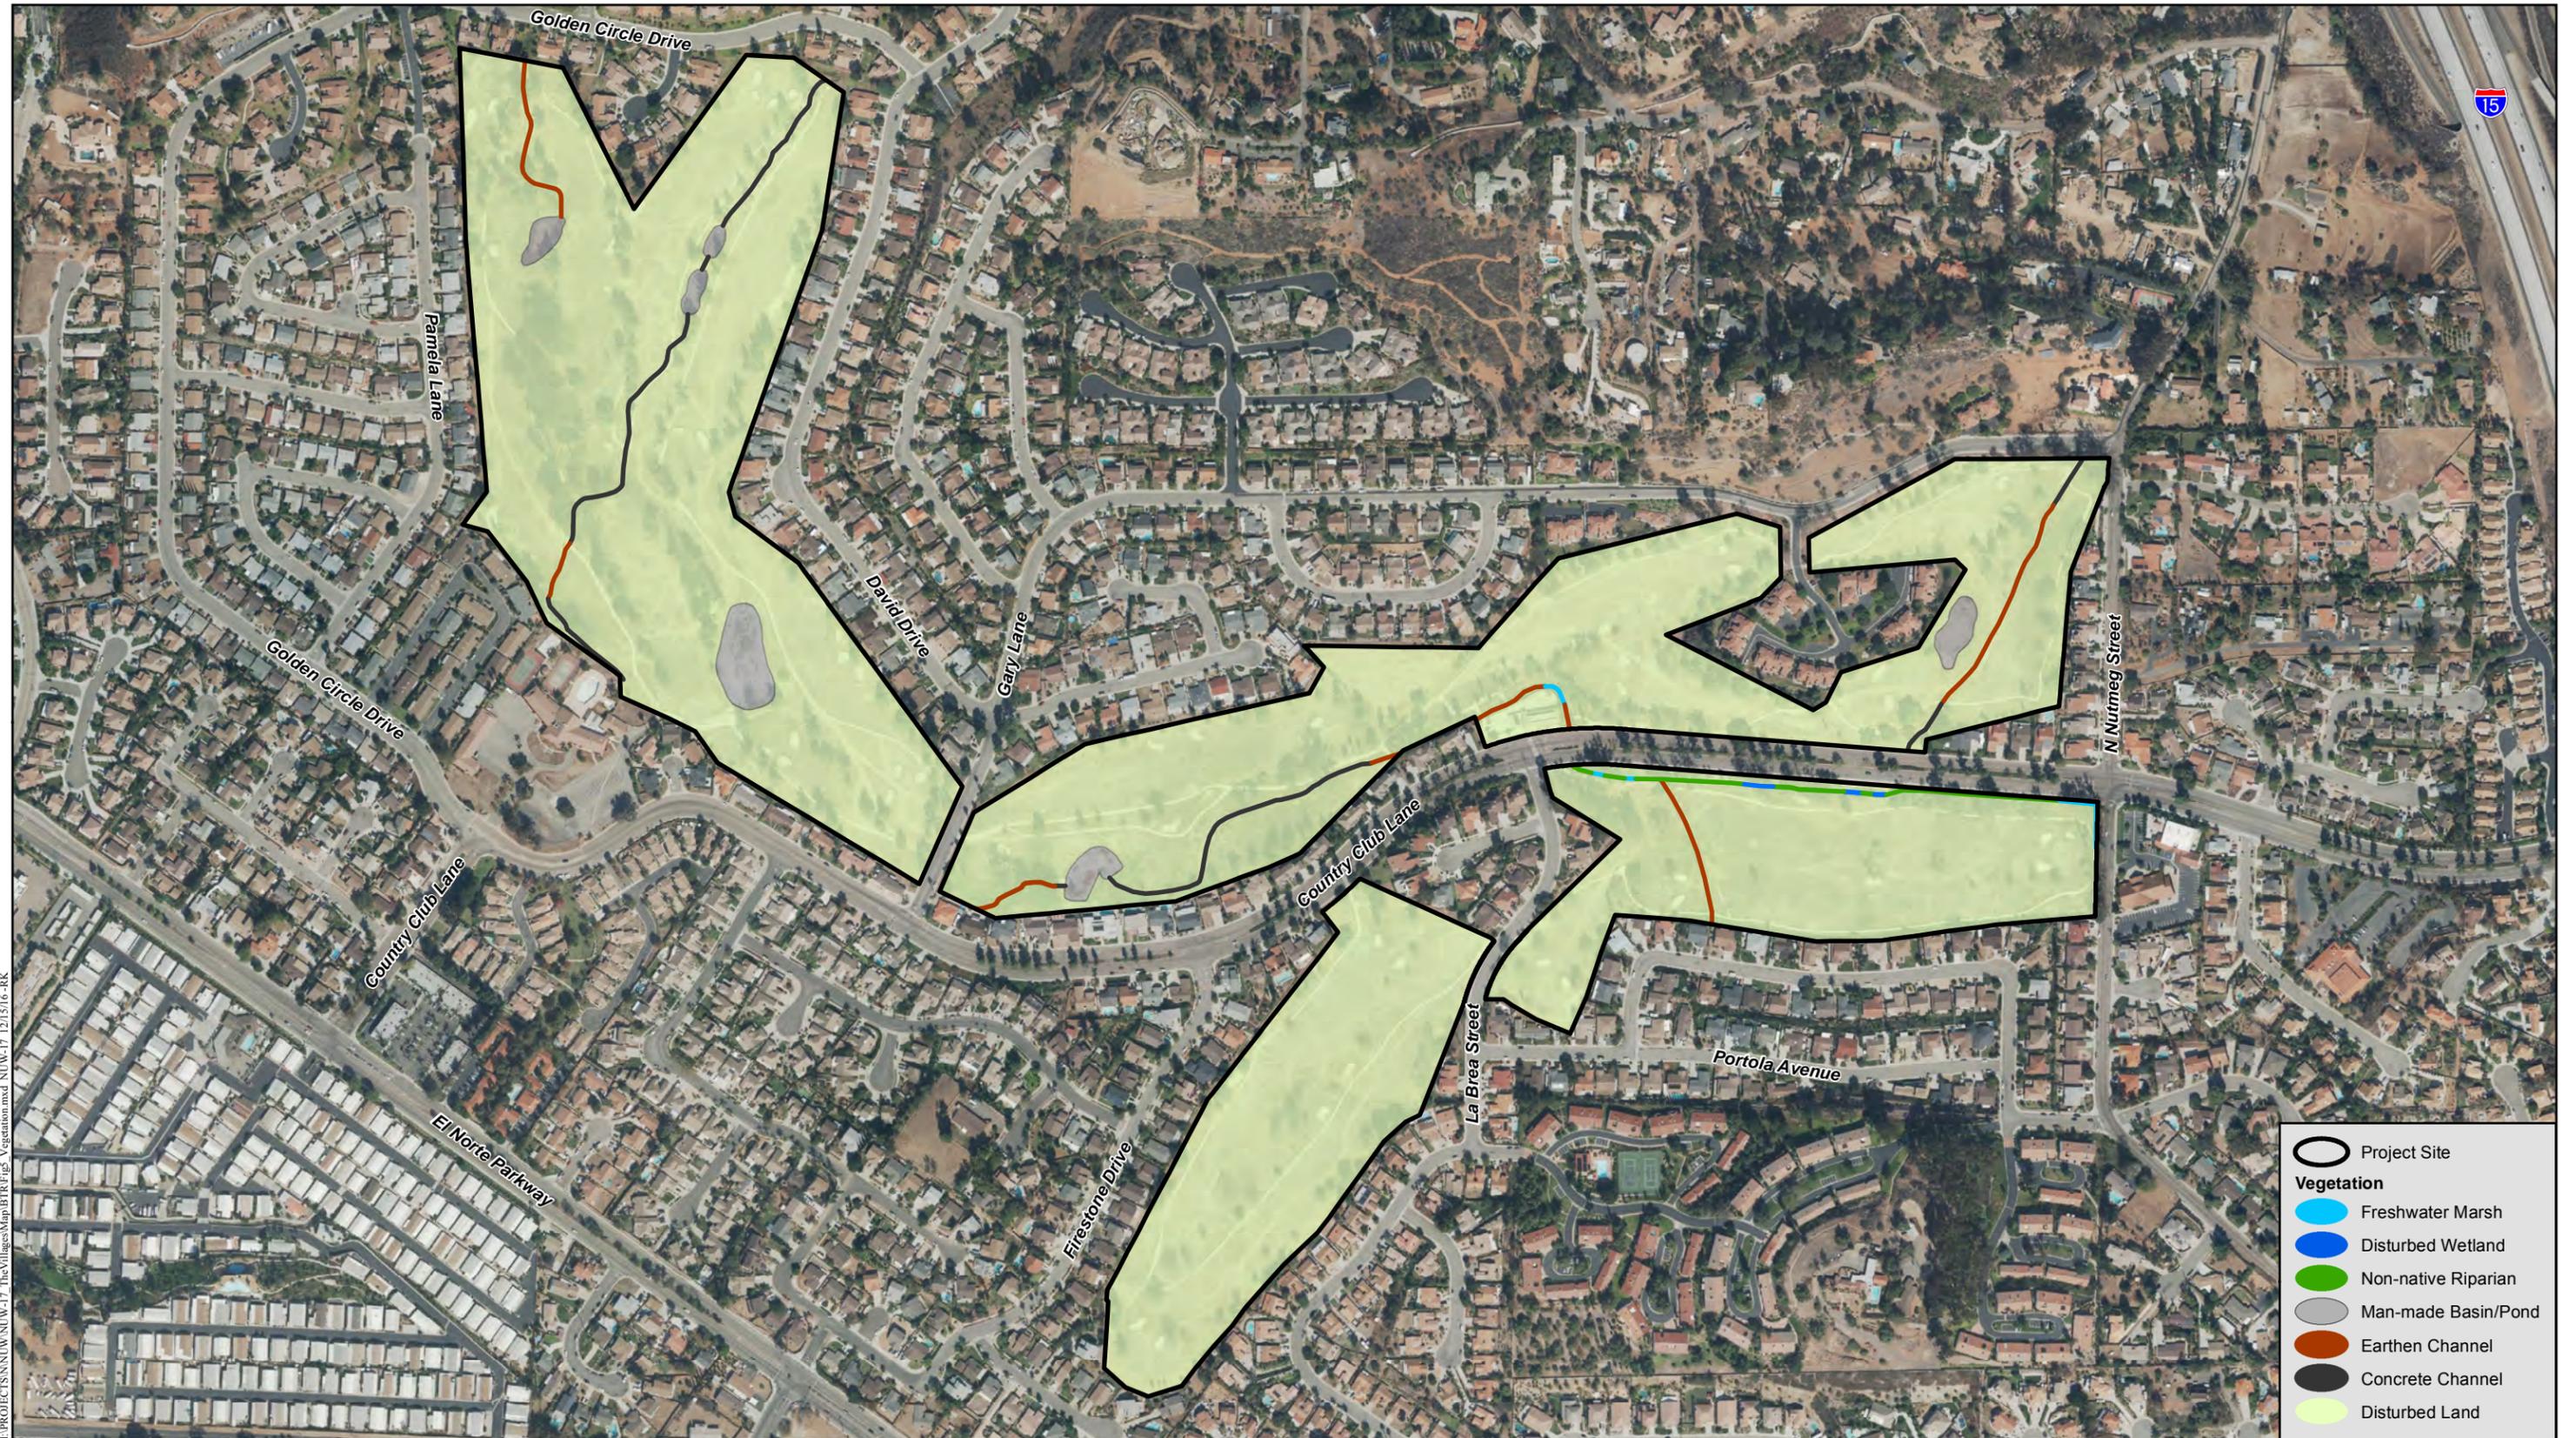
Figure 5

Project Site
Vegetation	
	Freshwater Marsh
	Disturbed Wetland
	Non-native Riparian
	Man-made Basin/Pond
	Earthen Channel
	Concrete Channel
	Disturbed Land

Vegetation

Seven vegetation communities/habitat types occur in the project site (Table 2; Figure 5): freshwater marsh, disturbed wetland, non-native riparian, disturbed land, man-made earthen channel, man-made concrete channel, and man-made basin/pond. Classification generally follows Holland (1986) and Oberbauer (2008), where applicable. Classification of man-made channels and ponds/basins were further refined by HELIX for clarity of the type of conveyance and detention feature in the context of jurisdictional waters and wetlands.

Freshwater marsh occurs over approximately 0.04 acre confined to limited portions of the earthen channels in the southeastern portions of the site. Broad-leaved cattail (*Typha latifolia*) is the dominant species observed, much of which was dead or desiccated due to the golf course areas no longer being artificially irrigated.

Approximately 100.7 acres of disturbed land is mapped over the old golf course grounds on the site. These areas show extensive sign of disturbance, large patches of non-native ruderal forbs (weeds), remnant golf course developments (e.g., cart paths, bunkers, etc.), and ornamental vegetation scattered throughout.

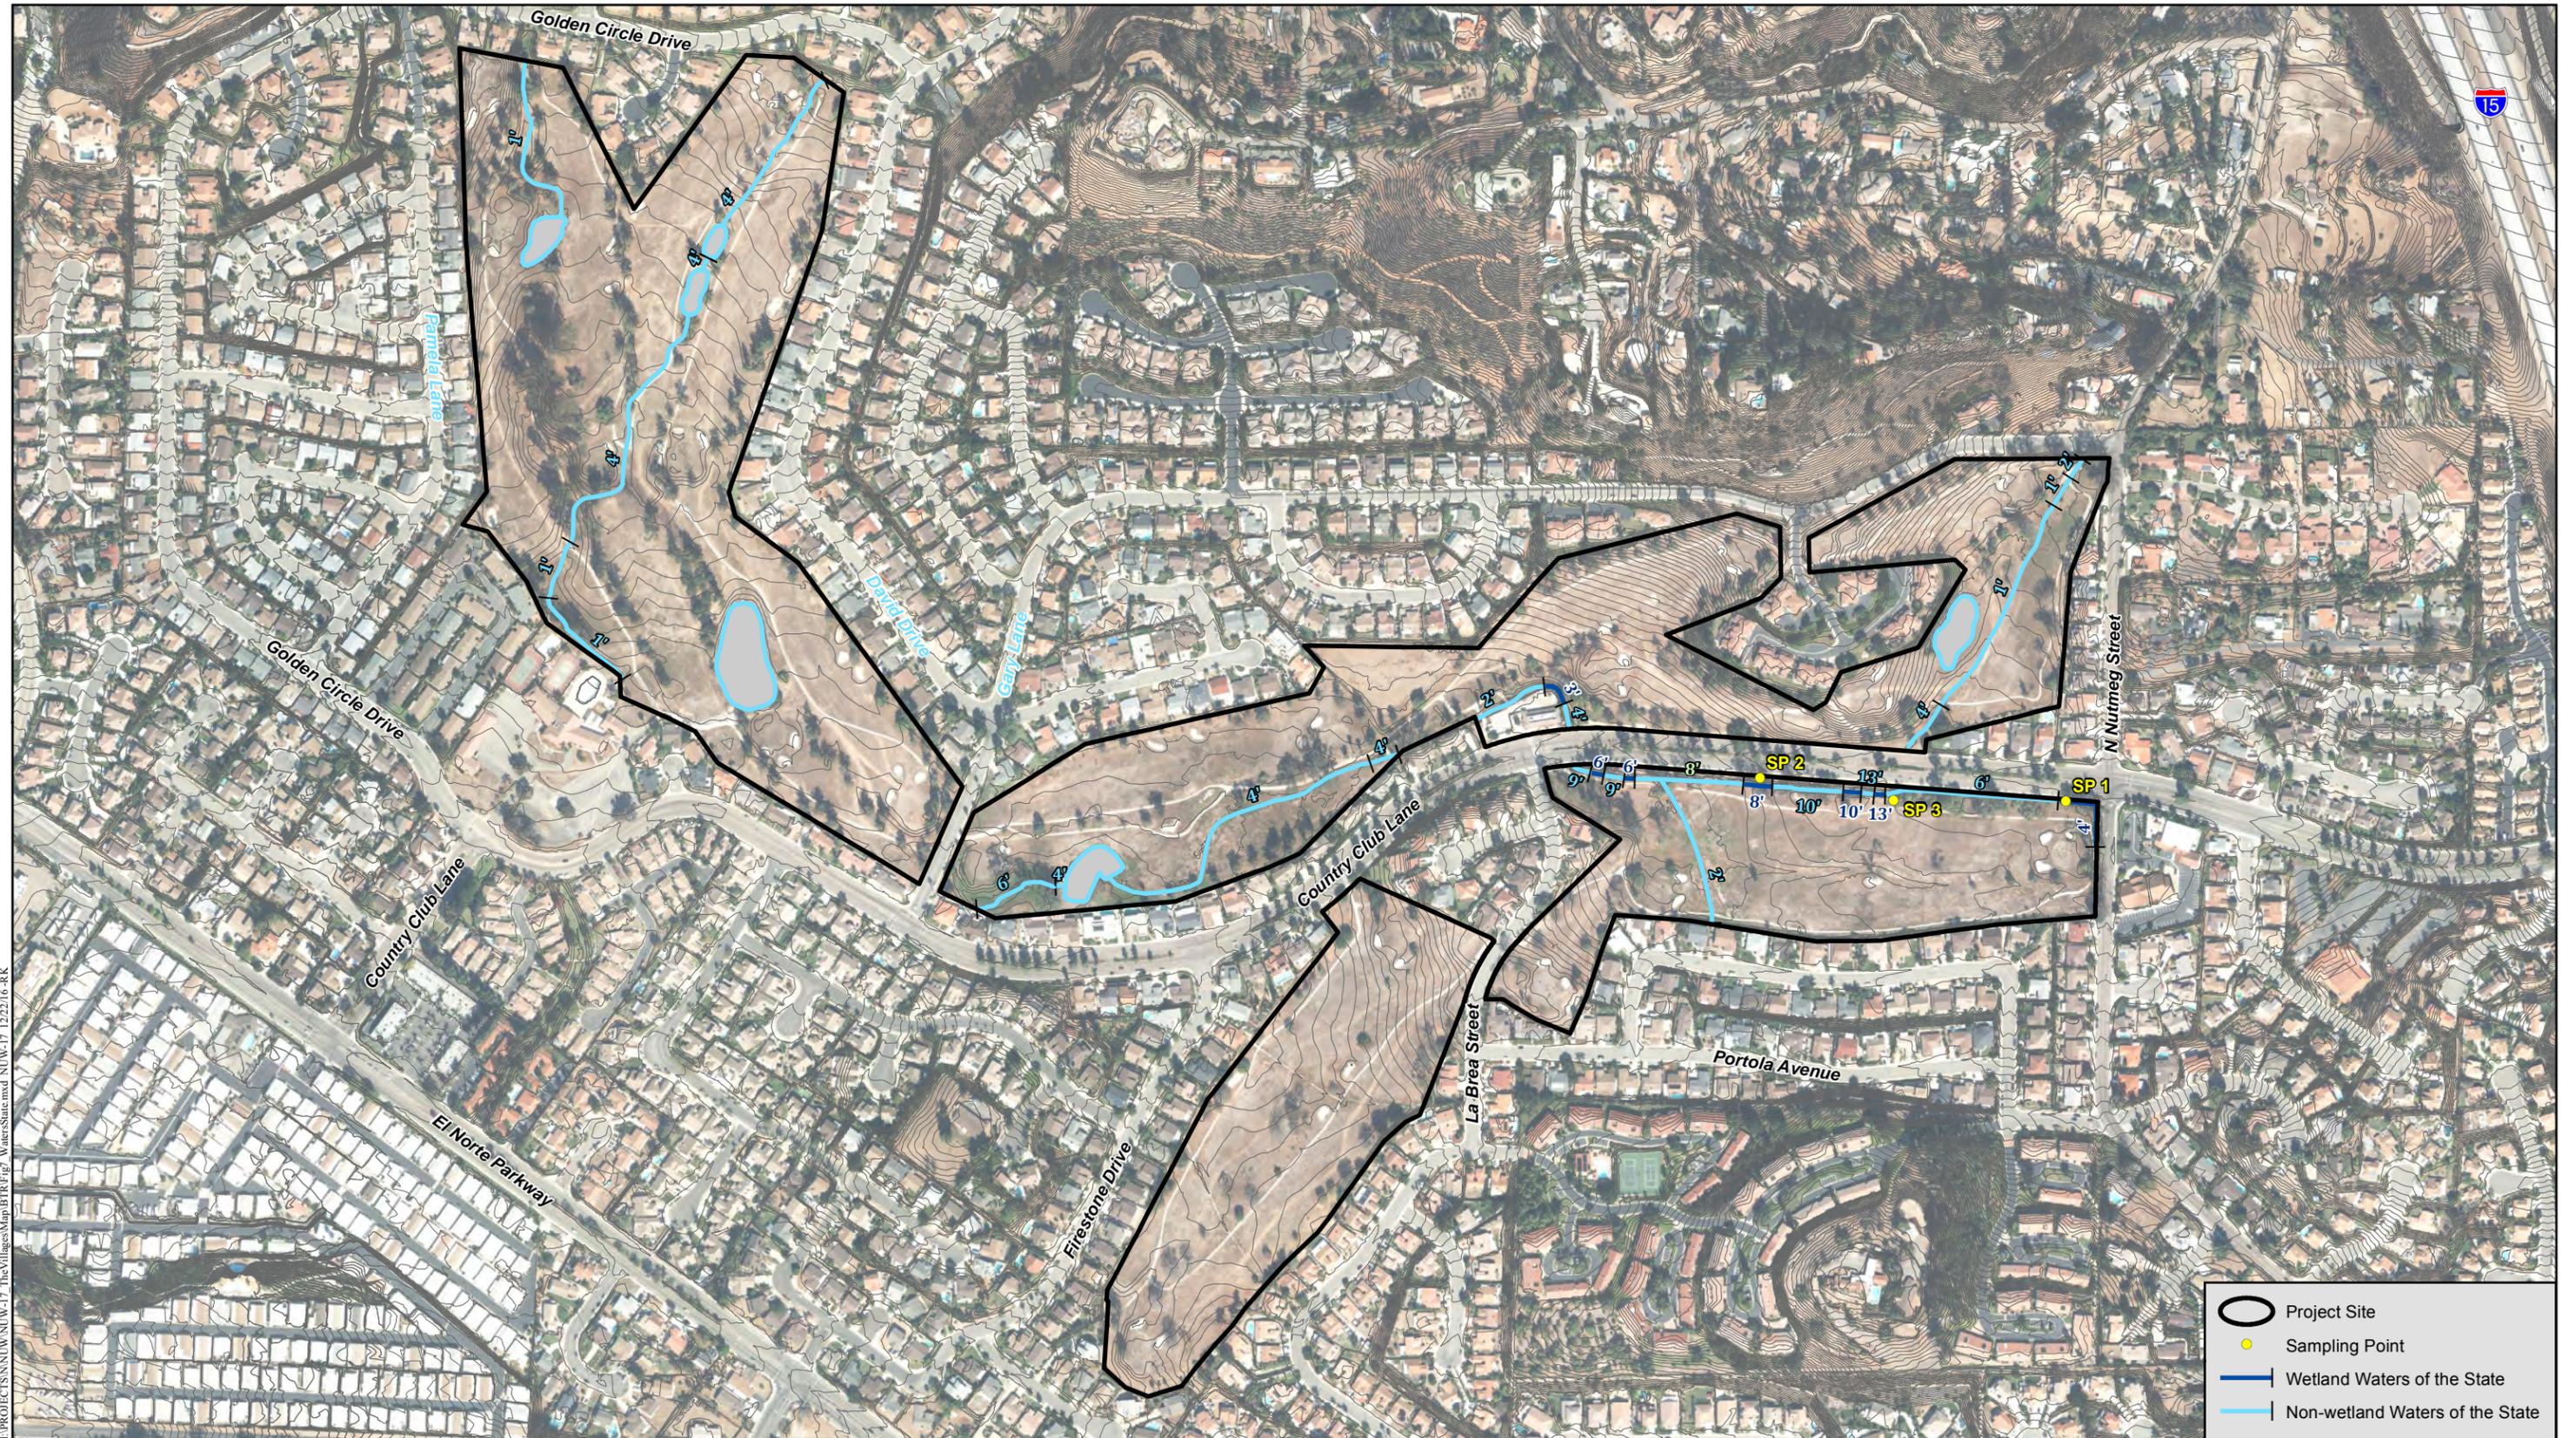
Potential RWQCB-jurisdiction within the project site includes 0.08 acre of wetland waters of the State (550 linear feet) and 2.48 acres (7,615 linear feet) of non-wetland waters of the State, as summarized below in Table 3 and depicted on Figure 7. The waters are all isolated and regulated by the RWQCB pursuant to Porter-Cologne.
