DRAFT
EL CABALLO PARK MASTER PLAN REPORT
DATE: 02-11-14

PREPARED FOR:
CITY OF ESCONDIDO
201 NORTH BROADWAY
ESCONDIDO, CA 92025

PREPARED BY:
WYNN-SMITH LANDSCAPE ARCHITECTURE, INC.
12315 OAK KNOLL RD., SUITE 230 POWAY, CA 92064

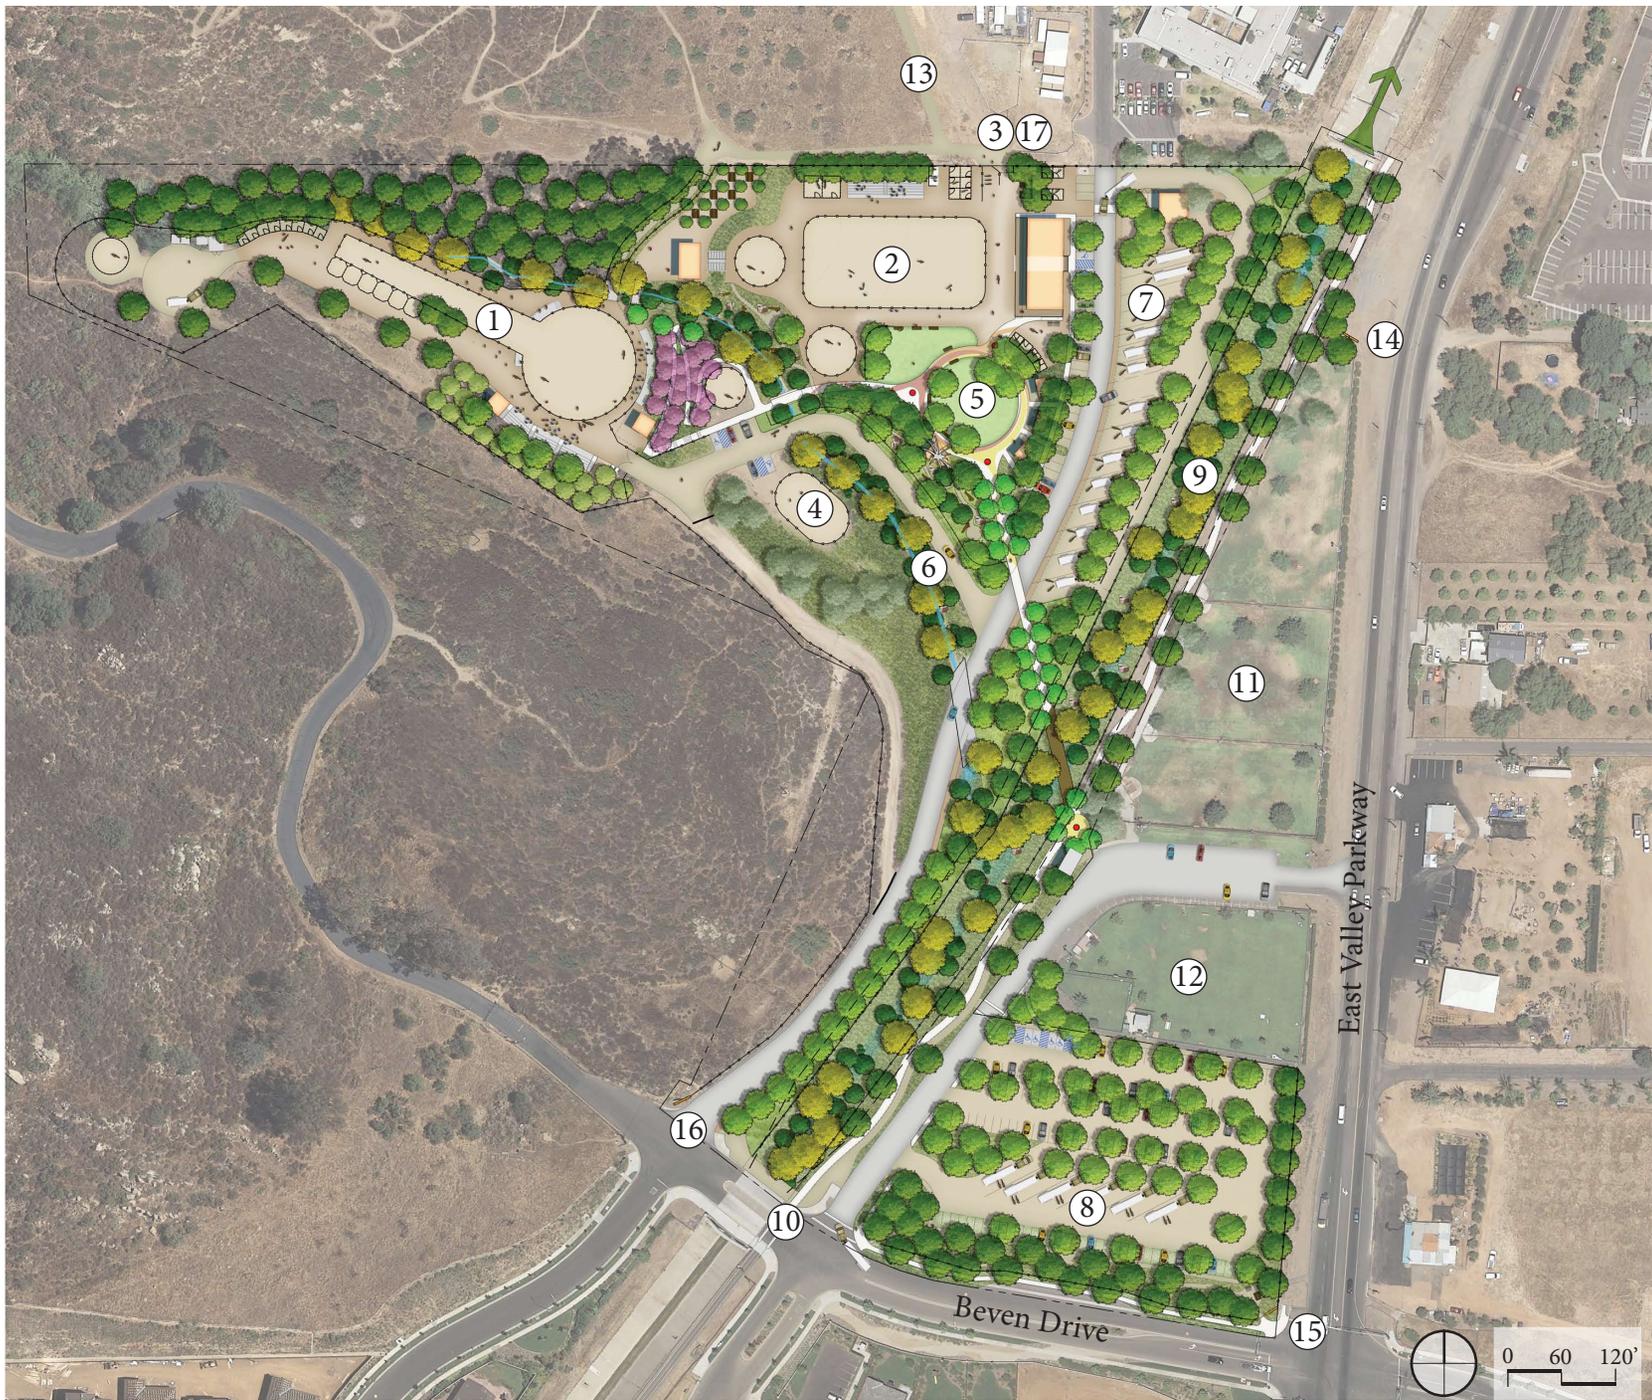
Figure 43: Final Master Plan

- ① Improved Existing Arena
- ② Lower Equestrian Area Development
- ③ Connection to Caballo Trail and Daley Ranch
- ④ Therapeutic Riding Arena
- ⑤ Common Gathering and Picnic Areas
- ⑥ Tributary Creek
- ⑦ Horse Trailer Parking
- ⑧ Overflow Parking
- ⑨ Improved Escondido Creek
- ⑩ Connection to Escondido Creek Trail
- ⑪ Mayflower Dog Park
- ⑫ Hidden Valley Obedience Club
- ⑬ Therapeutic Riding Trail
- ⑭ Monument Sign 1
- ⑮ Monument Sign 2
- ⑯ Monument Sign 3
- ⑰ Monument Sign 4

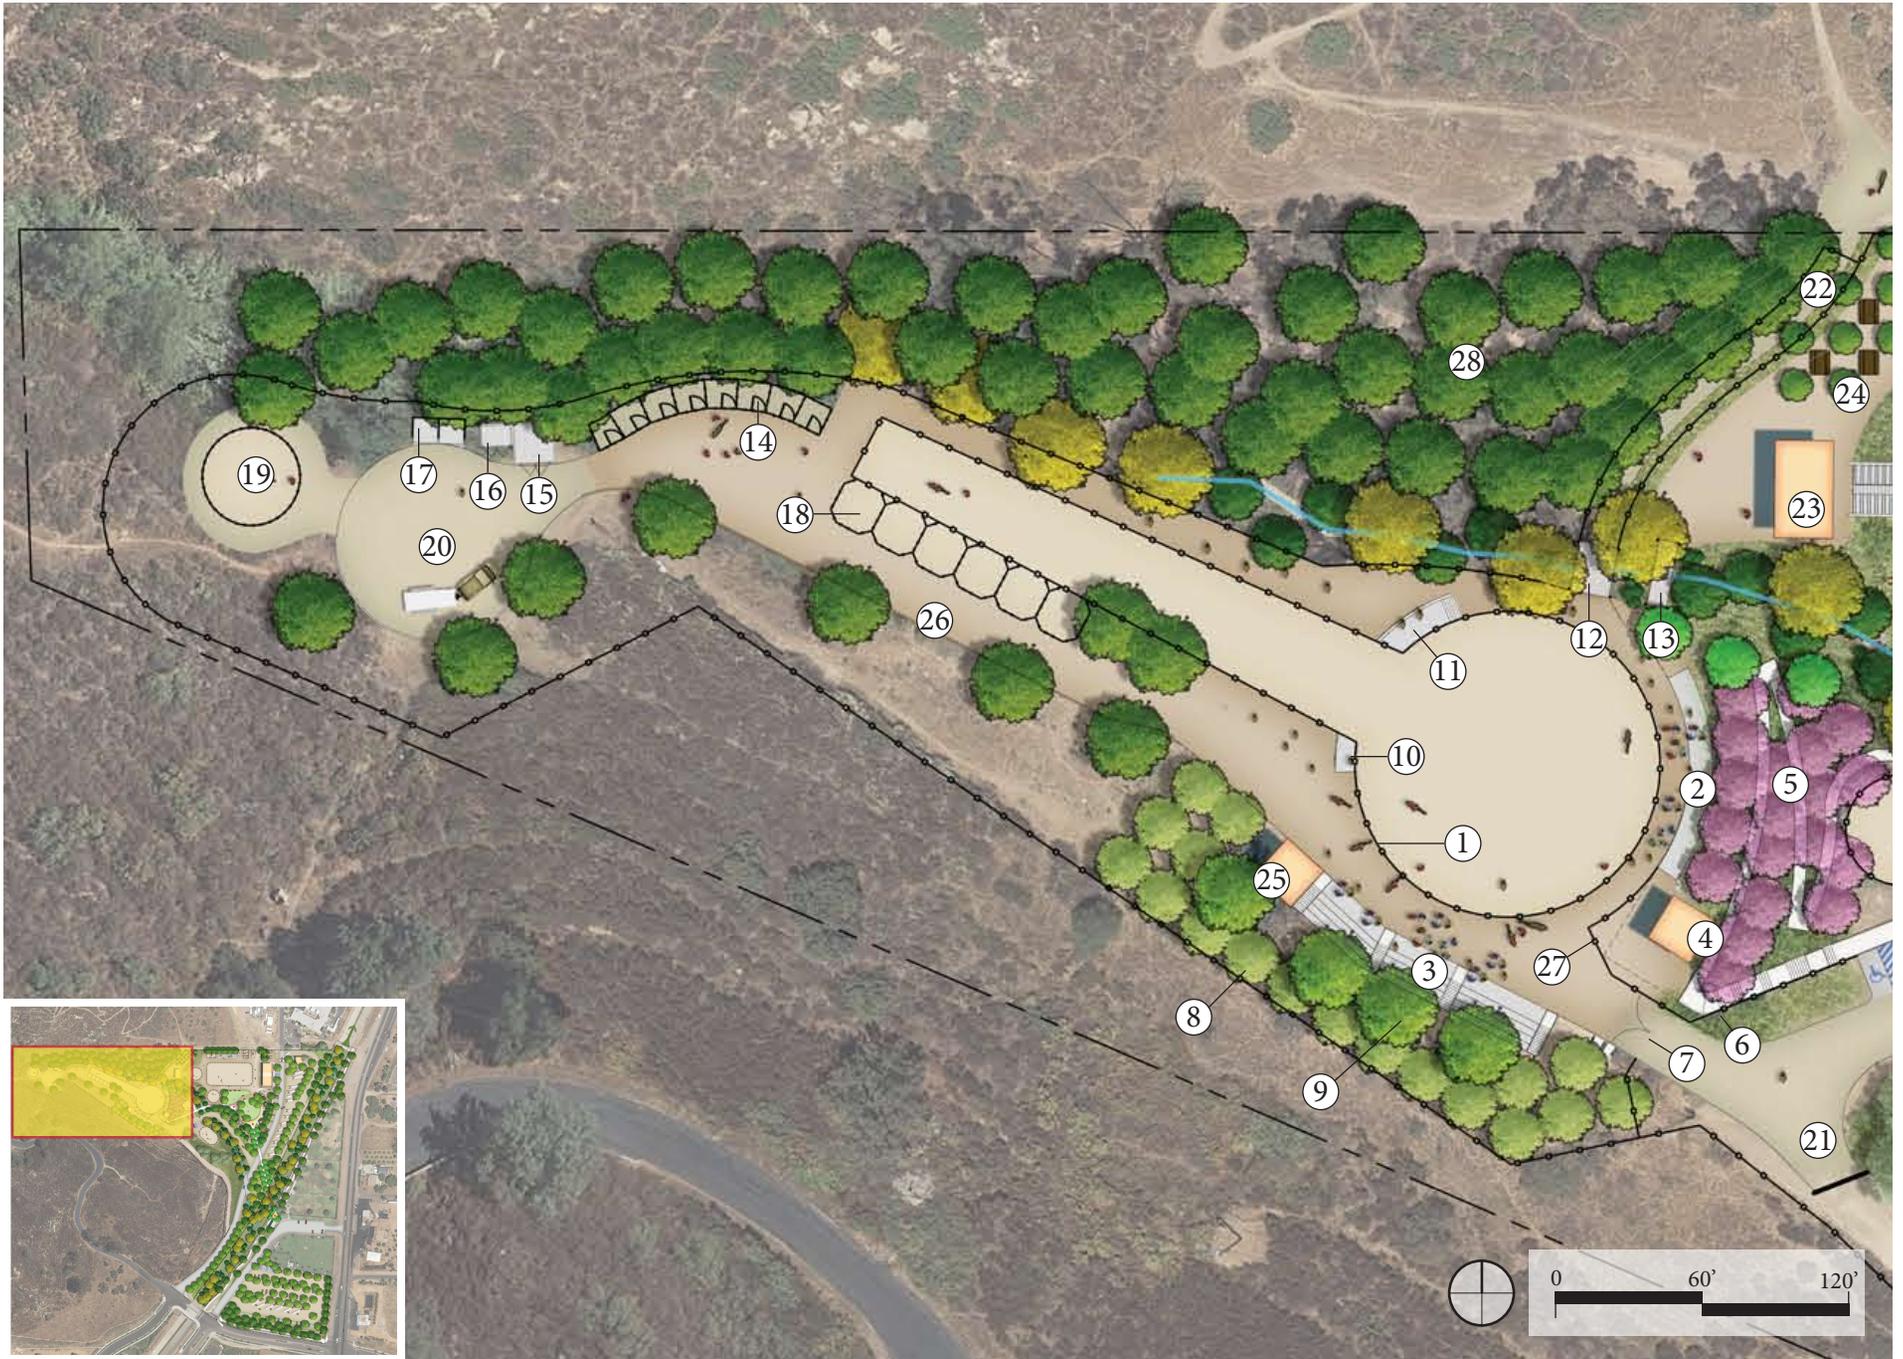
Figure 44: Existing Arena Area Improvements

The condition of the arena requires improvements to make the arena safer for animals and riders. It is proposed that the arena will be improved with better railings, solid siding and improved corrals for temporary holding of livestock.

- ⑪ Band Stand
- ⑫ 16’ Wide Bridge with Decomposed Granite Paving
- ⑬ Pedestrian Bridge
- ⑭ New 12’ x 12’ Corrals
- ⑮ Muck Storage
- ⑯ Trash Enclosure
- ⑰ Wash Racks (2)
- ⑱ Bull Corrals
- ⑲ Round Pen
- ⑳ Vehicular Turn-Around
- ㉑ Emergency Vehicular Hammerhead
- ㉒ Equestrian Entry Path
- ㉓ Shade Structure
- ㉔ BBQ, Picnic and Dance area
- ㉕ Changing Room
- ㉖ Expanded Vehicular Access
- ㉗ 4-Rail Fencing
- ㉘ Existing Eucalptus to be removed per phasing plan and replace with native trees

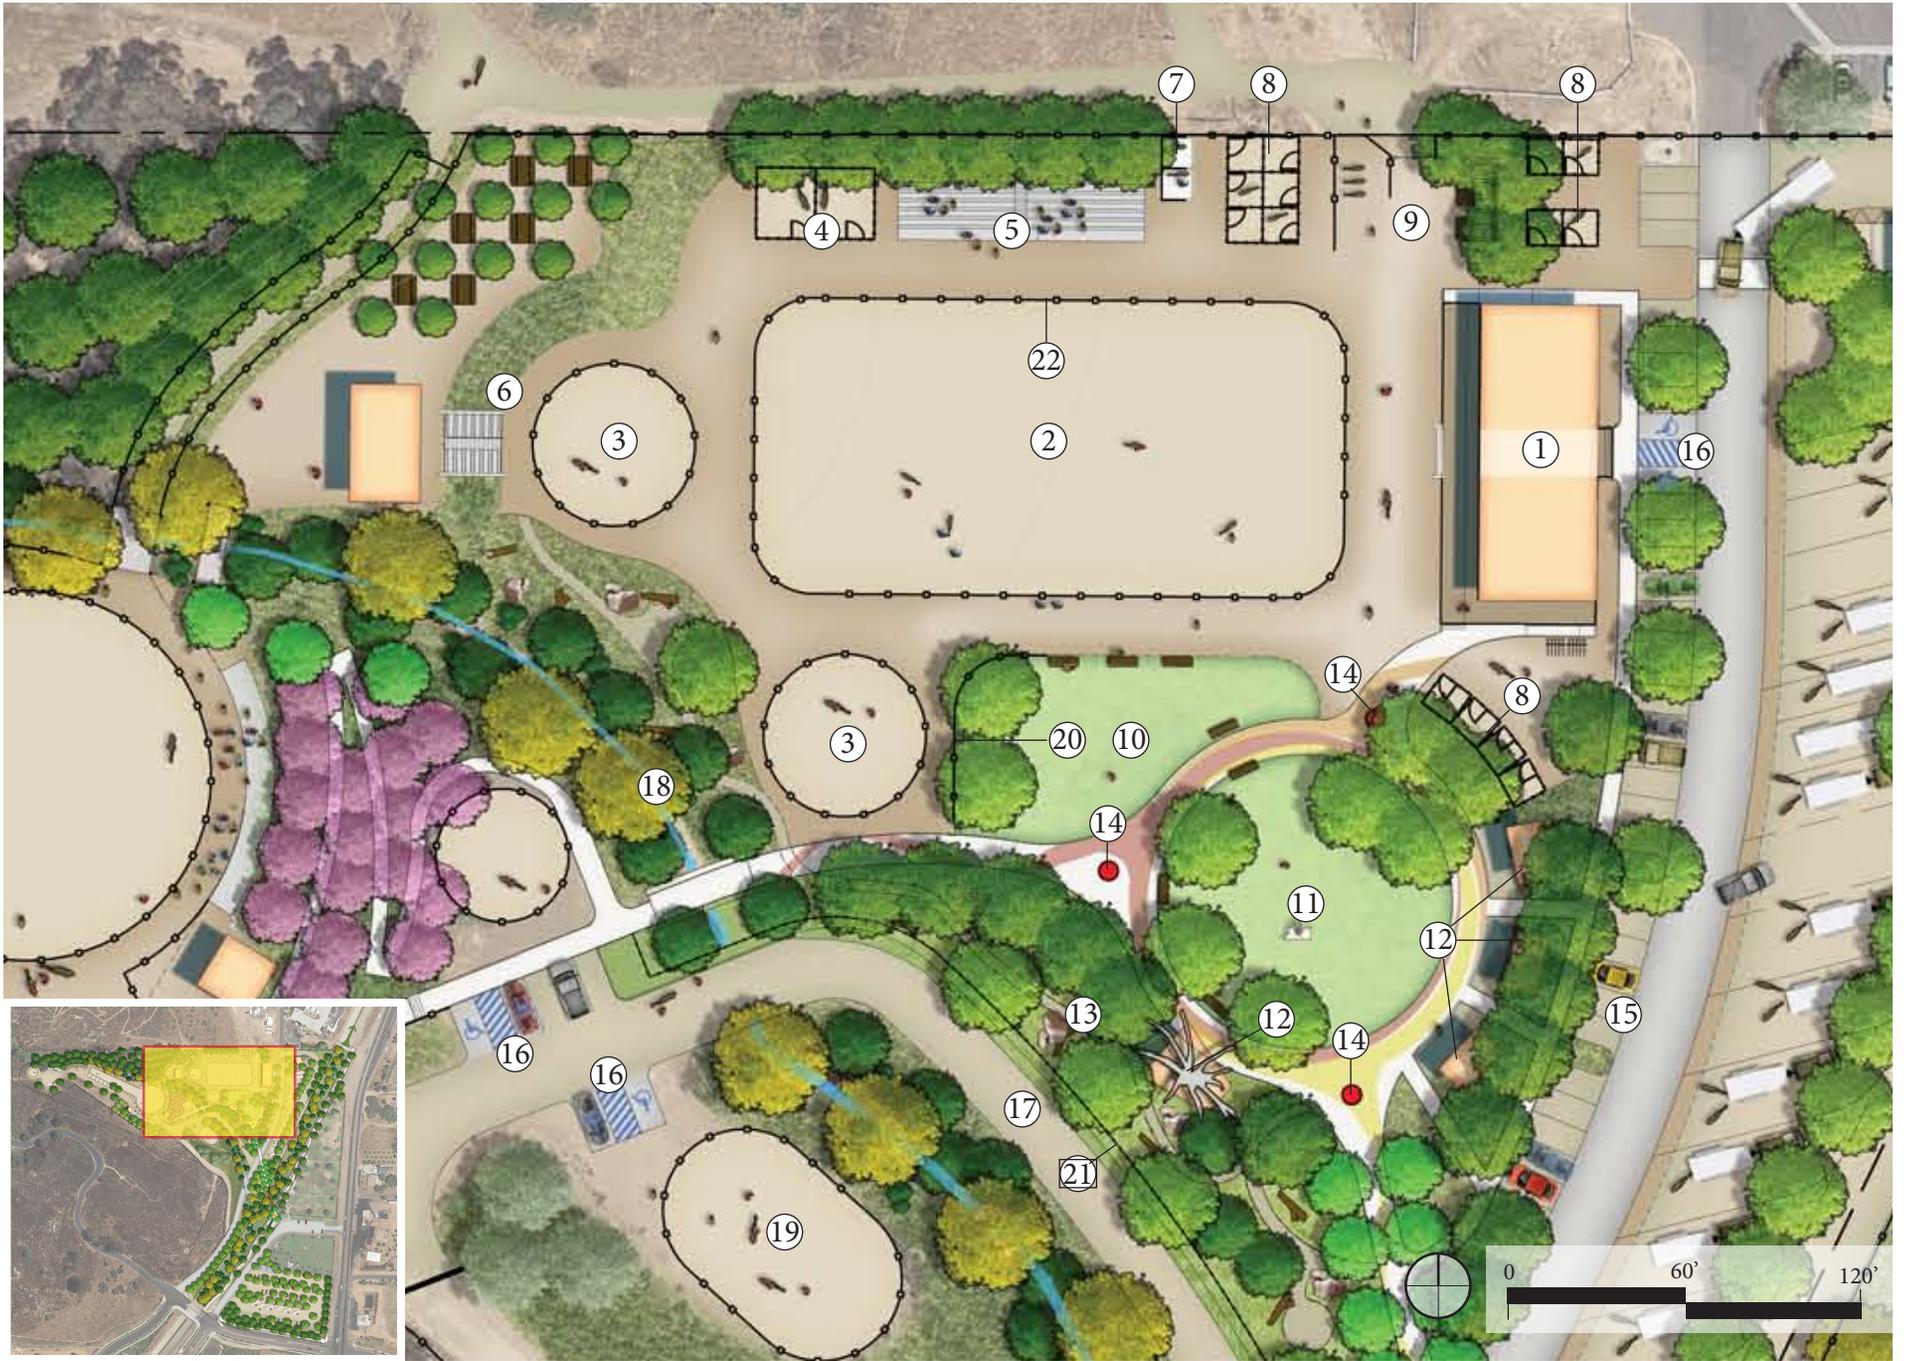
Figure 45: Lower Equestrian Area

The round lawn area, surrounded by paving with a "lasso" pattern, is integrated into the park providing passive and light active play opportunities. The perimeter of this space has three shaded picnic spaces, four horse corrals for visitors arriving by horse and a landscaped area to the west that will provide opportunities to learn about the environment and history of the area. An additional lawn area is provided north of the circular lawn area creating close viewing of activities in the large arena. The edges are natural without definition to create a rustic park appearance.

- ① Community Hall Building with 40' x 40' Multi-Use Space, Restrooms, Office Space, Kitchen/Concessions Space, Wrap around Porch and 2nd floor caretakers apartment
- ② 100' x 200' Arena
- ③ 55' Round Pen
- ④ 20' x 24' Corrals
- ⑤ Bleachers
- ⑥ Amphitheater Seating
- ⑦ Wash Racks
- ⑧ 12' x 12" Corrals
- ⑨ Staging Area at Caballo Trailhead
- ⑩ Mounded Lawn Area
- ⑪ Lawn Area Surrounded by Paved Walkway with Lasso Pattern to Reflect Equestrian Activities
- ⑫ Shade Structures
- ⑬ Nature Exploration Area
- ⑭ Public Art Opportunity
- ⑮ Standard Vehicular Parking
- ⑯ Disabled Parking Stalls
- ⑰ 24' Wide Two-Way Improved Access Road
- ⑱ Tributary Creek Improved with Native Planting
- ⑲ Therapeutic Arena
- ⑳ 2-Rail Fence
- ㉑ 3-Rail Fence
- ㉒ 4-Rail Fence

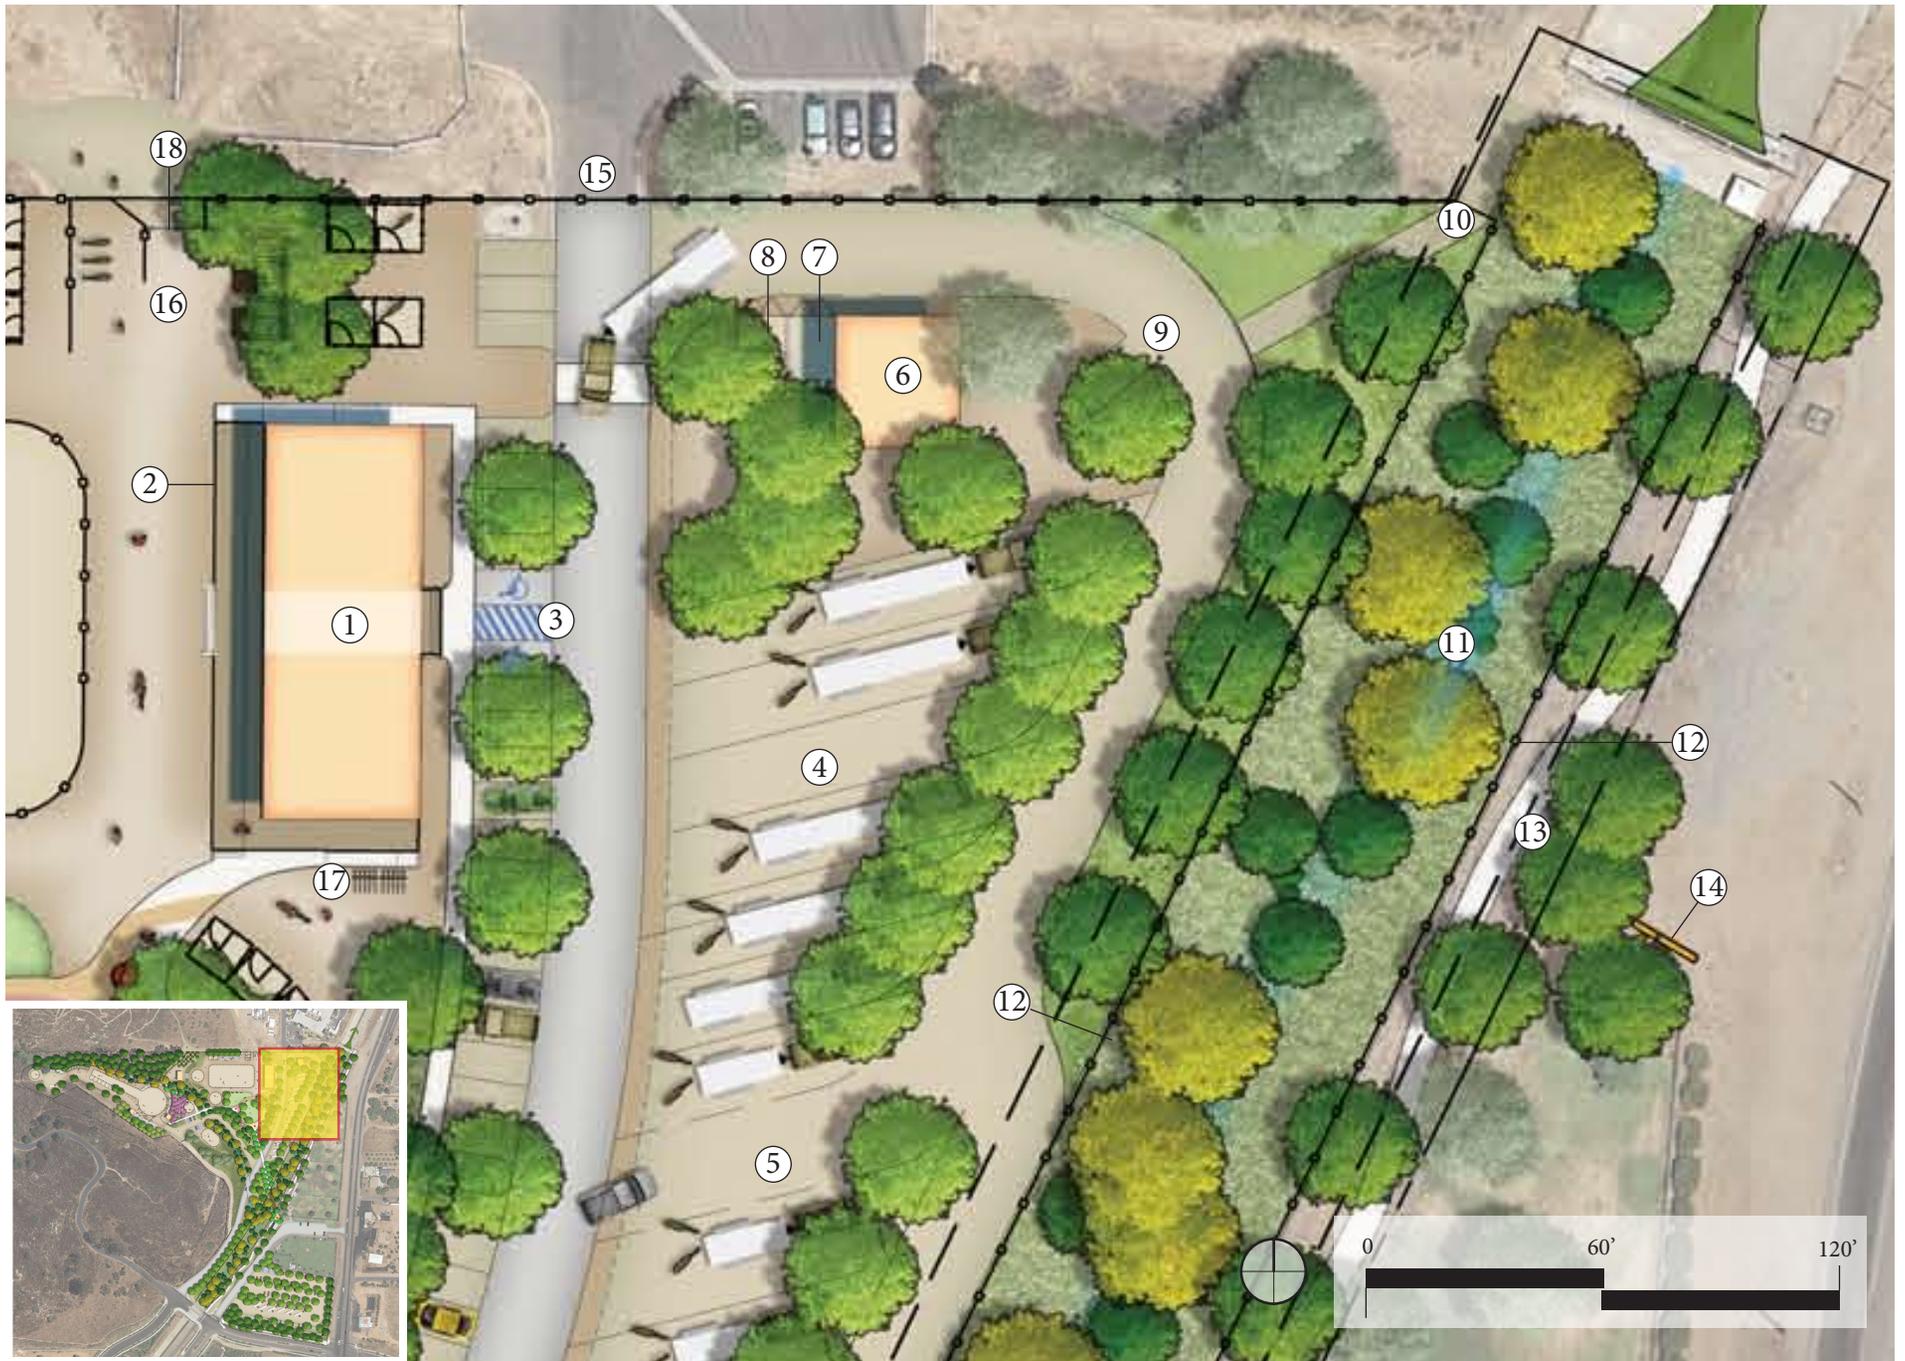
Figure 46: Horse Trailer Parking

- ① Community Hall Building / Restrooms / Caretaker Residence / Offices - raised 18”
- ② Porch - Raised 18”
- ③ Disabled Parking Stalls
- ④ Trailer Parking - 18’ x 60’ minimum with Decomposed Granite Surface
- ⑤ Emergency Drive Through and Turn-Around Loop
- ⑥ Maintenance Building
- ⑦ Muck Storage - Covered
- ⑧ Trash Enclosure
- ⑨ Maintenance Crew Parking
- ⑩ Pedestrian Access to Existing Pedestrian Bridge
- ⑪ Escondido Creek Channel
- ⑫ 4 - Rail Fence
- ⑬ Escondido Creek Trail Extension
- ⑭ City Entry Monument #1
- ⑮ Gate for Future Expansion of Road
- ⑯ Staging area for Daley Ranch
- ⑰ Bicycle Rack
- ⑱ Entry Monument #4

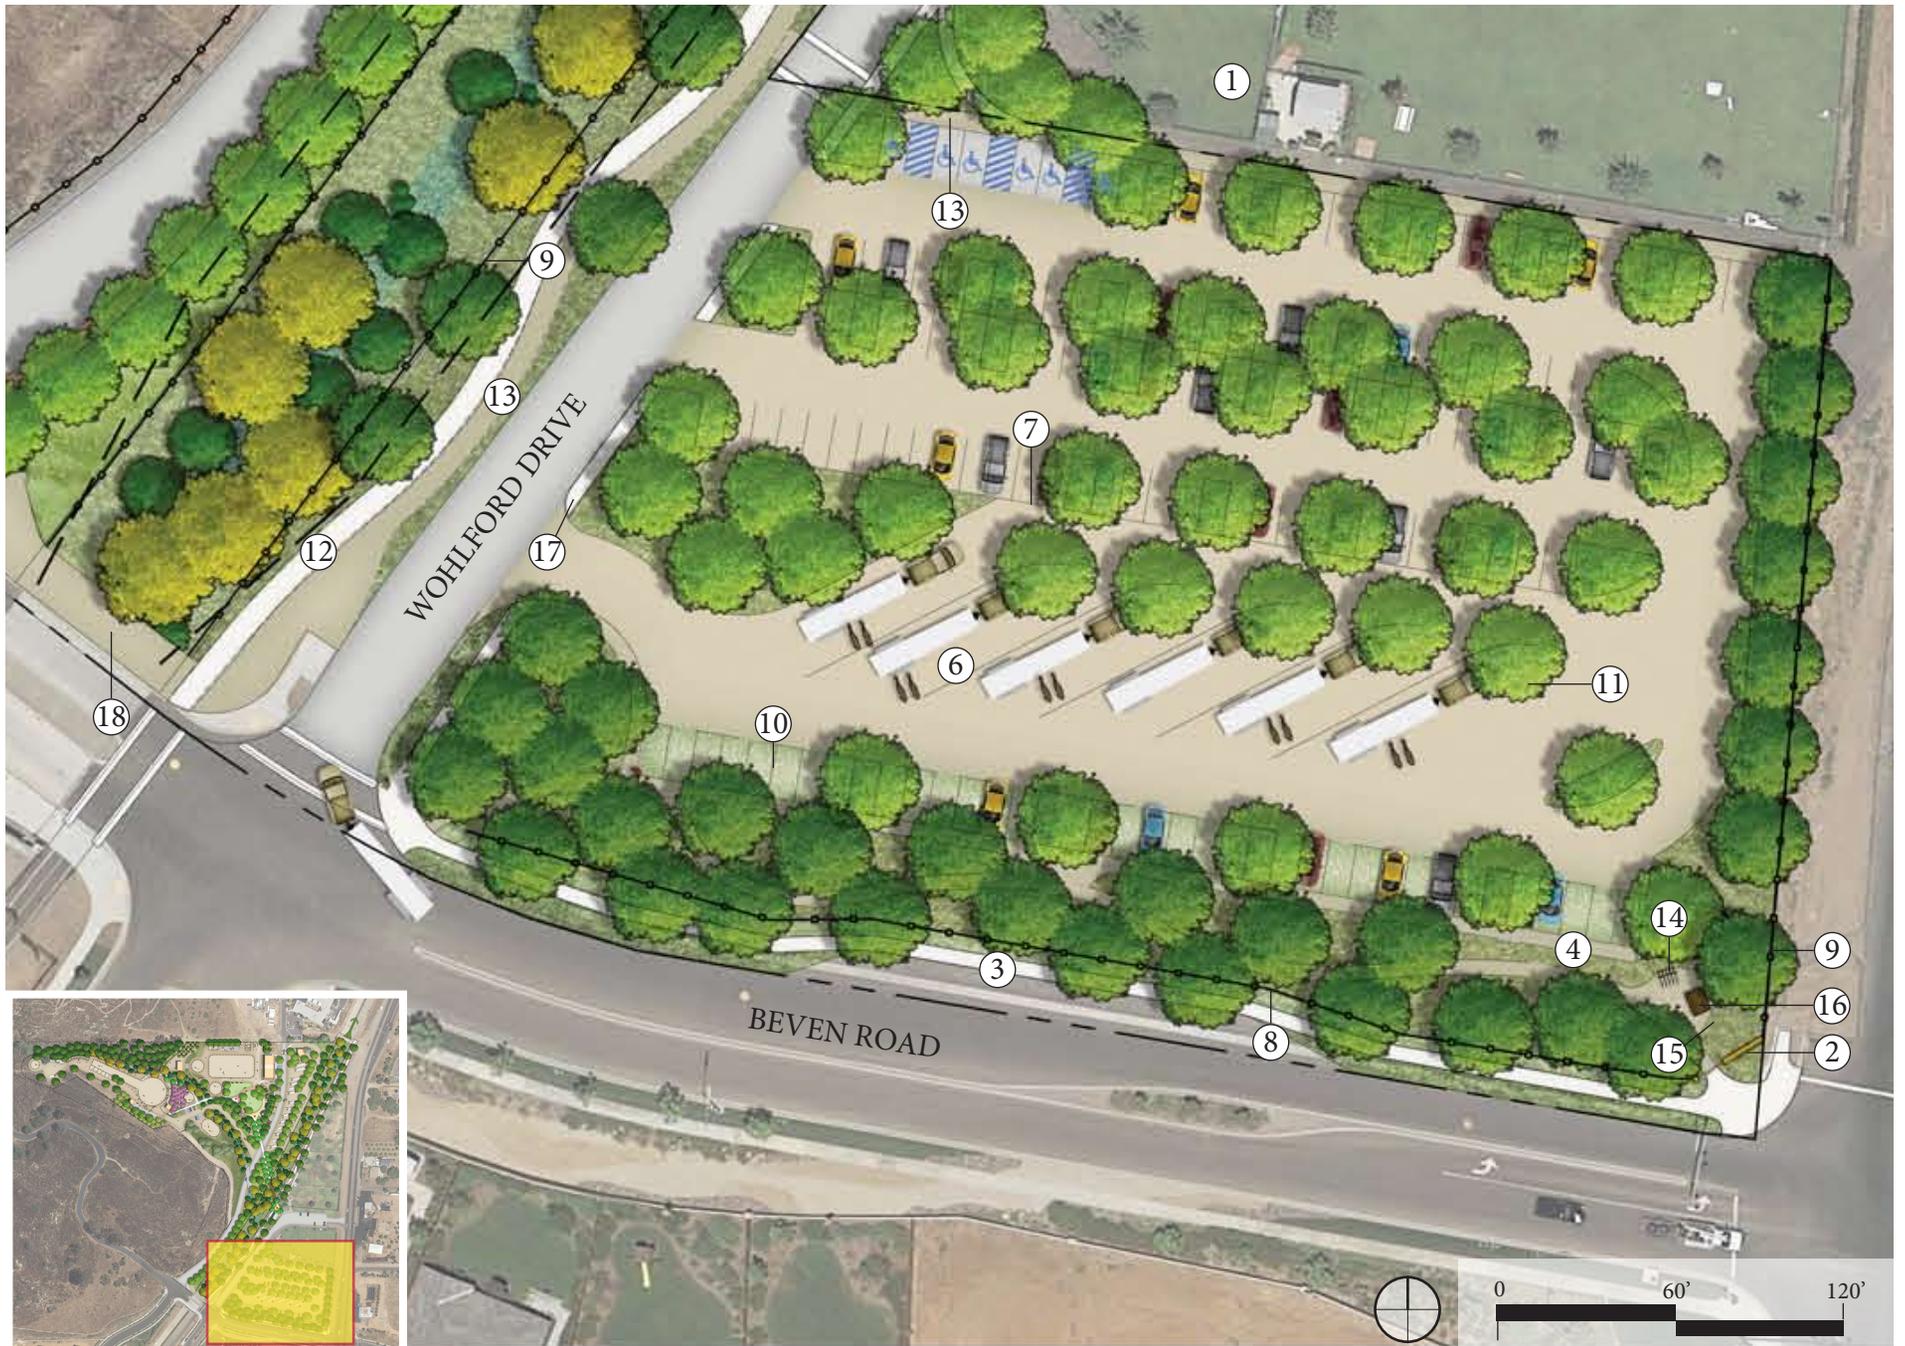
Figure 47: Lower Multi-Use Parking

The Park Entry Monument #2 identifies the park and other amenities found in the area. Pedestrians walk through the Ranch style gateway and walk along a meandering DG path with benches along the way. The landscape will be used to provide visual interest and water quality treatment meeting hydromodification requirements.

- ① Hidden Valley Obedience Club
- ② Park Entry Monument Sign #2
- ③ Existing Concrete Walkway
- ④ New Decomposed Granite Pathway with benches
- ⑤ Decomposed Granite Parking Lot
- ⑥ 28' x 75' Trailer and Motorhome Parking
- ⑦ Log Tire Stops from Eucalyptus Trees On-Site
- ⑧ 3 - Rail Fence
- ⑨ 4 - Rail Fence
- ⑩ GrassPave2 Parking Spaces to Expand the "Park" Experience
- ⑪ Shade Trees
- ⑫ Escondido Creek Trail Extension
- ⑬ Decomposed Granite Pathway
- ⑭ Bicycle Rack
- ⑮ Drinking Fountain
- ⑯ Picnic Table
- ⑰ New Concrete Pathway
- ⑱ 16" Wide Bridge with Decomposed Granite Paving

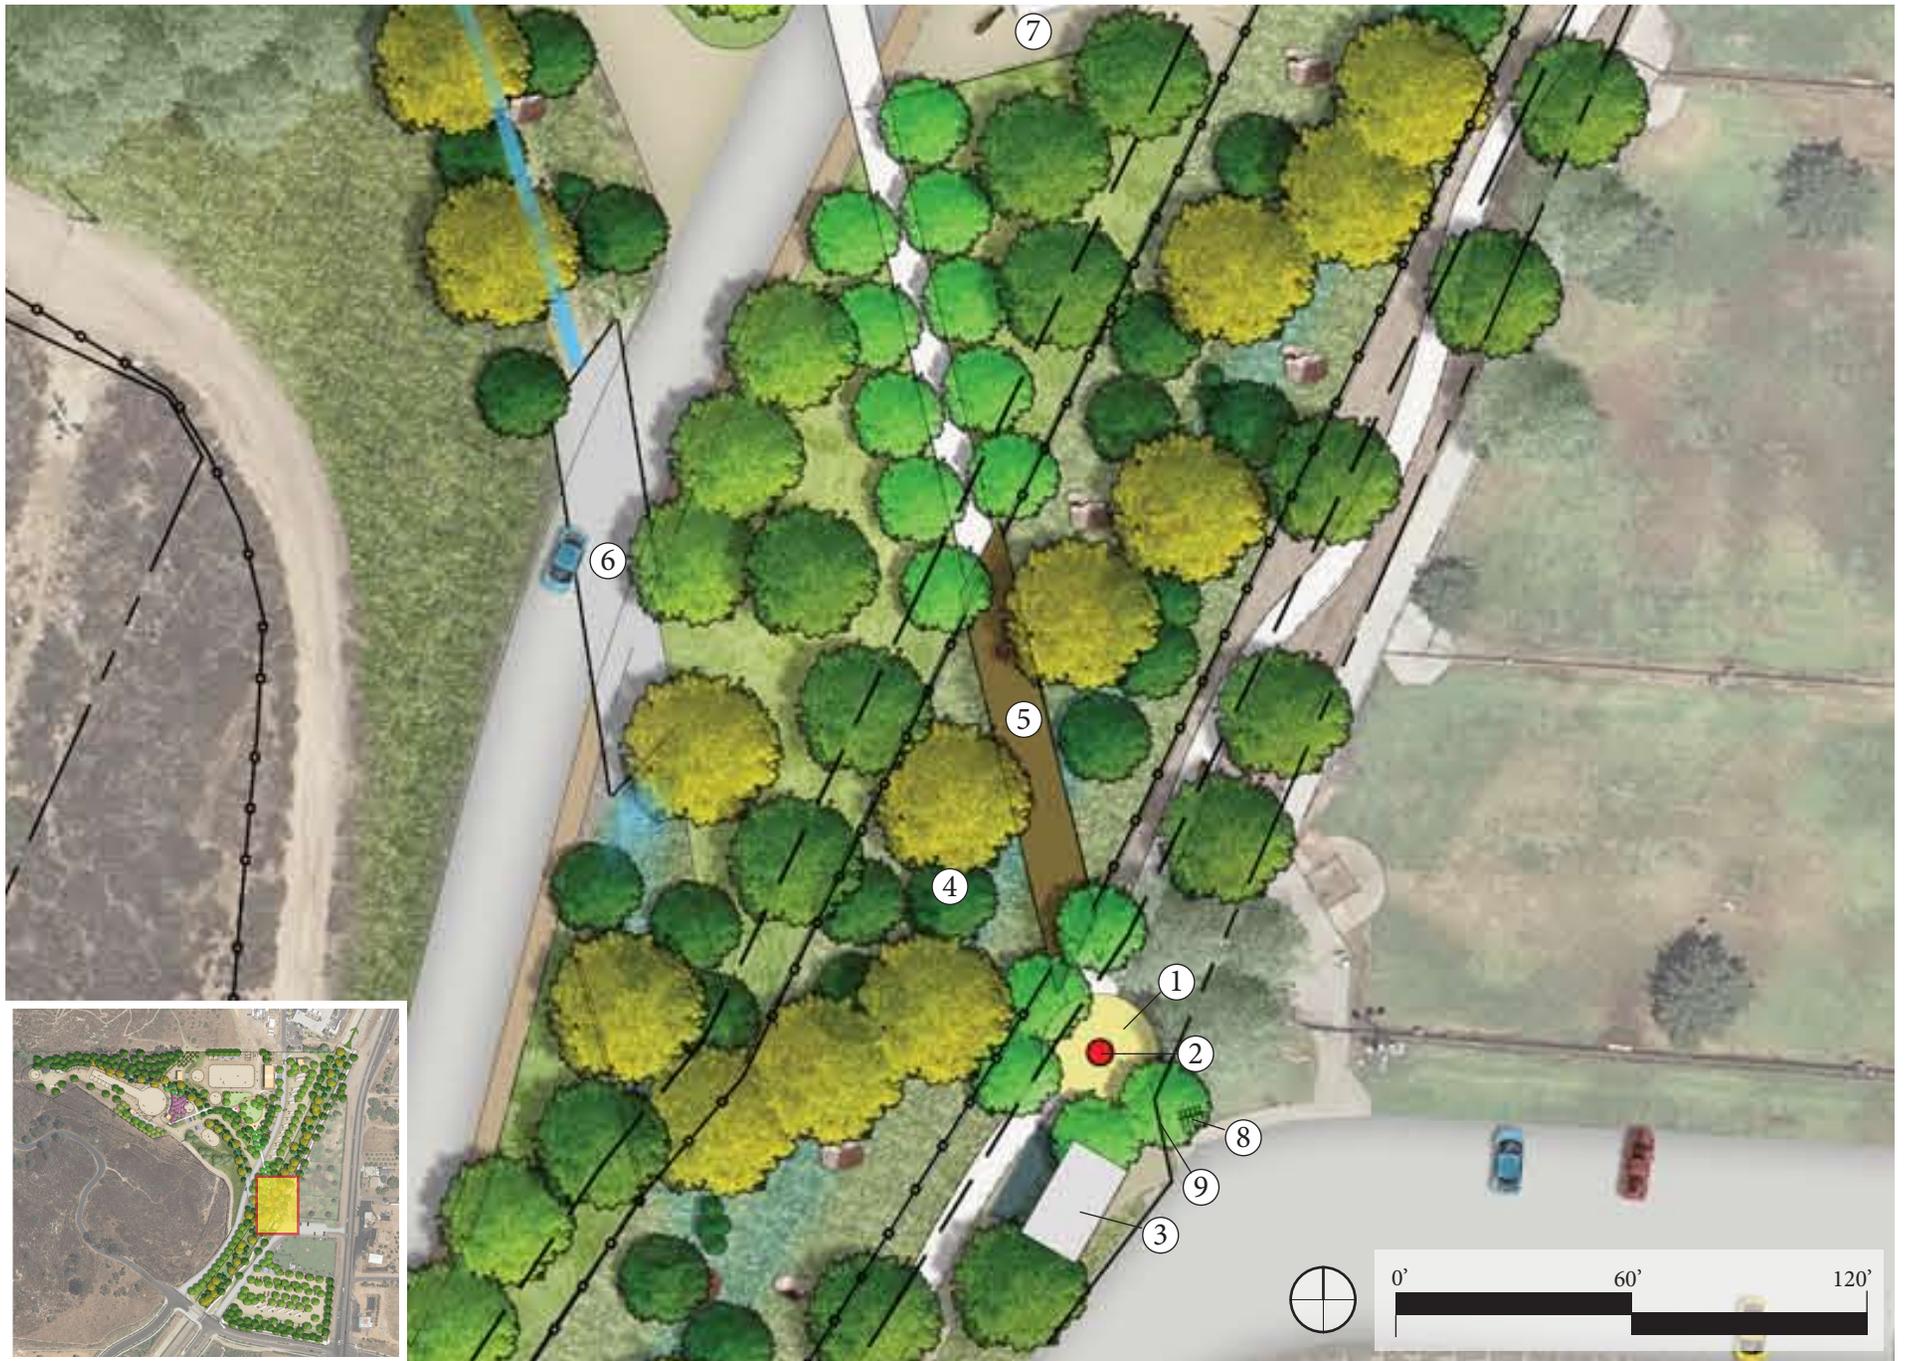
Figure 48: Dog Park - El Caballo Park Connection

A rustic bridge is proposed to link the two spaces with an entry point strategically located at the southwest end of Mayflower Dog Park with a direct view and path to the heart of El Caballo Park. Existing parking is immediately adjacent to this park entry.

- ① Dog Park Connection Node
- ② Public Art
- ③ Restrooms
- ④ Escondido Creek Channel
- ⑤ New Pedestrian Bridge
- ⑥ Existing Culvert
- ⑦ Trailer Parking
- ⑧ Bicycle Rack
- ⑨ Drinking Fountain

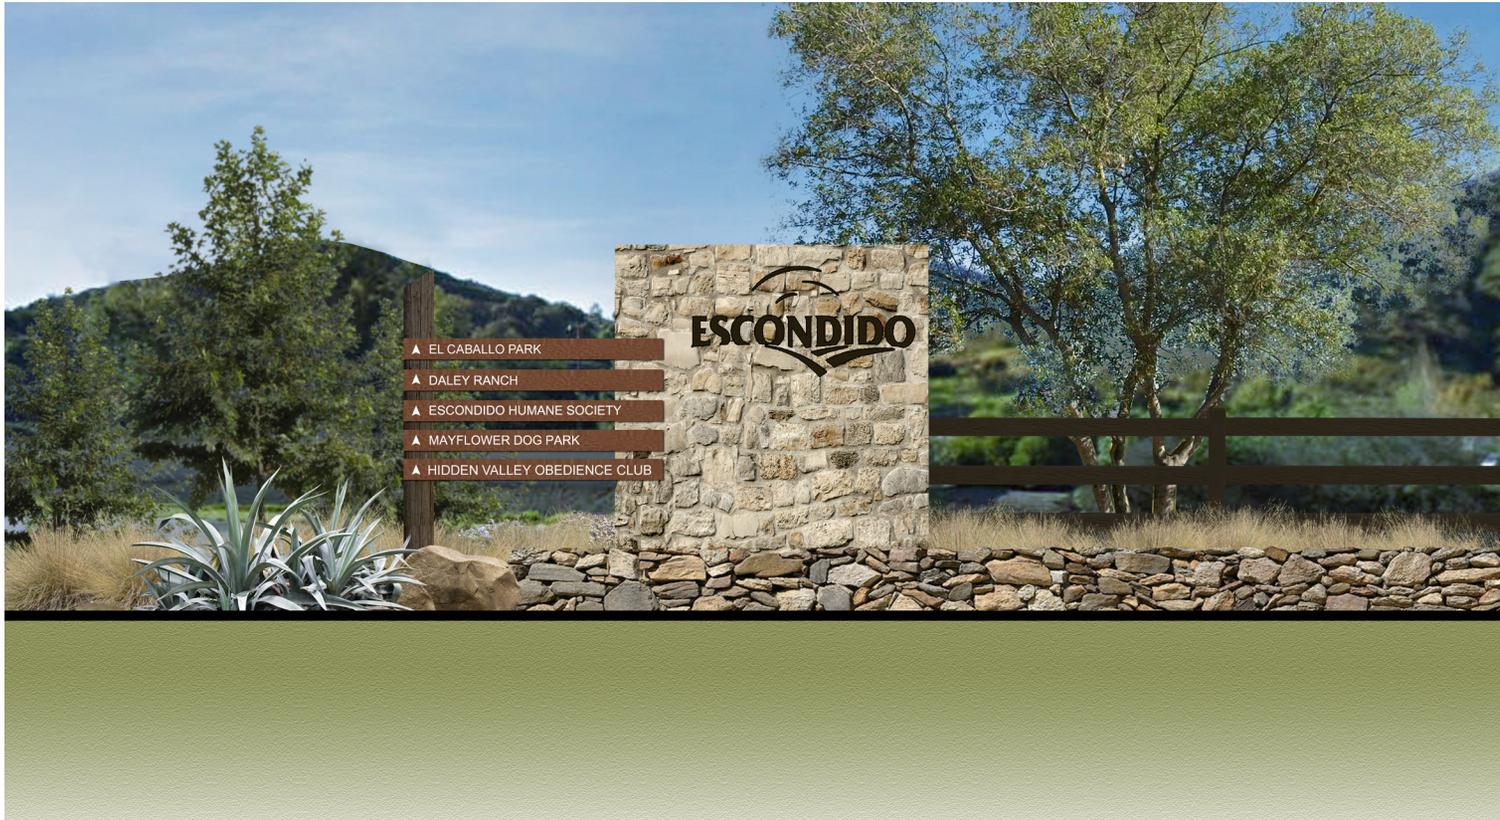
Figure 55: Entry Monument Sign #1

Entering Escondido from the northeast, drivers will see this entry monument at the north end of the park, next to East Valley Parkway. This monument acts as the gateway signage to the City and identifies the following nearby destinations:

- El Caballo Park
- Daley Ranch
- Escondido Humane Society
- Mayflower Dog Park
- Hidden Valley Obedience Club

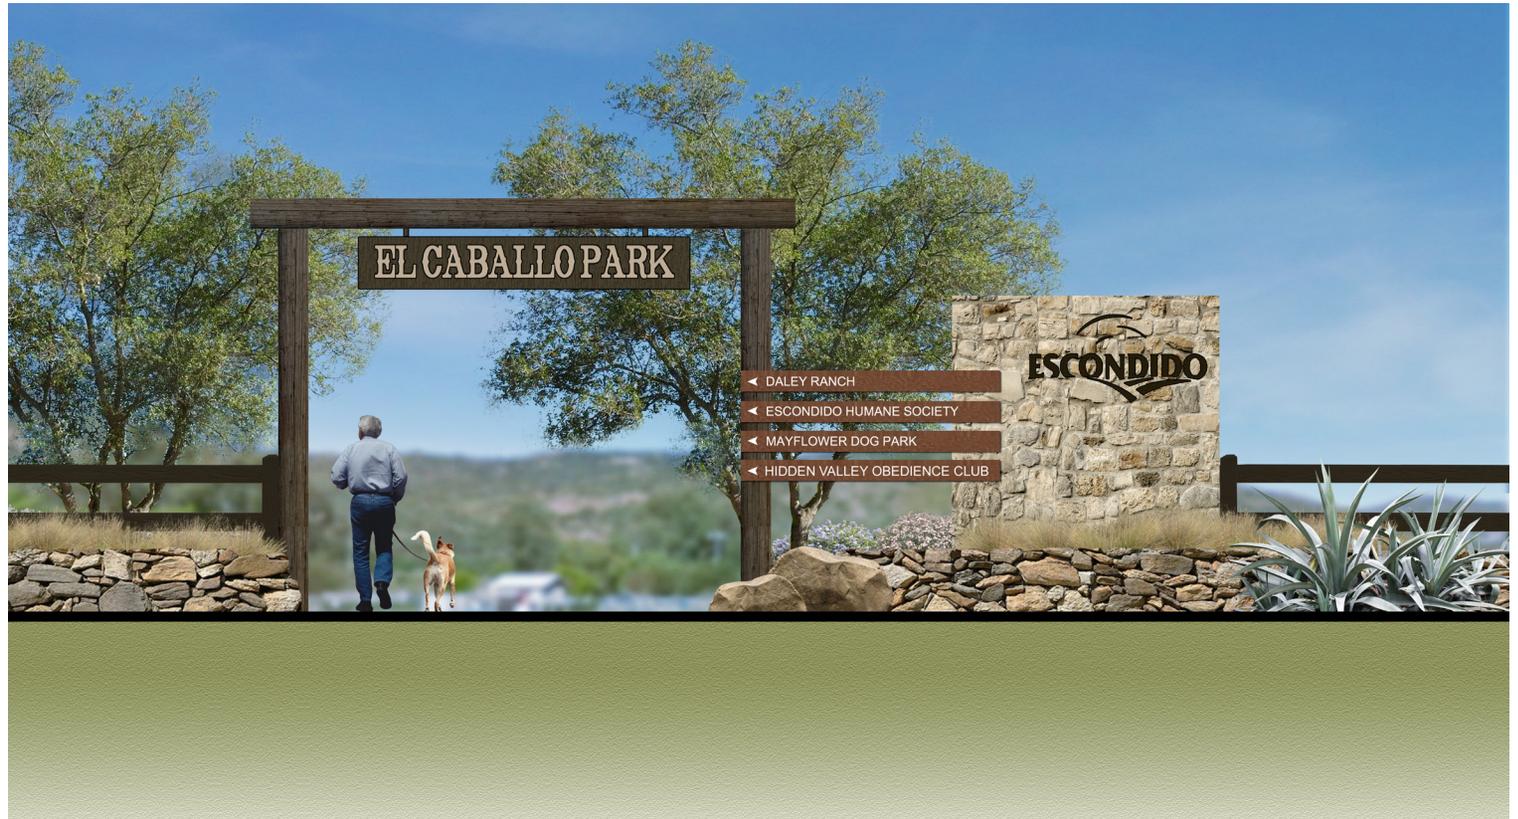
Figure 56: Entry Monument Sign #2

- Daley Ranch
- Escondido Humane Society
- Mayflower Dog Park
- Hidden Valley Obedience Club

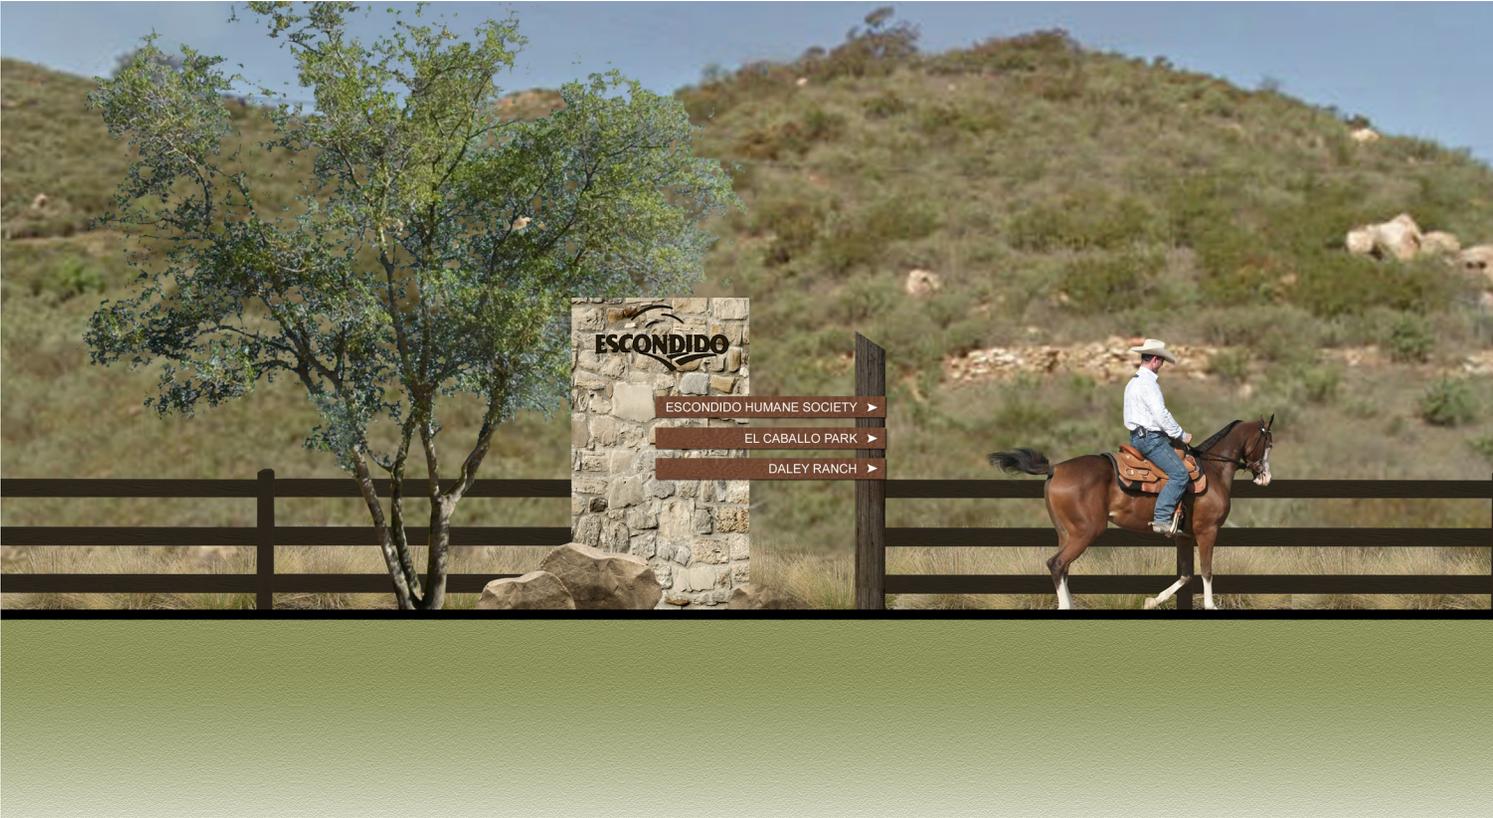
Figure 57: Entry Monument Sign #3

Signage on the monument text is the following:

- El Caballo Park
- Daley Ranch
- Escondido Humane Society

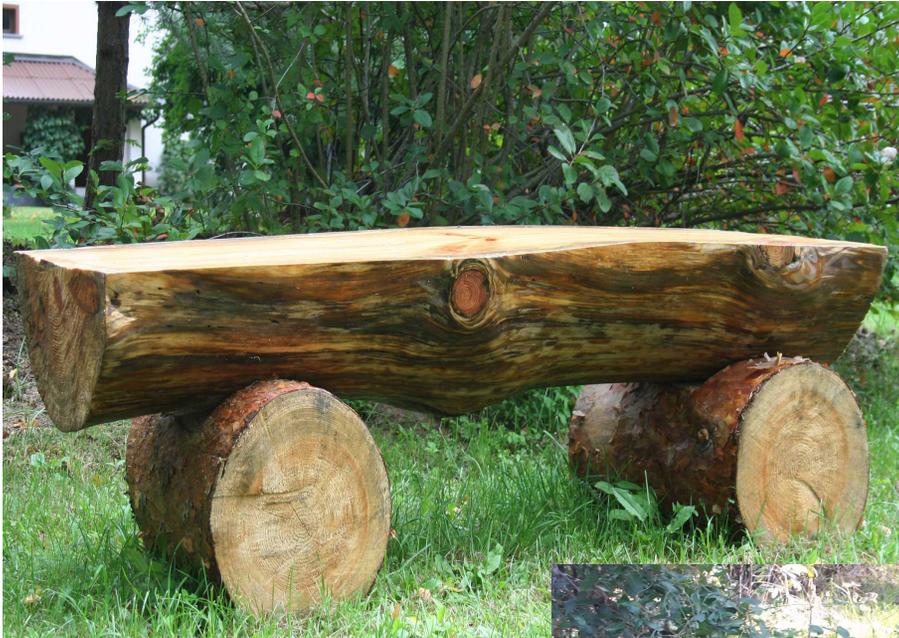
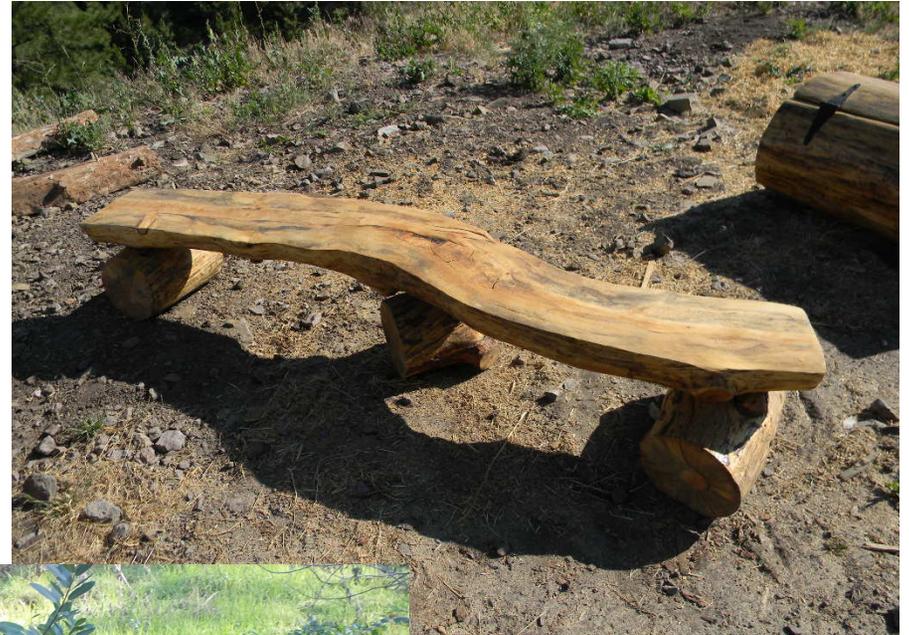
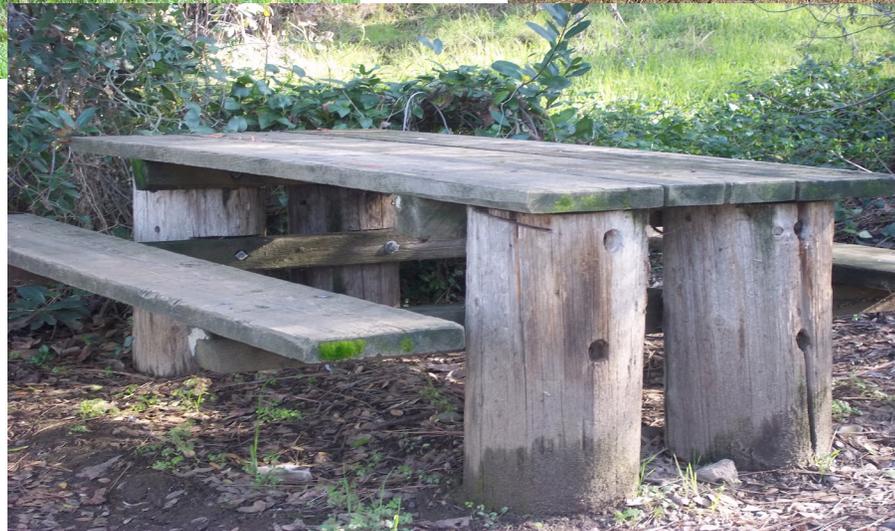
Figure 61: Furniture

Furniture throughout the park is to be rustic and made of natural looking materials. Benches may be made of the Eucalyptus trees growing on site and are to be made at the time the Eucalyptus trees are cut down at the northwest corner of the property.

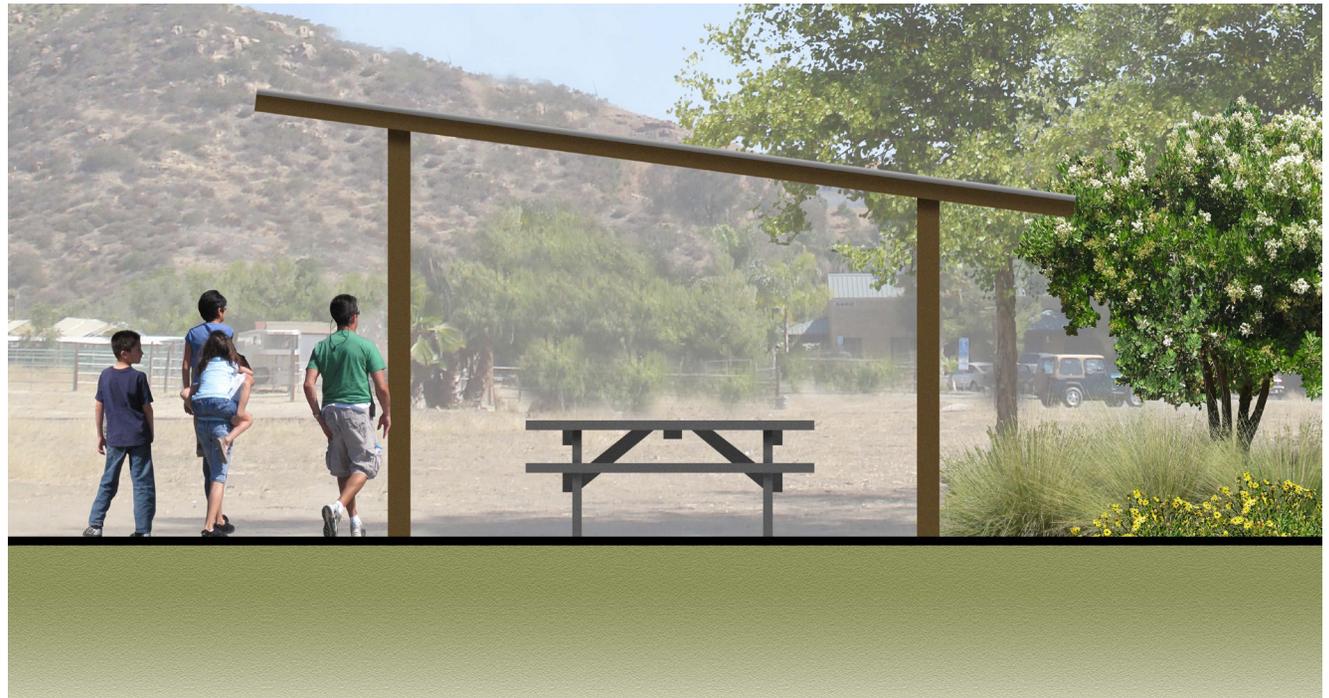
Figure 62: Shade Structures

Materials are selected to reduce the cost of park development and to follow a style of construction on a “no-frills” working ranch. Quality construction will still be required as in any other public park.
