DRAFT
EL CABALLO PARK MASTER PLAN REPORT
DATE: 02-11-14

PREPARED FOR:
CITY OF ESCONDIDO
201 NORTH BROADWAY
ESCONDIDO, CA 92025

PREPARED BY:
WYNN-SMITH LANDSCAPE ARCHITECTURE, INC.
12315 OAK KNOLL RD., SUITE 230 POWAY, CA 92064

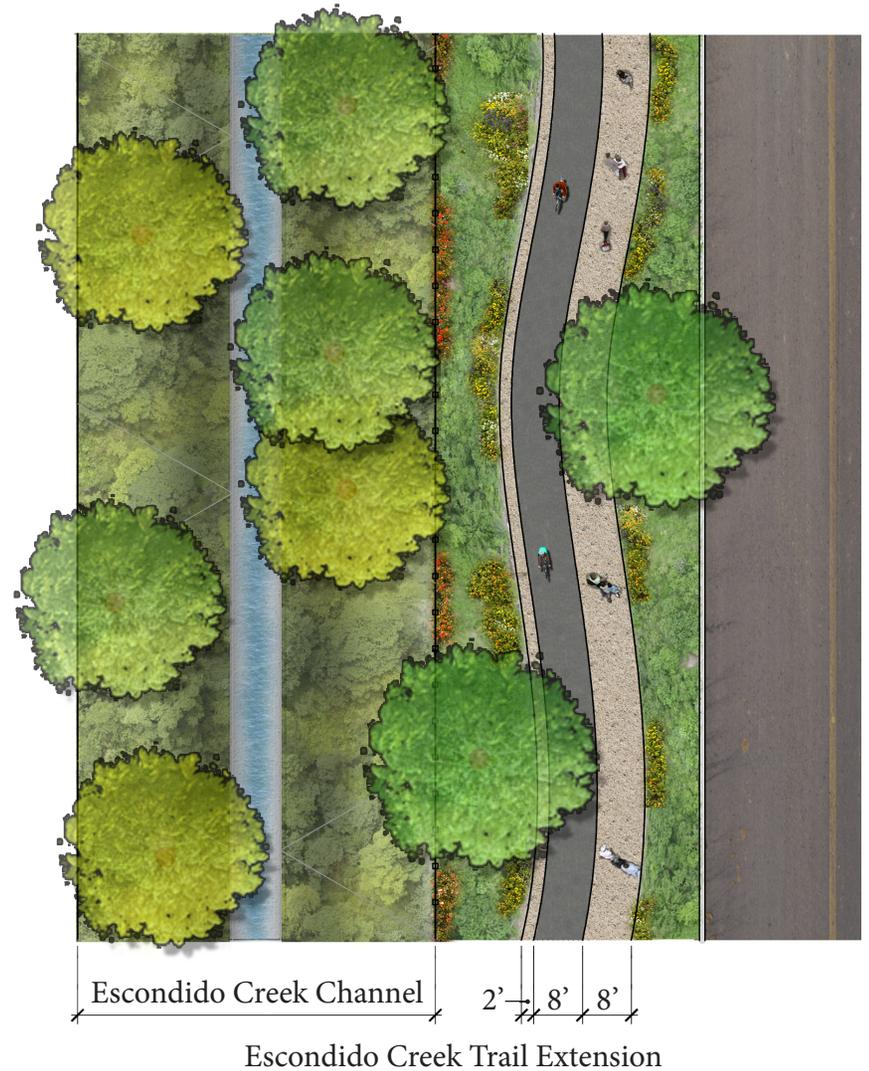
A 4-Rail fence, 5' high, will separate the trail from the Escondido Creek. Native plants will be used for the length of the trail with vines spaced intermediately along the fence line.

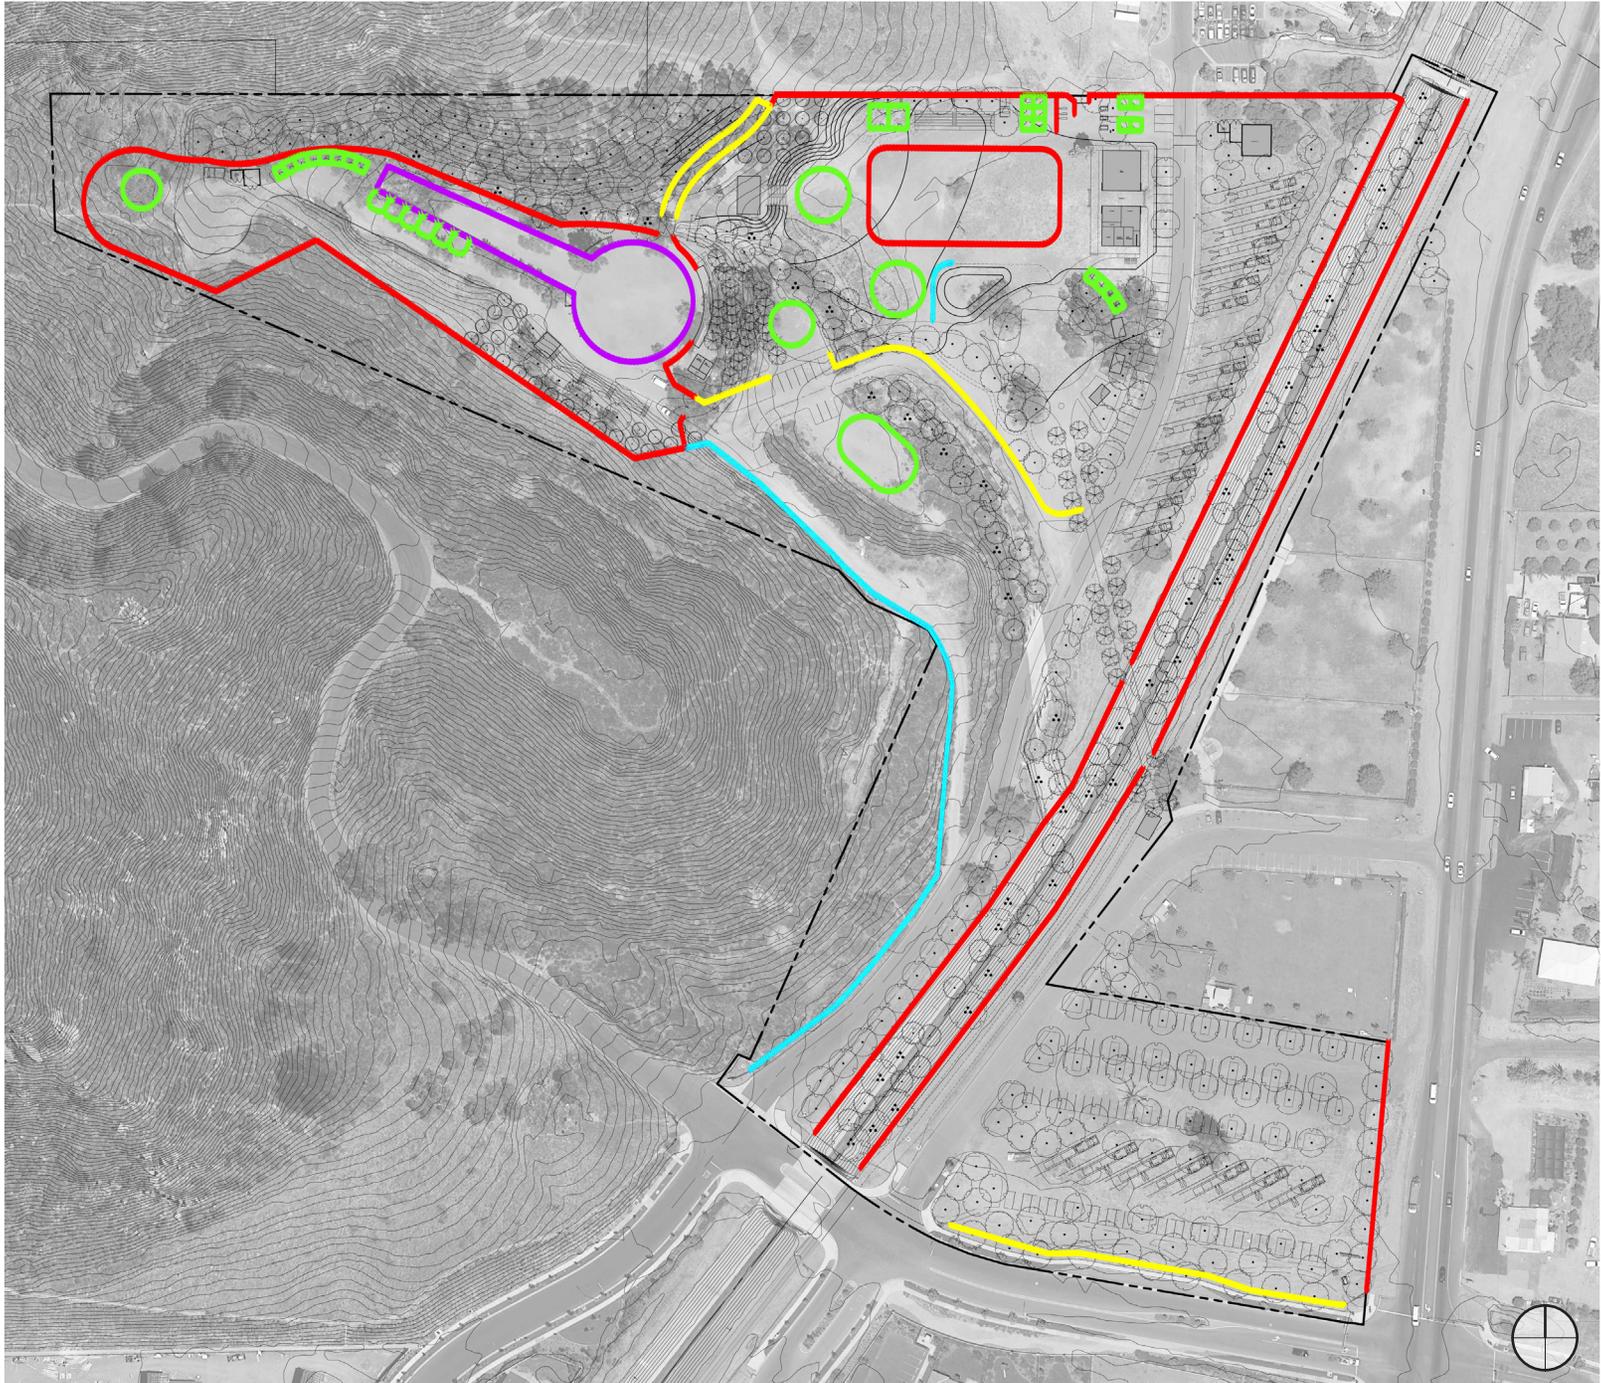
Figure 68: Fencing Master Plan

For night-time security, a simple vehicular gate is located at the entry to the park along Save-A-Life Drive.

Fencing along East Valley Parkway is to be coordinated with the work associated with the widening of East Valley Parkway.

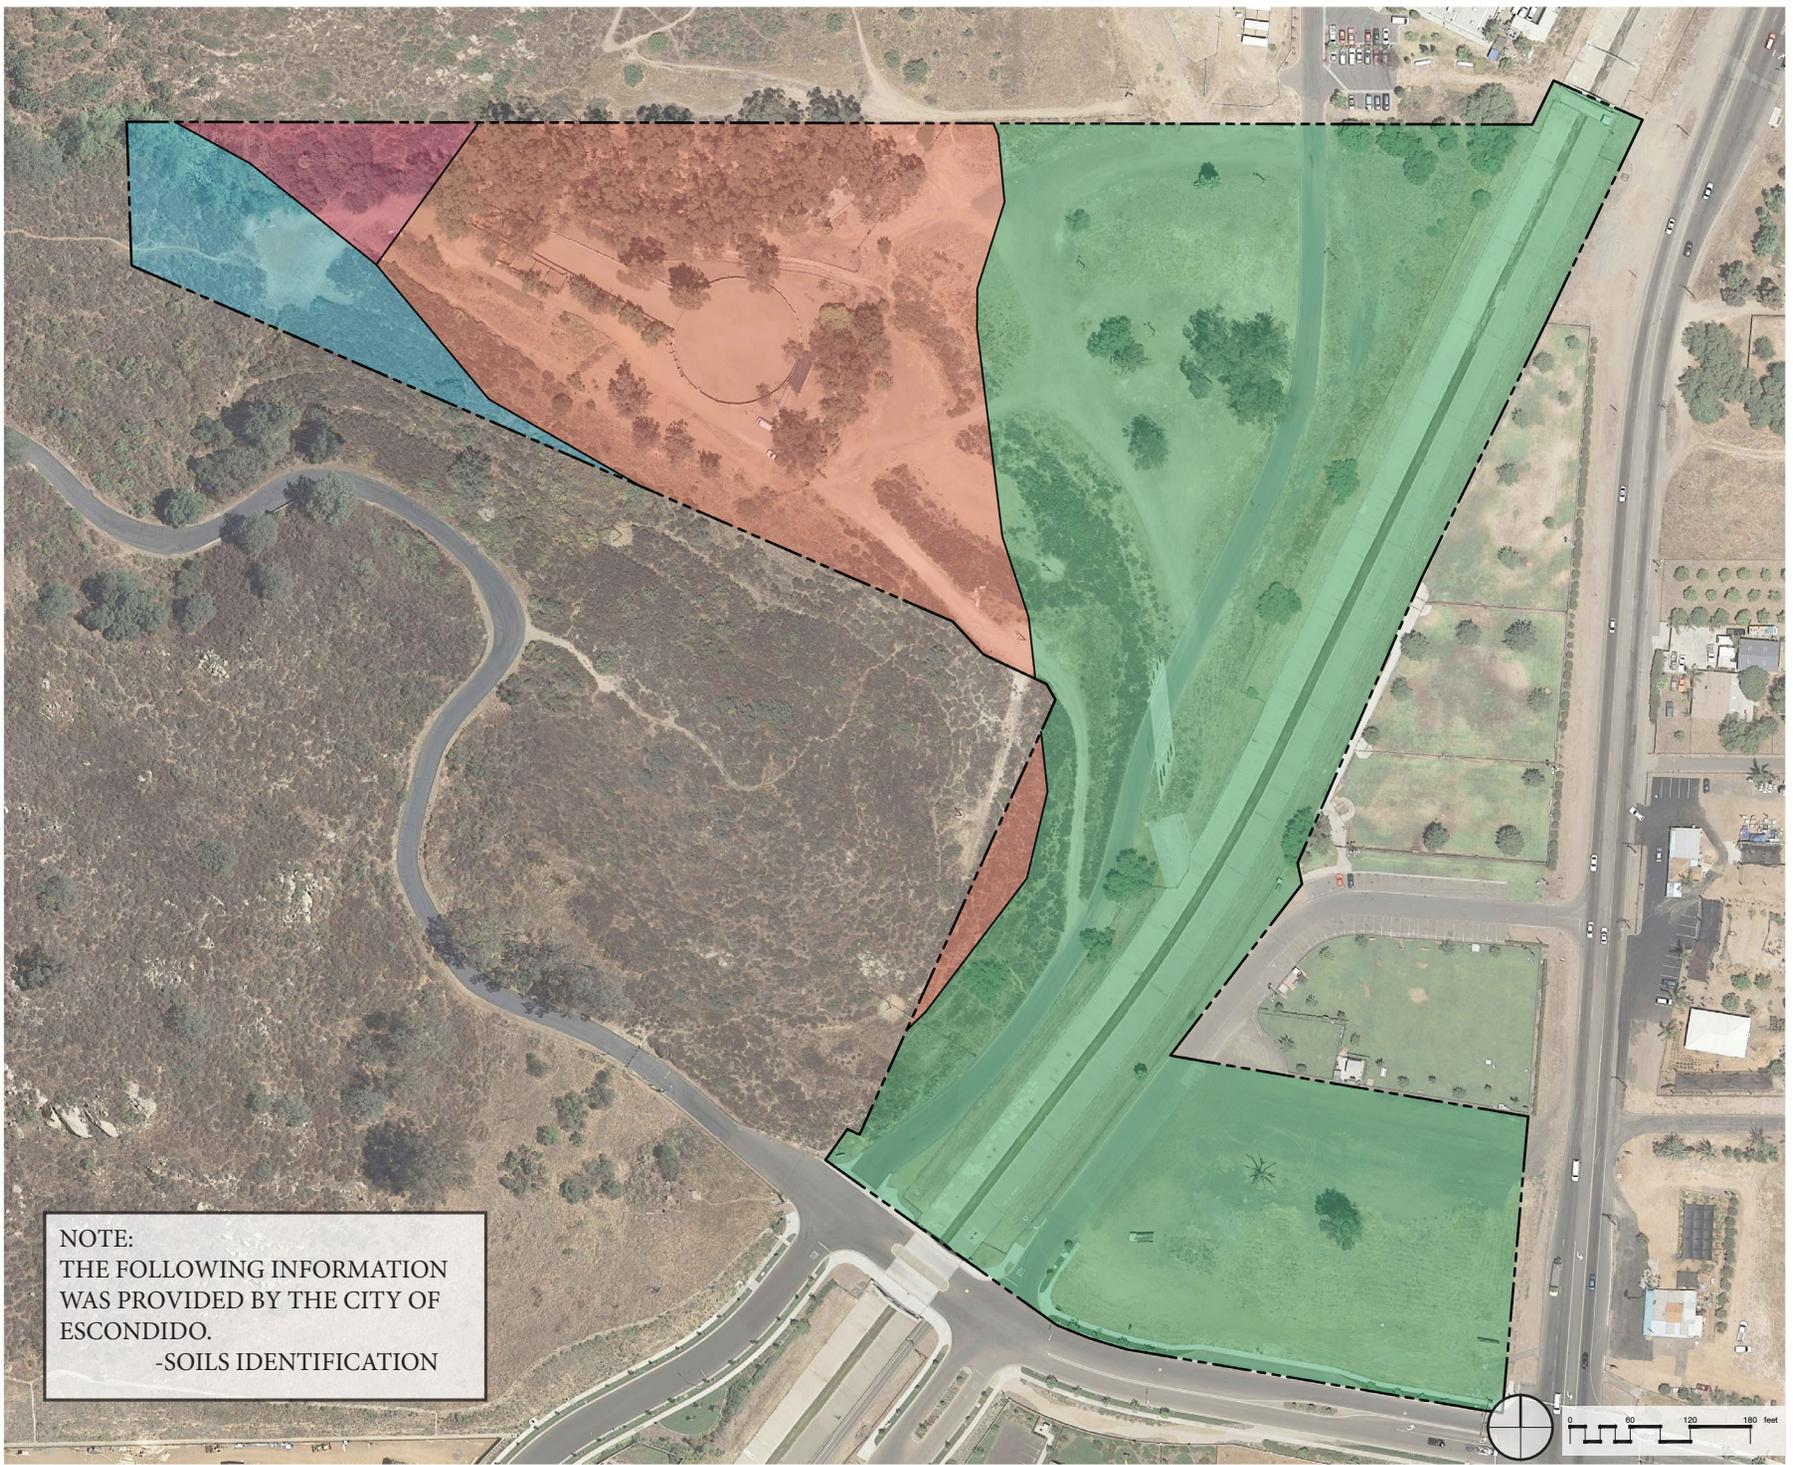
Figure 76: Soils Analysis Plan

Visalia Sandy Loam, 0 to 2 percent slopes

NOTE:
 THE FOLLOWING INFORMATION
 WAS PROVIDED BY THE CITY OF
 ESCONDIDO.
 -SOILS IDENTIFICATION

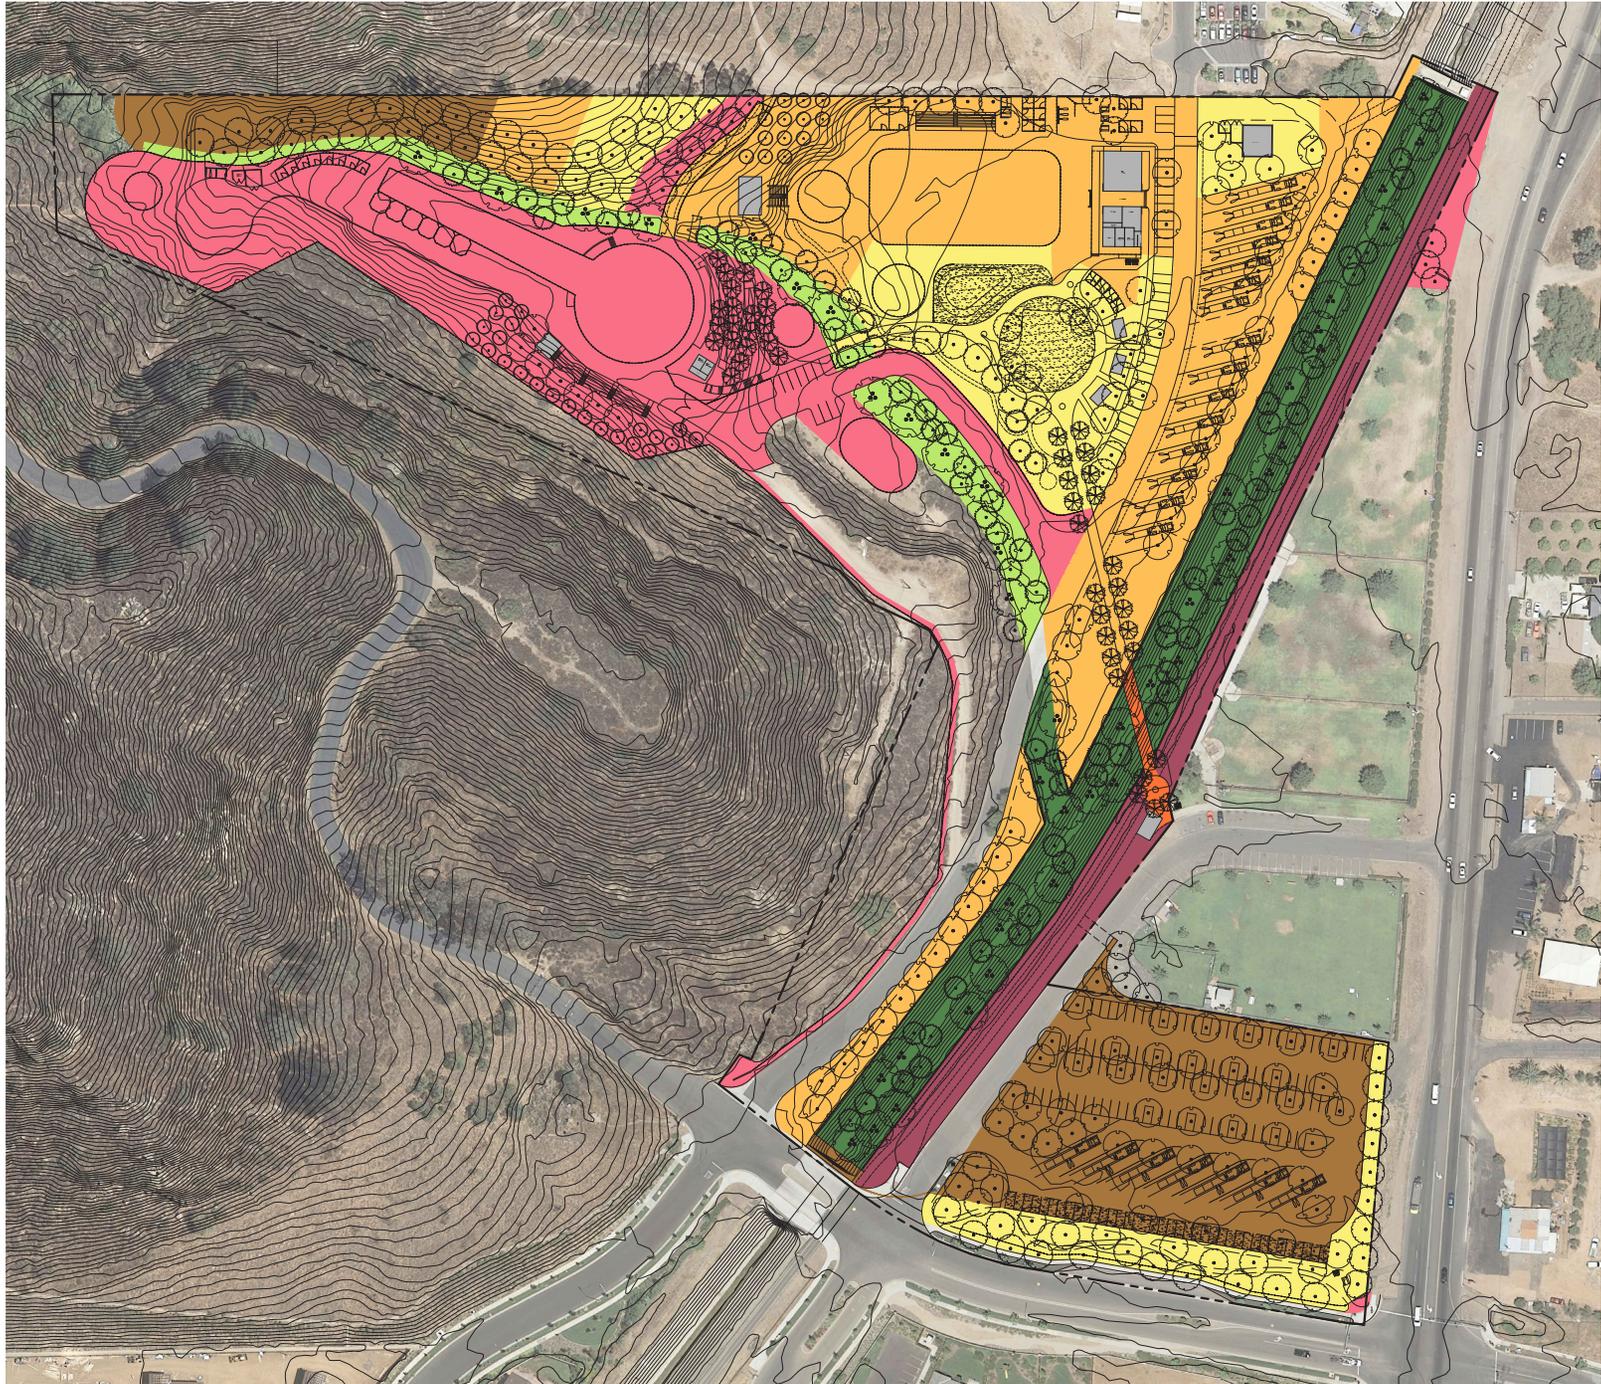
Figure 82: Phasing Plan

This phase includes maintenance building, picnic shade structures, nature exploration areas, open lawn, paved pathways, 4 small corrals, a pedestrian bridge over the existing small tributary creek and standard vehicular parking areas.
